Property: 801 Ferndale Dr
Round Rock, TX 78664
Client: Koustav Bhattacharya
Inspection Type: Property Assessment Report
Lead Inspector: Andy Jordan #9458
Date: August 31, 2016

ADDENDUM: REPORT SYNOPSIS

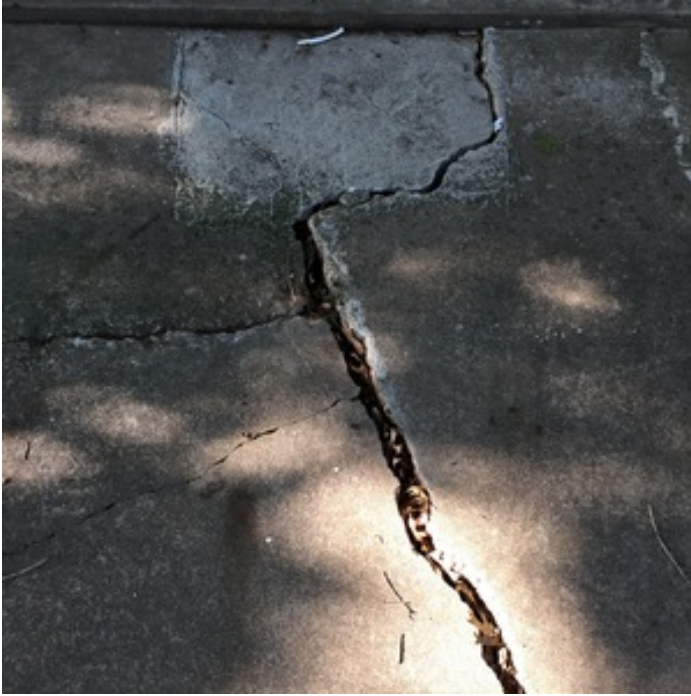
Evidence of previous foundation repair was noted. Concrete patches at the driveway and front porch are typical indicators of previous pier placement. Consulting with the current owner is recommended to determine if documented repair information is available. Contacting the repair company (if applicable) is recommended to determine what, if any, warranty protections are associated with the structure.

PATCH FROM REPAIR

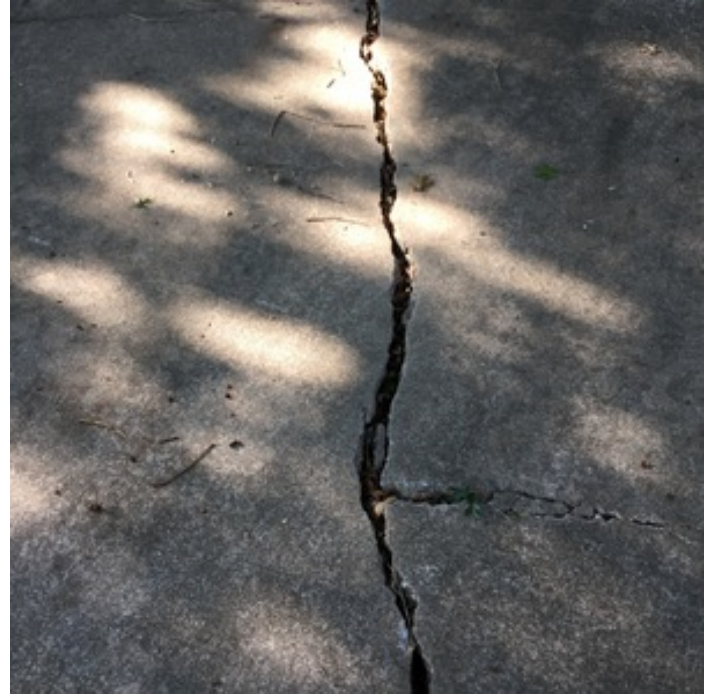
- Slab Crack/Fracture at Right Exterior Foundation: Appx. 1/8" Running Vertically
- Slab Fracture at Front Porch: Appx. 1/4" Gap and Height Offset of 1/4" Running Horizontally
- Fractured Driveway Slab: Evidence of Soil Shifting and Damage
- Various Drywall Cracks and Flaws: Most Crack Gaps 1/8" or Less Running Diagonal, Horizontal, and Vertical
- Uneven Doors Throughout: Evidence of Settlement
- Elevated Survey Readings (ZipLevel Pro - Calibrated 10/2016): Total Difference of 3.7"

DRIVEWAY FRACTURES

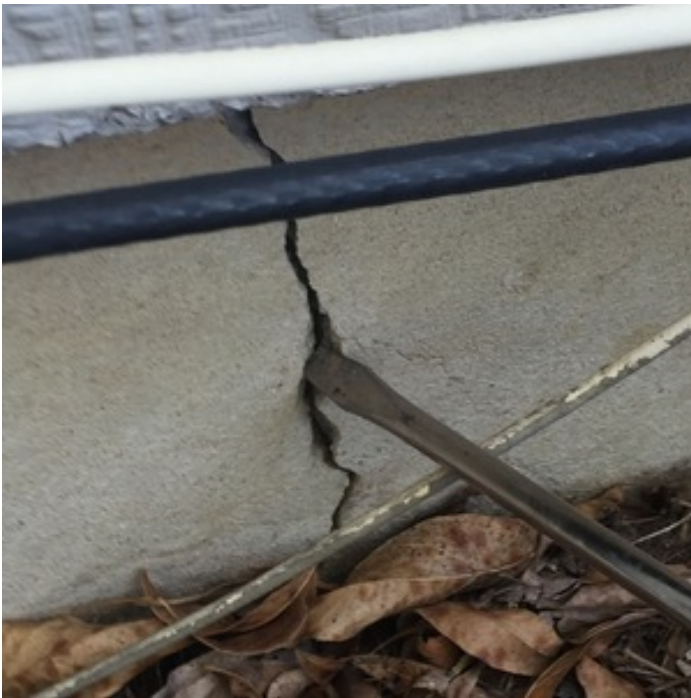
1/8" CRACK RIGHT FOUNDATION

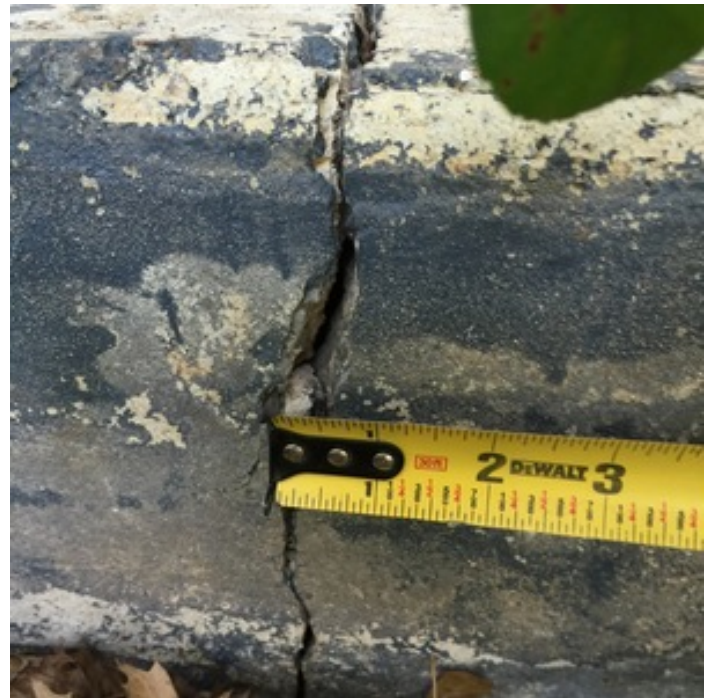
1/4" CRACK FRONT PORCH

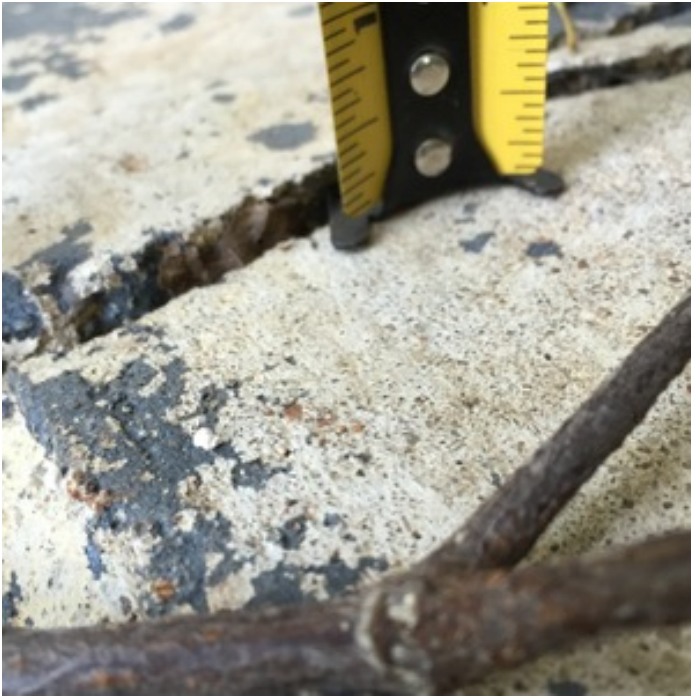
1/4" VERTICAL SHIFT FRONT PORCH

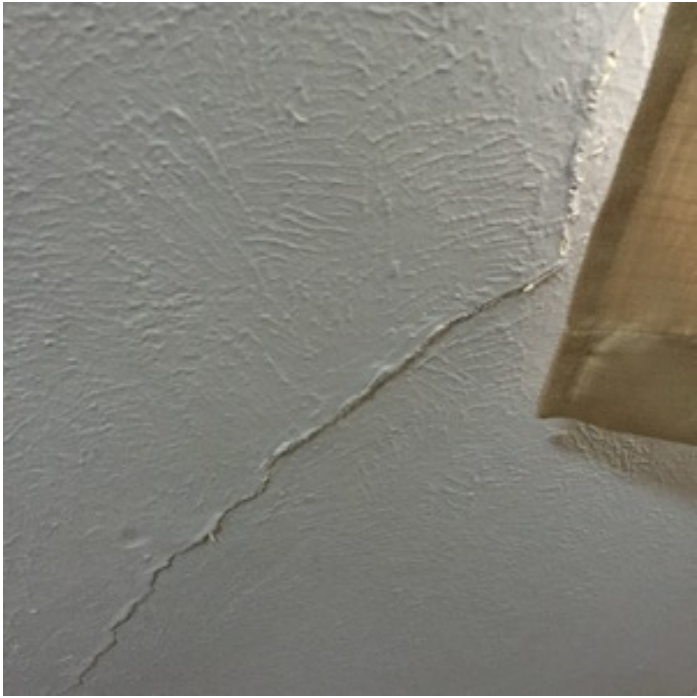
Generally speaking, the interior walls are in fair condition for the age and type of structure. An above average amount of wall damage/issues were noted due to settlement. For the most part, the wall damage appears to be cosmetic in nature and should be updated at the owner's discretion.

DIAGONAL WALL CRACKS

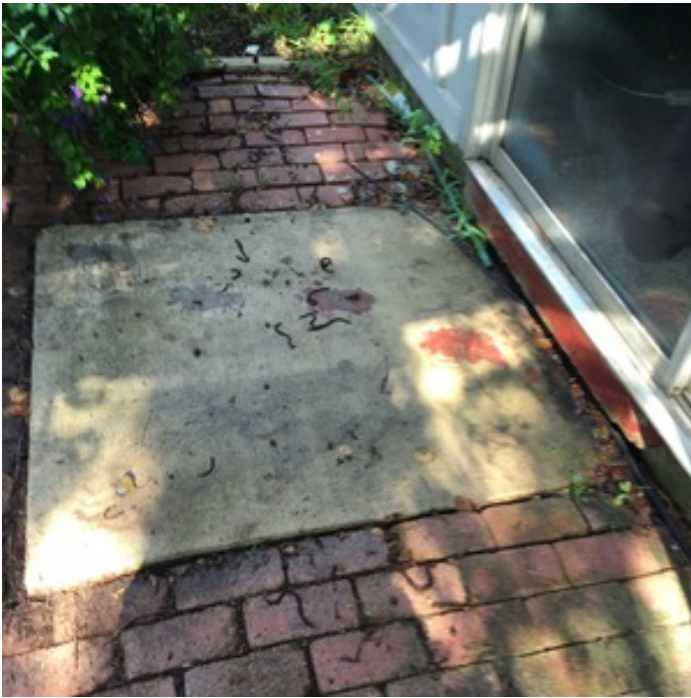
IMPROPER SLOPE BACK SLAB

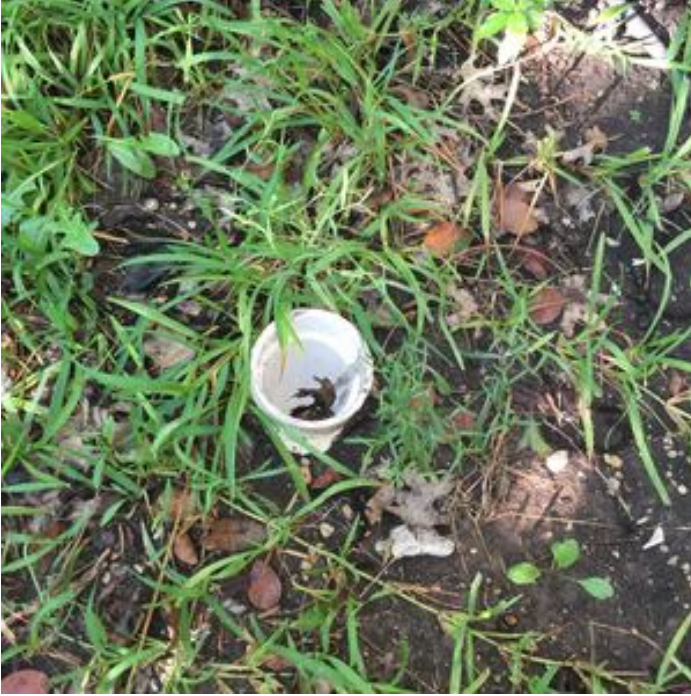
UNUSED DRAIN EXTENSION

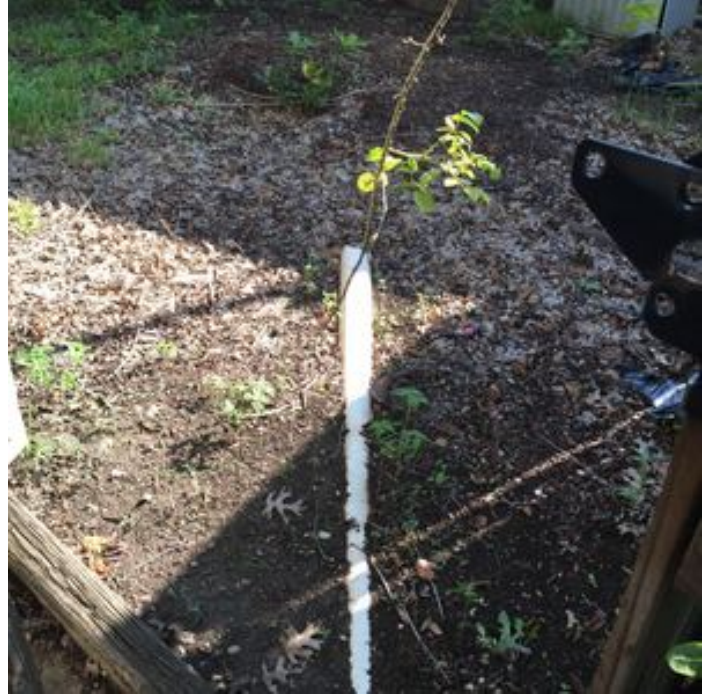
UNUSED DRAIN EXTENSION

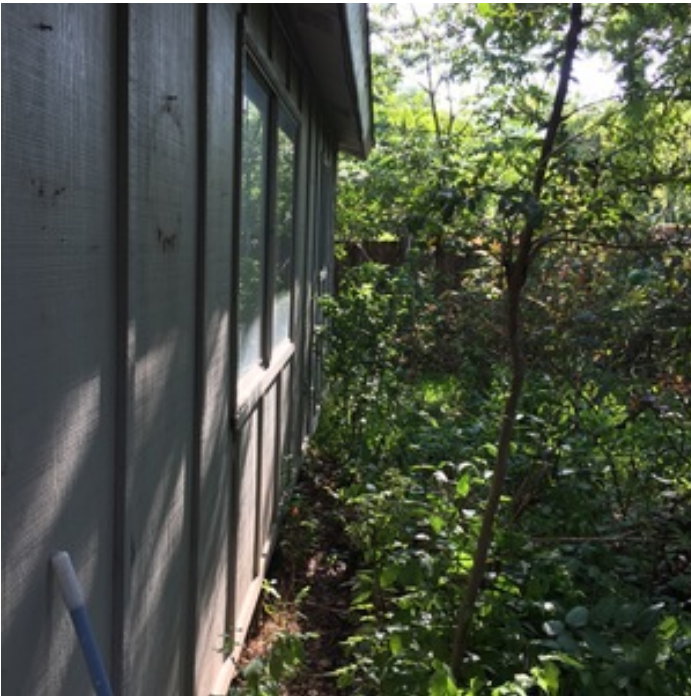
NEGATIVE DRAINAGE BACK YARD

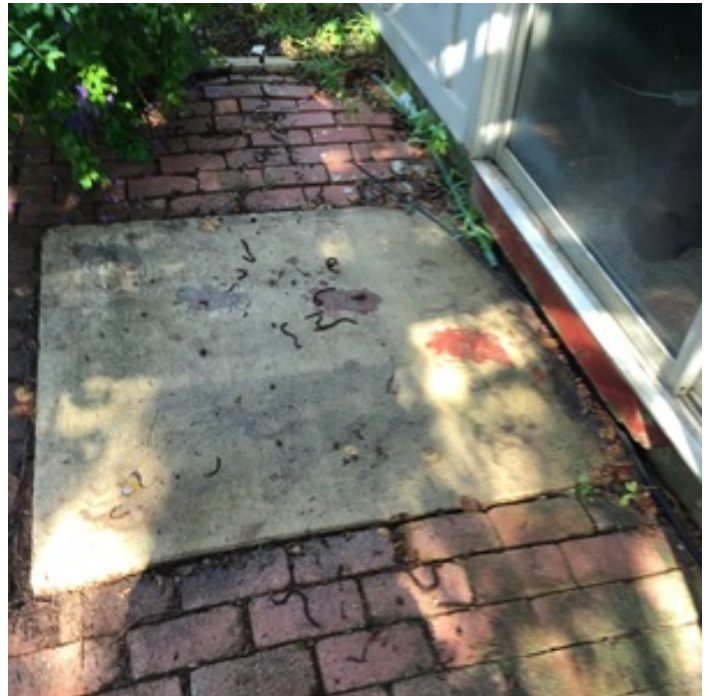
- Rain Gutter Improvement Needs
- Low Spots (Pooling Water Areas) Near Foundation: Excess Moisture Concern
- Marginal/Negative Drainage (Various Areas) - Excess Moisture Concern
- Improper Slope at Back Porch: Causing Excess Moisture to Settle at Foundation

IMPROPER SLOPE AT BACK PORCH

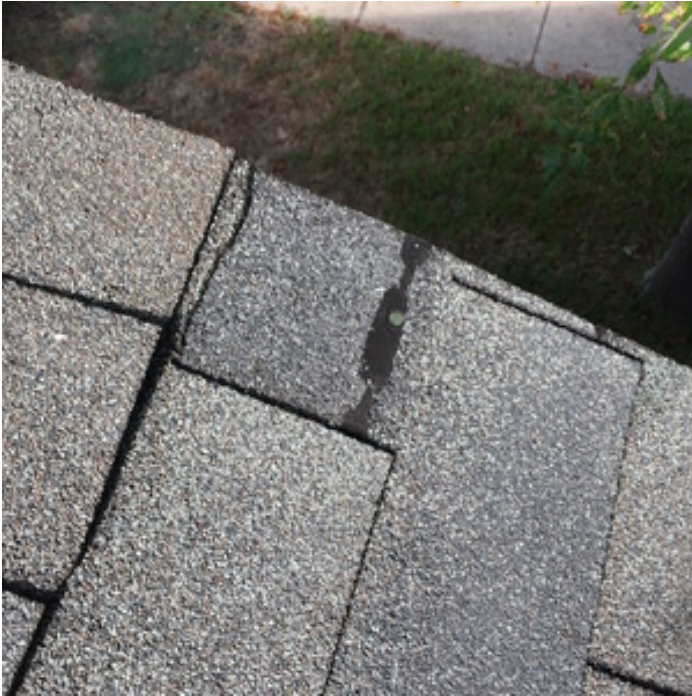
- Tree Limb in or Nearing Contact at Various Locations: Trim to Prevent Damage
- Caulk/Seal Nail Heads at Vent Boots and Flashing: Moisture Entry Prevention
- Missing/Torn Shingle Right Slope Perimeter: Replace Per General Maintenance

MISSING SHINGLE

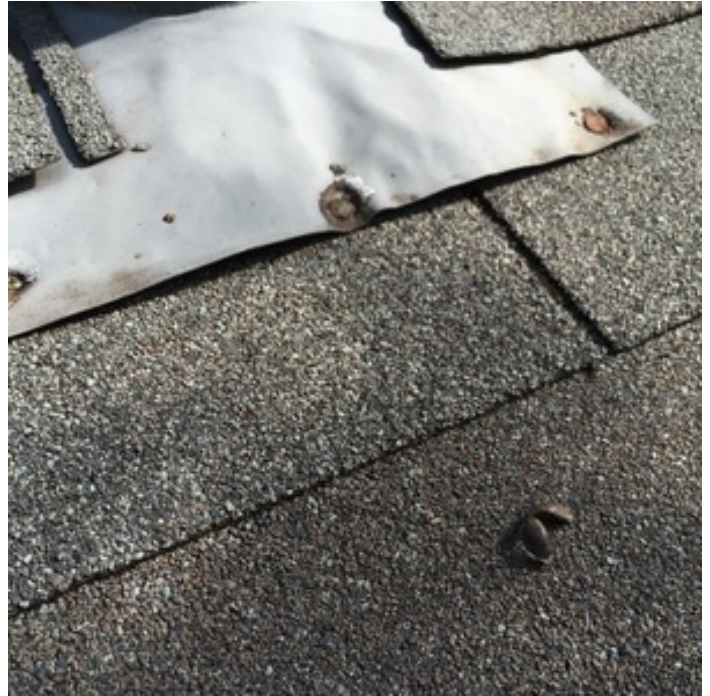
CAULK/SEAL NAIL HEADS

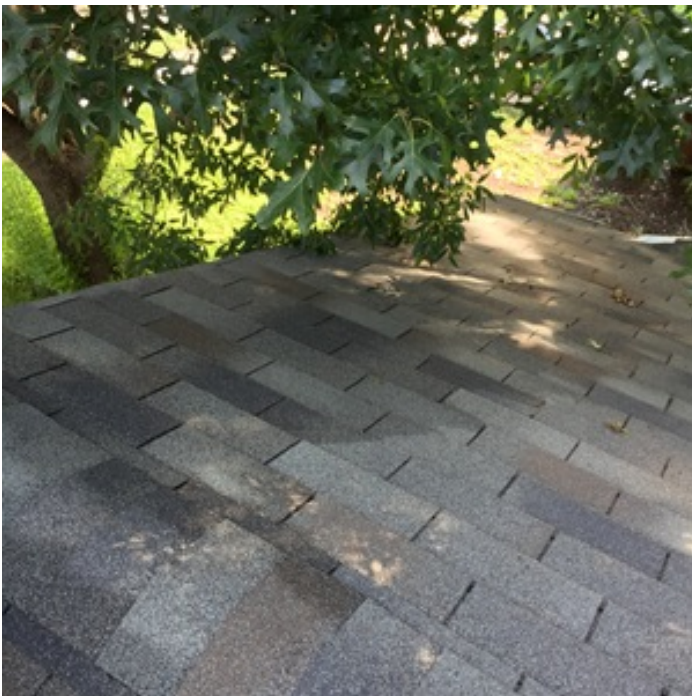
MINOR TREE CONTACT

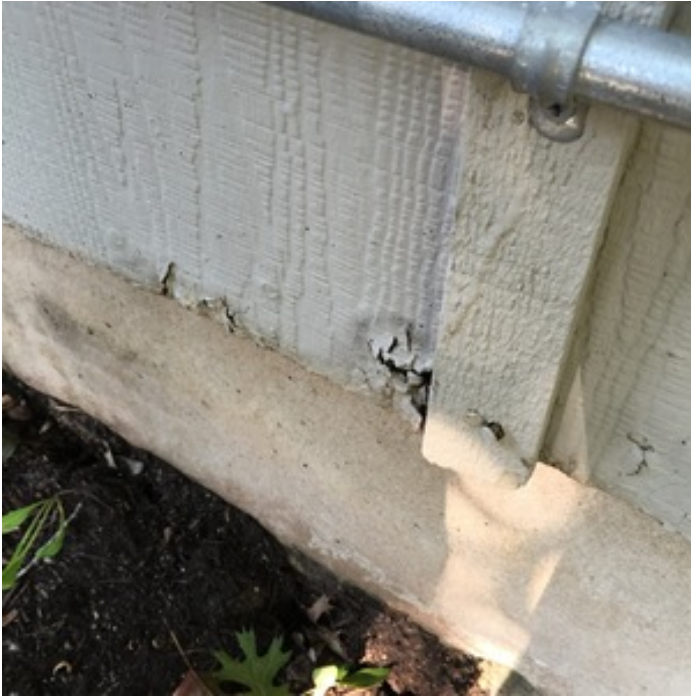
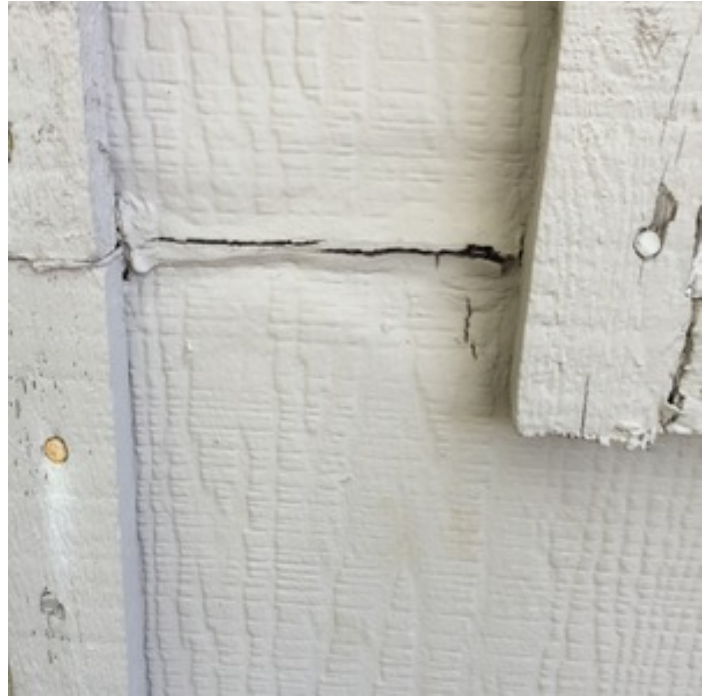
Masonite siding at the exterior walls was noted. Masonite siding naturally absorbs water and swells slightly. With proper sealant application, caulking and regular paint maintenance, this process can be controlled and the material can remain in good condition. However, improperly installed and maintained Masonite siding can undergo serious deterioration in a relatively short amount of time. At the time of inspection, the Masonite siding appeared to be in the early stages of disrepair. Maintenance updates will be needed. Issues noted include; but are not limited to:

MASONITE DAMAGE

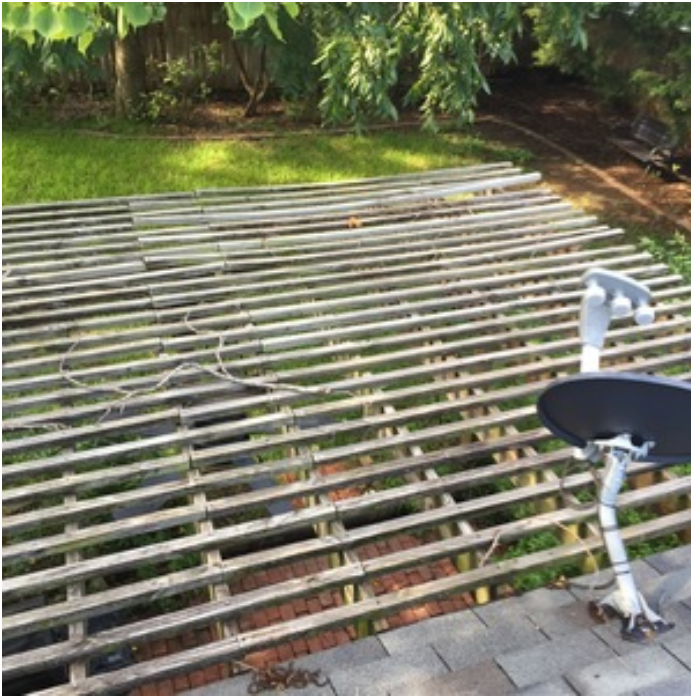
- Significant Deterioration of Decking Material
- Various Areas of Wood to Soil Contact
- Unprofessional Installation and/or Repair
- Uneven Slab Sloping Towards Structure
- Loosening and Damaged Framing and Roofing Material

LOOSE/DAMAGED MATERIAL

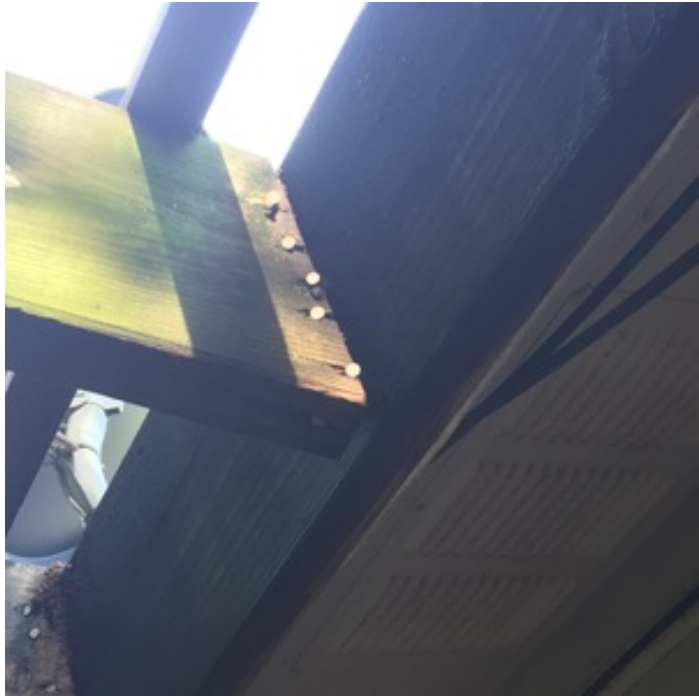
LOOSE/IMPROPERLY SUPPORTED FRAMING

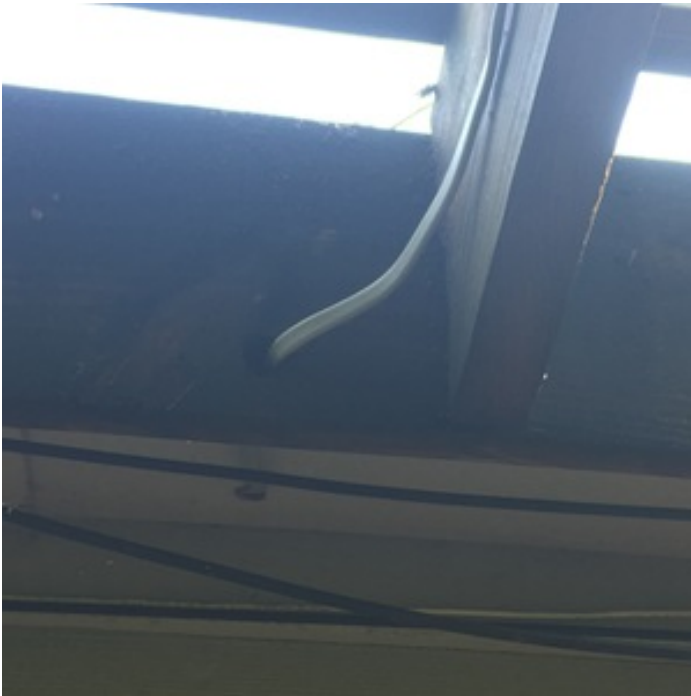
IMPROPER ELECTRICAL (EXPOSED WIRE)

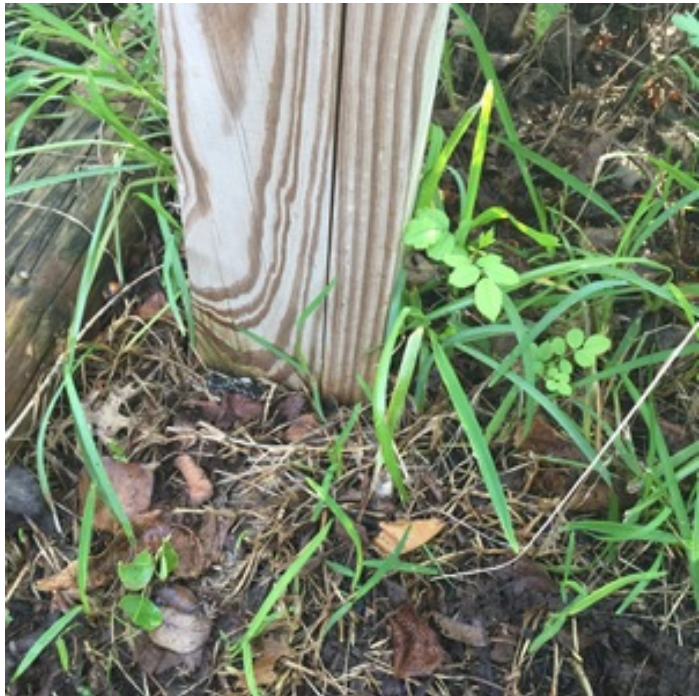
WOOD/SOIL CONTACT

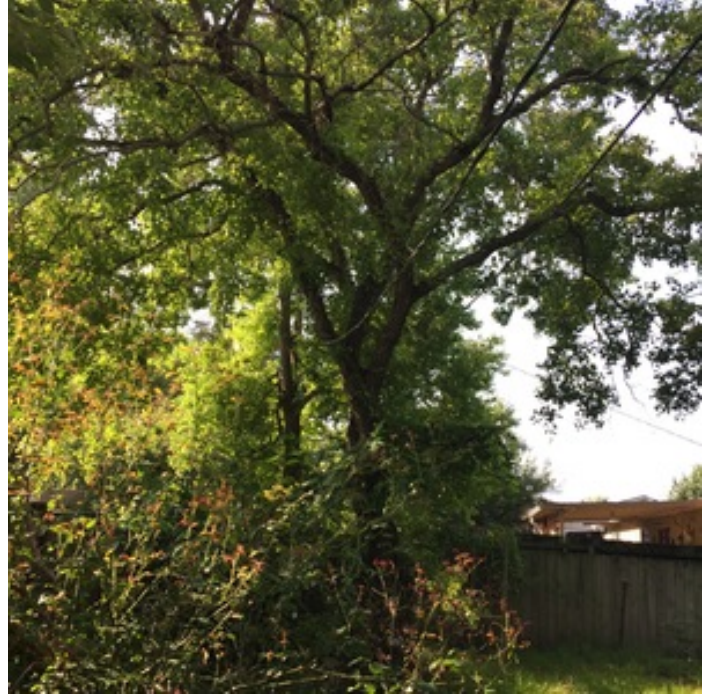
- Main Supply Line In Contact w/ Tree: Contact Tree Specialist to Trim Branches as Needed
- Label Main Panel Breakers: Improved Safety and General Update
- No Bonding Screw/Strap Discovered: Bond Main Panel to Improve Safety and Meet General Standards

MAIN FEED CONTACTS TREE

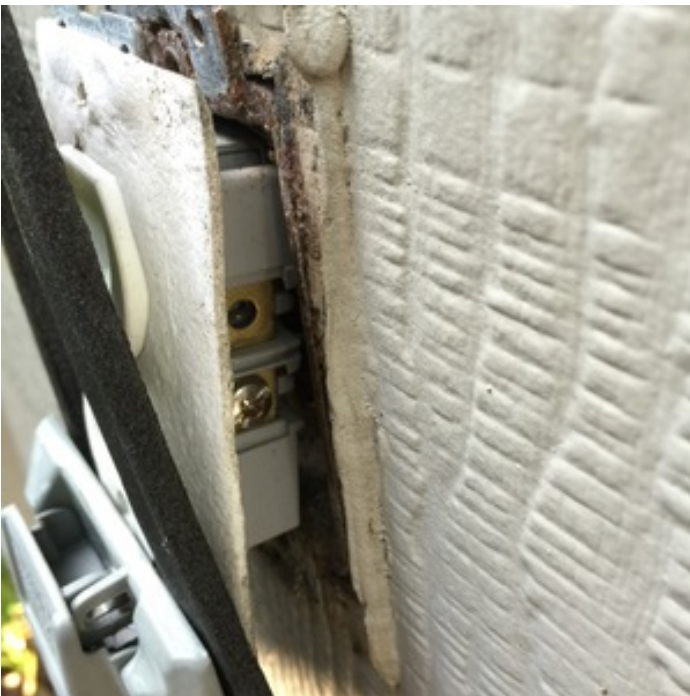
- Open Ground Guest Bath: Update to Improve Functionality and Safety
- Open Ground at Back Porch: Update to Improve Functionality and Safety
- Loose/Exposed Outlet Back Porch: Properly Install to Improve Functionality and Safety
- Refrigerator Not Plugged Into Dedicated Outlet: Update As Needed (Plugged Into Counter Top Outlet)
- Install Additional Fire Alarms in Bedrooms: Safety Update
- Protect Exposed Wires at Back Porch: Place in Conduit to Improve Safety
- Remove/Protect Porch Fan: Ensure Fan Rated for Outdoor Use and Protect From Weather

LOOSE OUTLET

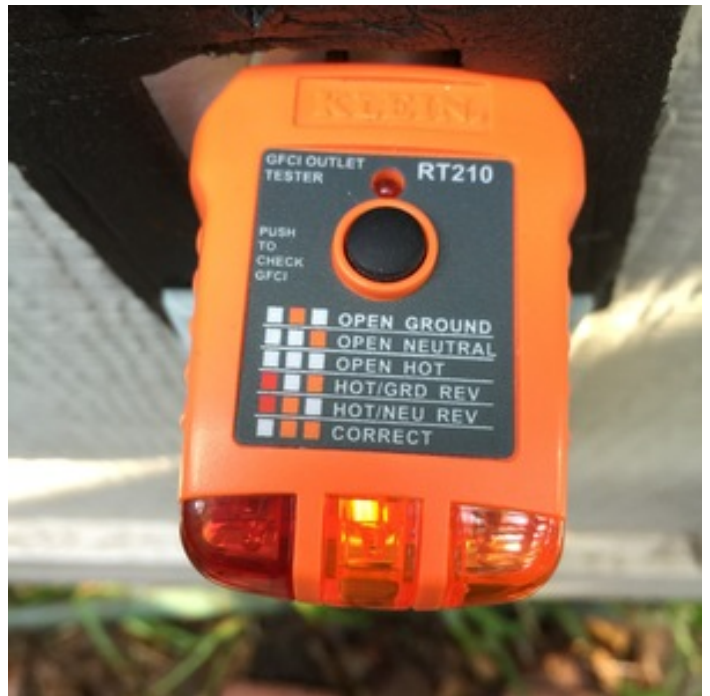
OPEN GROUND WIRING

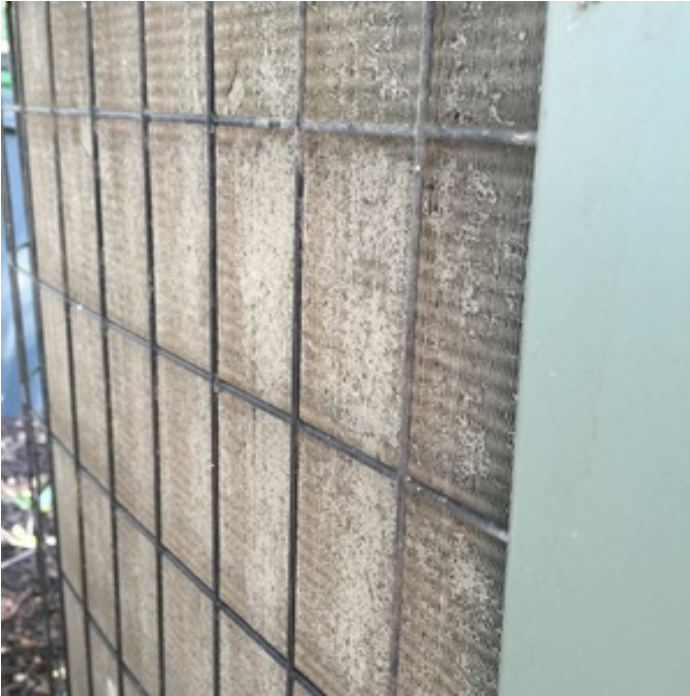
- Partial Coil Blockage at Condenser: Service and Clean System
- Drain Leak at Float Switch Connection (HVAC Closet): Repair As Needed
- Duct Deterioration (Attic - Gray Duct): Monitor and Update As Needed (No Major Air Leaks Discovered)
- Air Leak at Plenum: Service and Eliminate at Leaks at Plenum (Duct Connection at Closet Unit)

BLOCKAGE AT COIL FINS

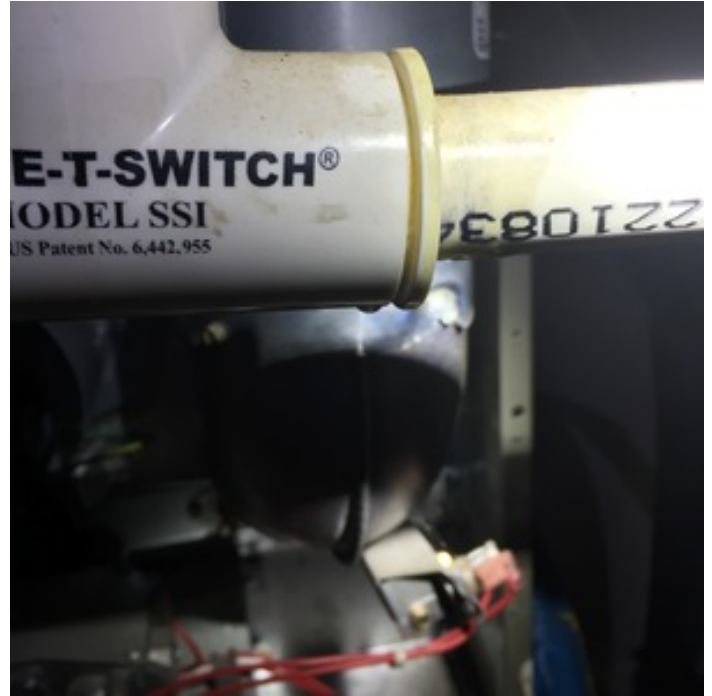
MINOR LEAK

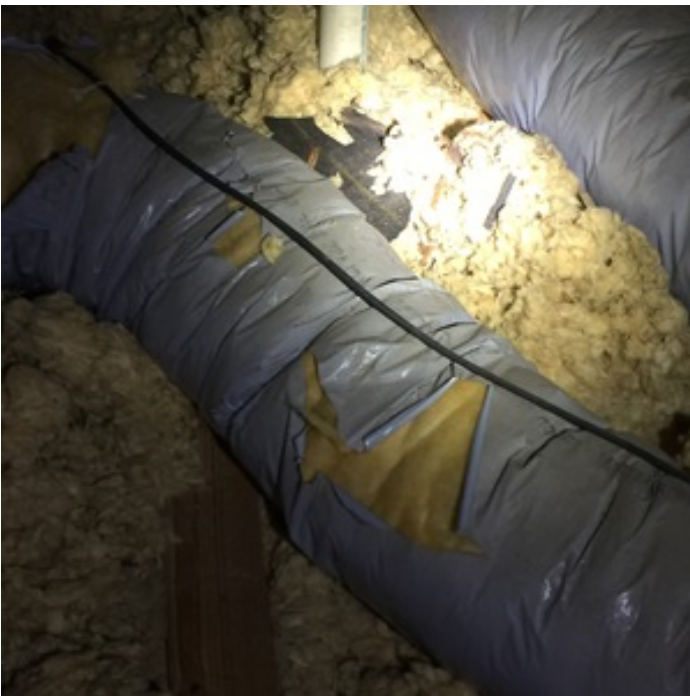
MINOR DUCT DETERIORATION

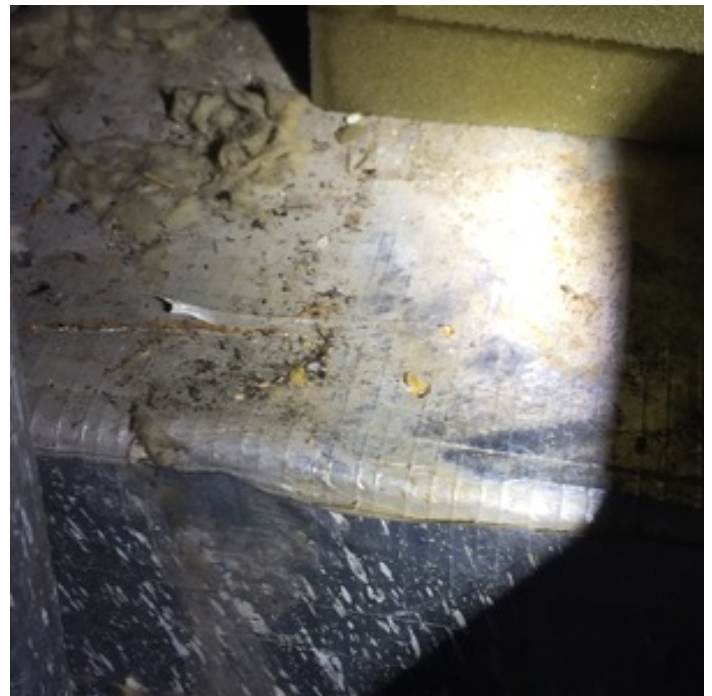
AIR GAP AT PLENUM
