PROPERTY INSPECTION REPORT

Concerning: Sample Copy Austin, TX 78731
(Address or Other Identification of Inspected Property)

By: Andy Jordan, Lic #9458 September 13, 2016
(Name and License Number of Inspector) (Date)

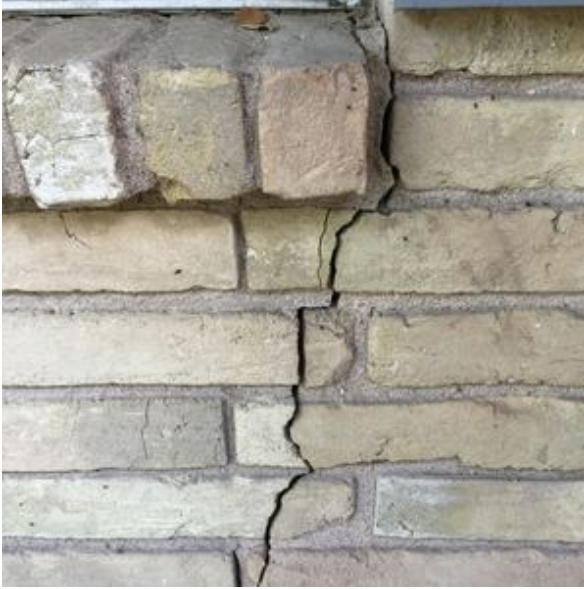
The visual analysis of the structure and foundation did not reveal indicators associated with excessive foundation movement and failure. Evidence of moderate phenomena (structural damage caused by settlement) was noted. Relative height differences recorded by foundation surveying equipment (ZipLevel Pro) indicate that settlement common to the structure's location, type, and age has occurred. The survey information correlates with visual indicators (primary source of evaluation). In this inspector's professional opinion, the structure is currently supported by the foundation to an adequate degree. Noted evidence of structural damage caused by settlement appears to be, for the most part, cosmetic in nature. Ensure that the home is properly maintained and updated as needed. Any recommendation or concerns noted in this report should be addressed by skilled professionals. If further evaluation or verification of these findings are required, a structural engineer should be contacted. A site drawing and readings have been recorded and filed. Survey drawings are available by request or per the scope of work.

SETTLEMENT CRACKS - MONITOR

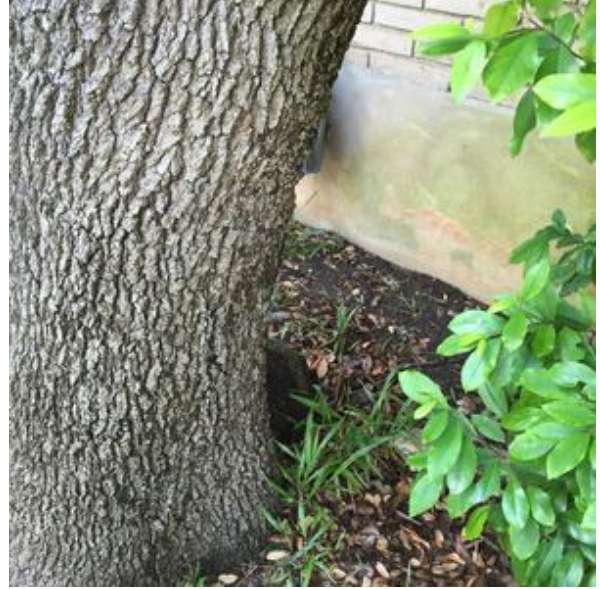
Large trees were noted as being near the main structure. Trees and their associated root systems can affect a structure through direct contact, root activity, and/or moisture absorption. Ensure the tree remains trimmed back to avoid direct damage. Consulting with an arborist may aid in determining if additional improvements or adjustments are warranted.

TREE NEAR STRUCTURE

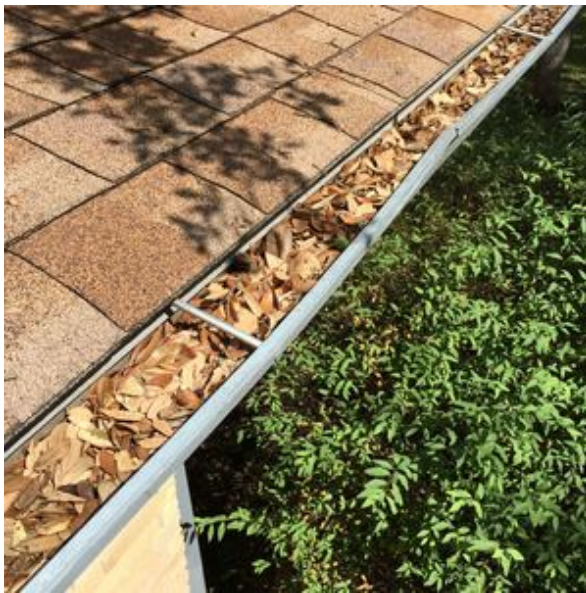
Common adjustment and general servicing needs were noted throughout the rain gutter system. Contacting a gutter specialist is recommended to address common issues and maintenance needs.

SERVICE GUTTERS

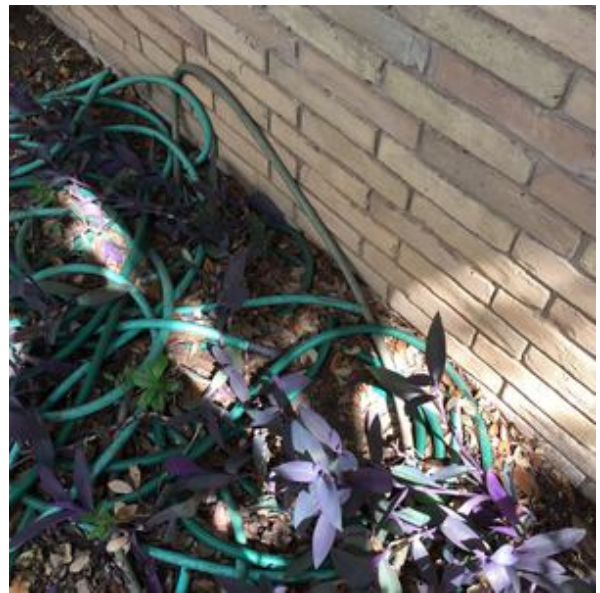
Elevated soil lines were noted at the exterior walls (soil rises above foundation - contact w/ siding). High soil lines increase the likelihood of moisture damage and insect intrusion. General standards call for no less that 3" of foundation wall to be visible above all soil lines. Adjustments to the soil line should take place to properly protect the structure and reduce the likelihood of damage. Areas of elevated soil lines were noted in the following locations:

-Right Wall Garage

ADDRESS SOIL LINE (MINOR)

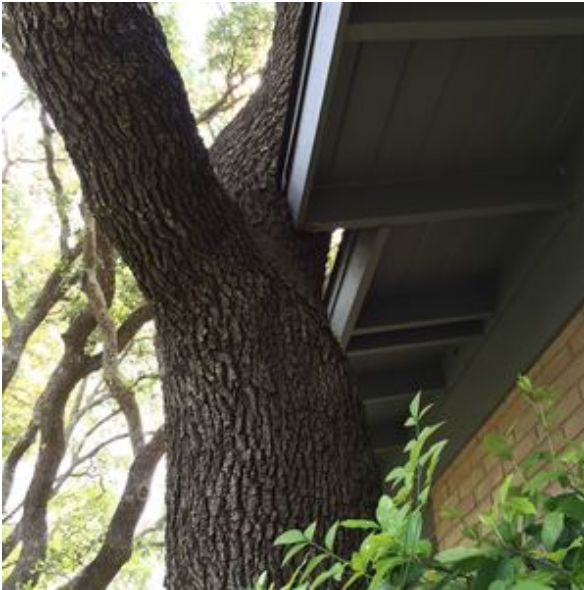
Current tree limb contact with the roof and structure was noted. At the time of inspection, no significant damage to roofing material was discovered, however, updates are required to prevent more significant damage at a future date. Tree contact with the roof and structure can lead to material damage in a relatively short amount of time. A tree specialist should address limb contact and make needed adjustments to surrounding trees/shrubs. Ensure updates and maintenance are addressed in an expeditious manner.

TREE CONTACT WITH STRUCTURE

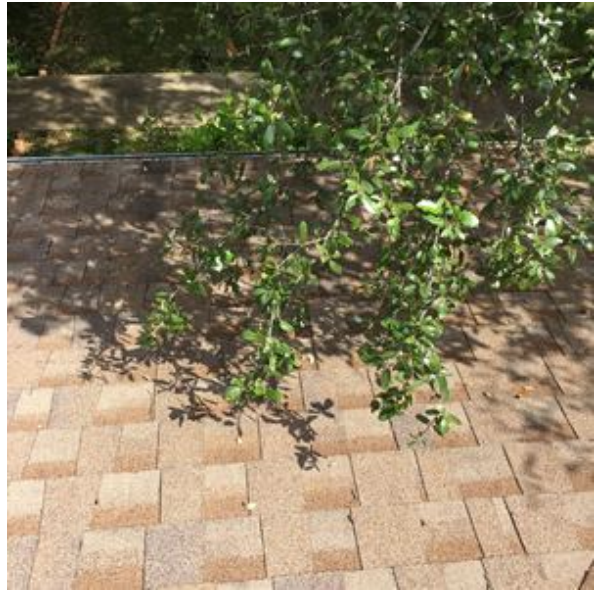
LIMBS NEARING CONTACT

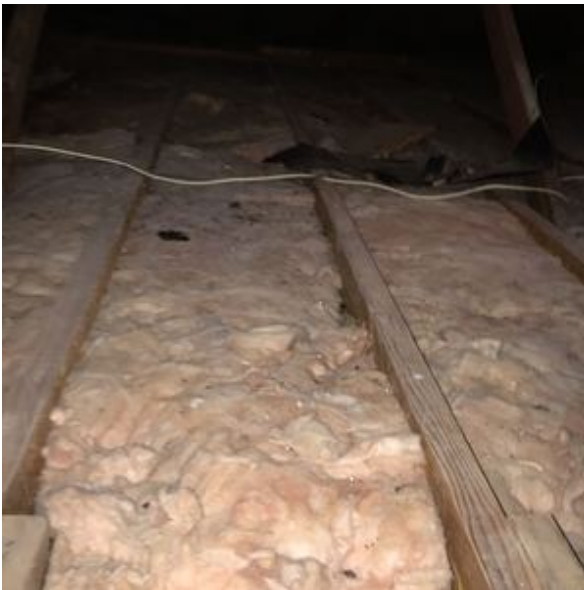
Areas of reduced insulation (by today's standards) were discovered in the attic at various locations. The redistribution or installation of additional insulation is recommended to improve the overall energy efficiency of the structure. The overall degree of reduced insulation is considered minimal for a structure of this age and type. Updates would be considered a general improvement.

INSULATION MEETS DATED STANDARDS

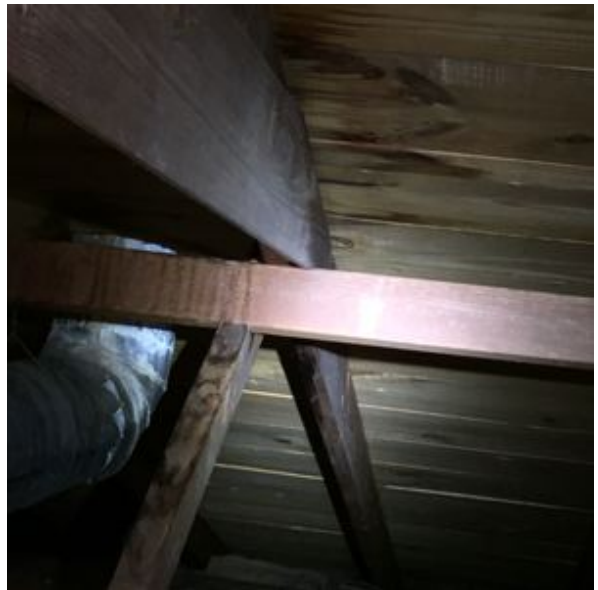
Evidence of previous moisture entry and minor sub-roof and/or framing material damage was noted at various roof exit points (vent/exhaust exits). At the time of inspection, the areas of noted moisture entry were visually assessed and tested with moisture metering equipment. Active leaks were not discovered during the site assessment. Ensure all needed caulking/sealing updates take place at the roof level. Regularly monitoring these areas (particularly after heavy storms) is recommended to ensure active leaks are not present.

PREVIOUS MOISTURE ENTRY (MINOR)

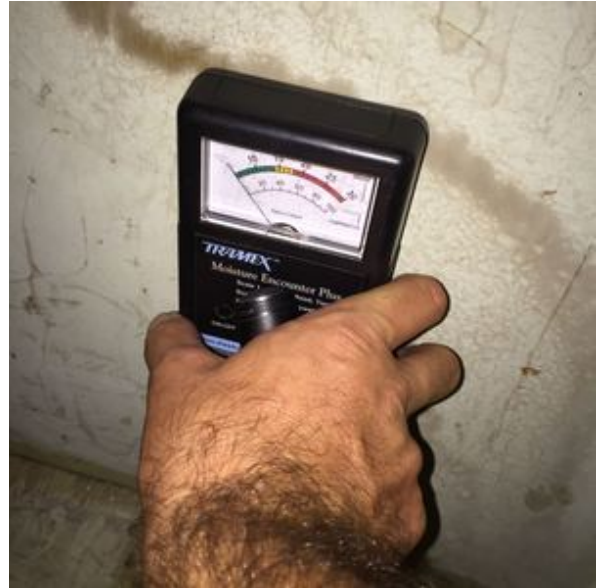
Previous moisture damage at the HVAC closet wall was noted. Additional testing for elevated moisture levels were conducted (Tramex Moisture Encounter). At the time of inspection, moisture levels in this area were within normal levels. Ensure this area is monitored per general maintenance guidelines.

NORMAL LEVELS HVAC CLOSET

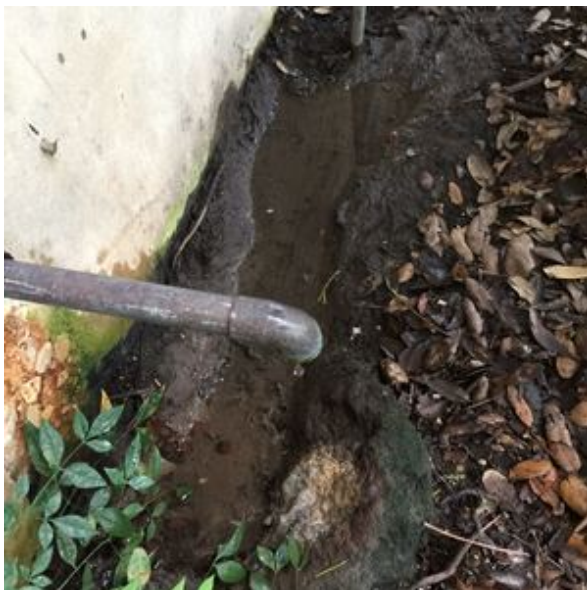
A system drain line (HVAC) is releasing moisture on and around the structure foundation. Updates to the drain line are required to prevent excess moisture issues.

DRAIN LINE UPDATES NEEDED

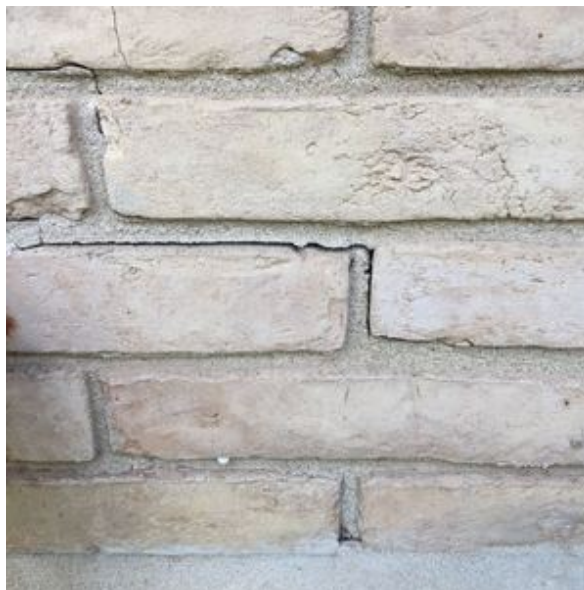
-Monitor Settlement Cracks at Various Locations: Ensure No Additional Settlement Cracks Occurring/Increasing

COMMON SETTLEMENT CRACKS

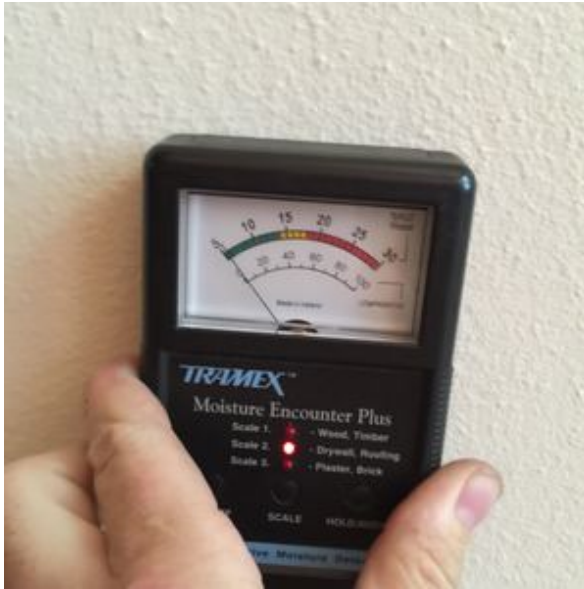
BENCHMARK READING

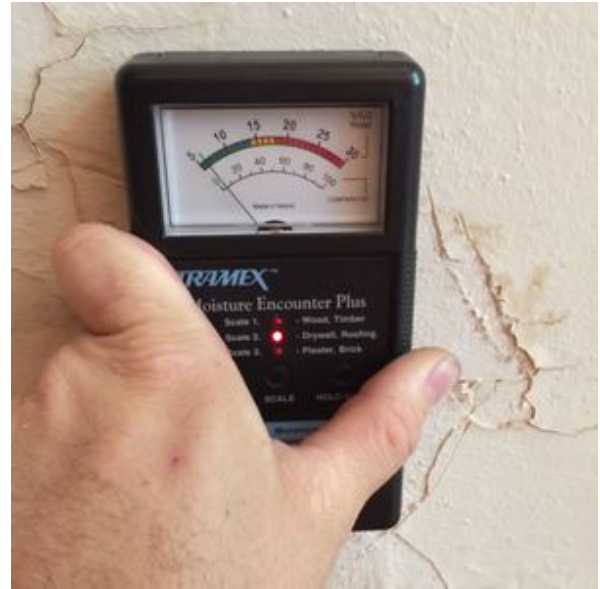
Previous moisture damage at the ceiling (near fireplace) was noted. Additional testing for elevated moisture levels were conducted (Tramex Moisture Encounter). At the time of inspection, moisture levels in this area were within normal levels. Leakage in this area was likely addressed when the roof was replaced. Ensure this area is monitored per general maintenance guidelines.

NORMAL LEVEL AT PREVIOUS LEAK

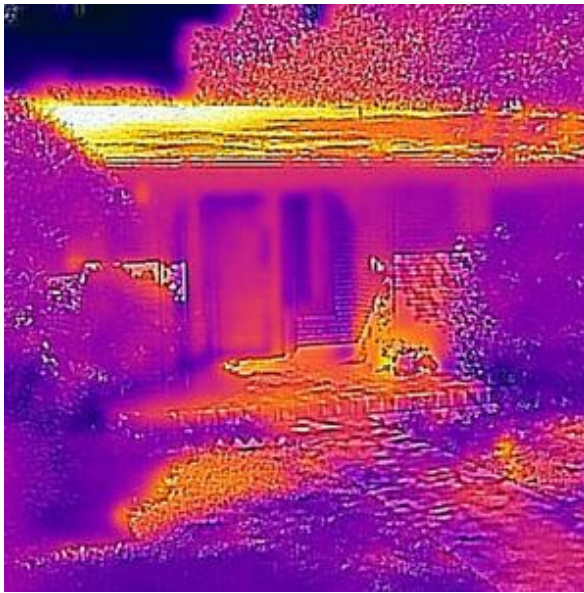
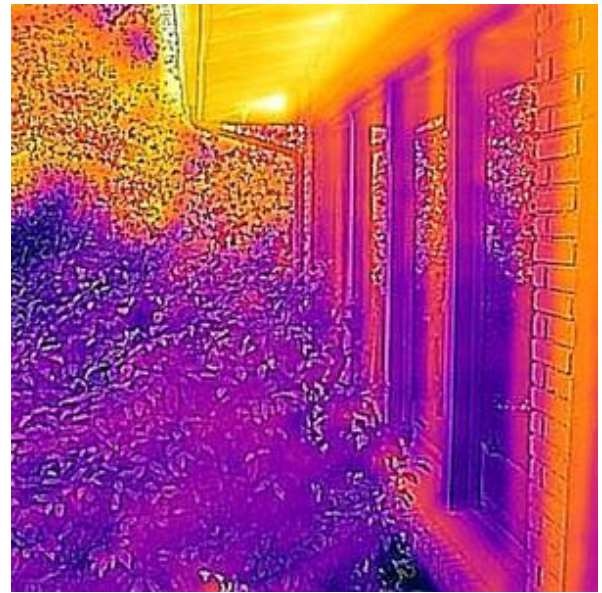
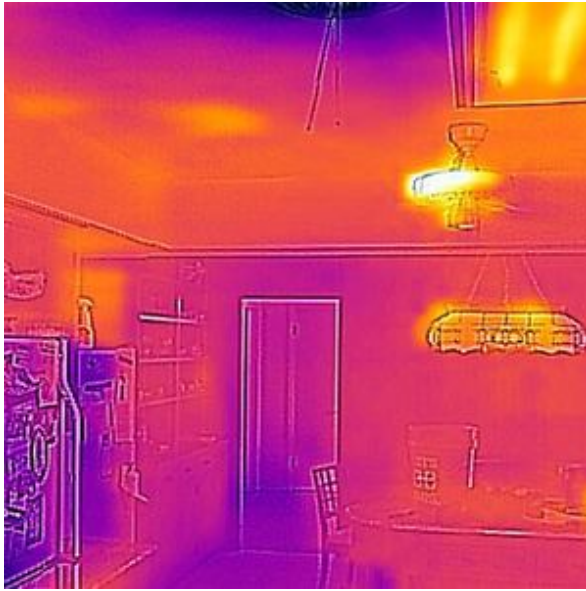
NORMAL READINGS

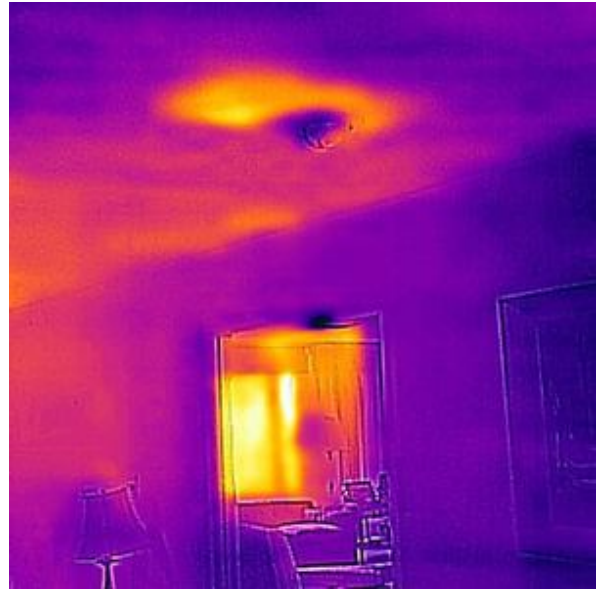
LOW INSULATION (OARNGE AT CEILING)

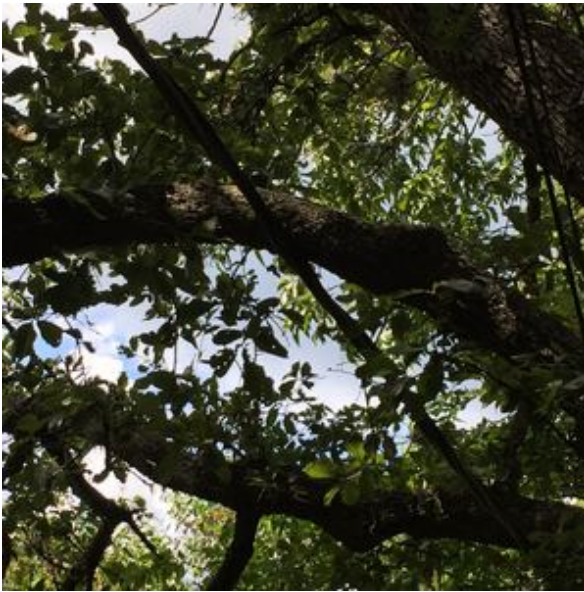
TREE CONTACT WITH SUPPLY LINE

Contacting a tree specialist or the electric utility provider is recommended to address tree branches in contact with electrical supply wires. Ensure this issue is addressed to prevent safety hazards and/or functionality disruptions.

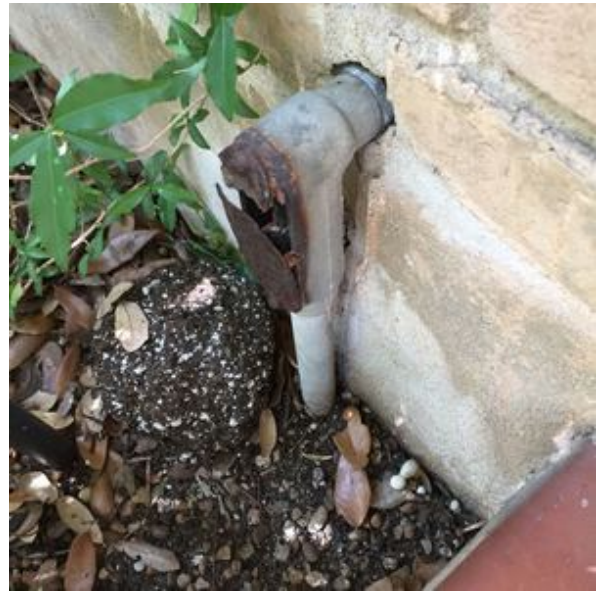
Replacement of a rusting and damaged conduit plate at the front exterior wall (near porch) is recommended to prevent moisture entry at this area.

REPLACE CONDUIT PLATE

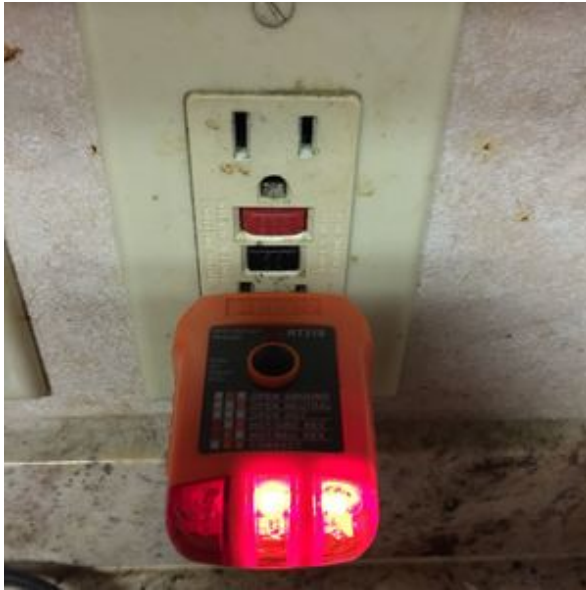
Various key locations of the home have been updated to meet more recent electrical safety standards. Any additional updates would be considered an overall improvement to system safety and functionality. Consulting with a licensed electrician is recommended to determine what updates would best benefit the home.

PROPER SYSTEM UPDATES NOTED

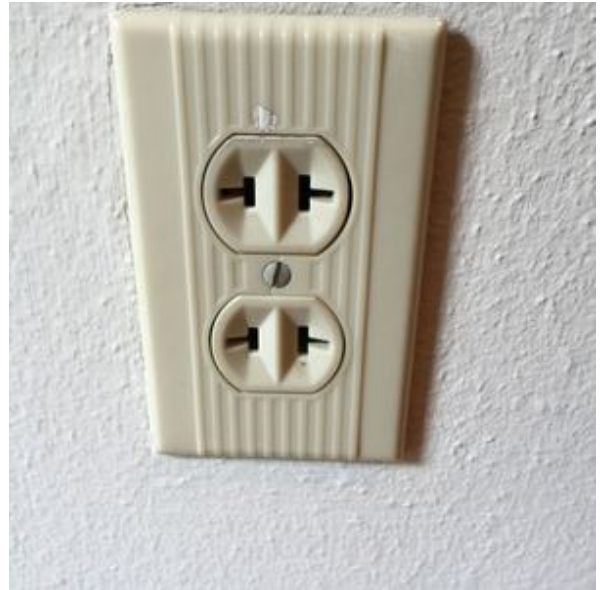
Most outlets throughout the structure are designed for ungrounded, two-prong electrical plugs. Replacing the dated outlets with three prong devices is recommended to improve system functionality. Any grounding updates to circuits would be considered a system improvement.

DATED OUTLETS

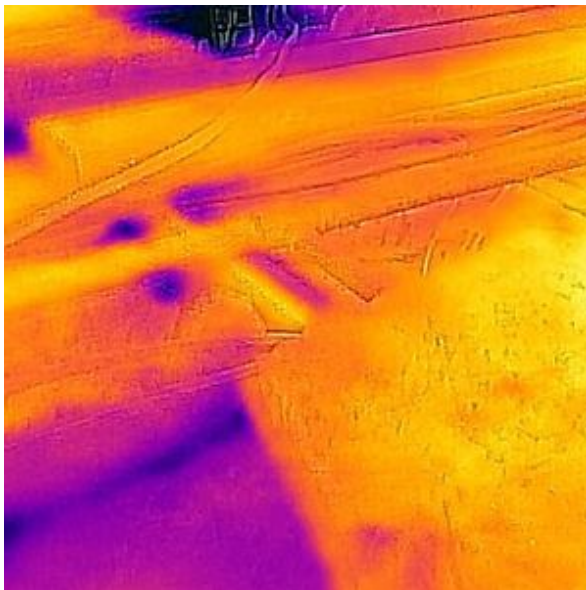
NORMAL READINGS - THERMAL CAMERA

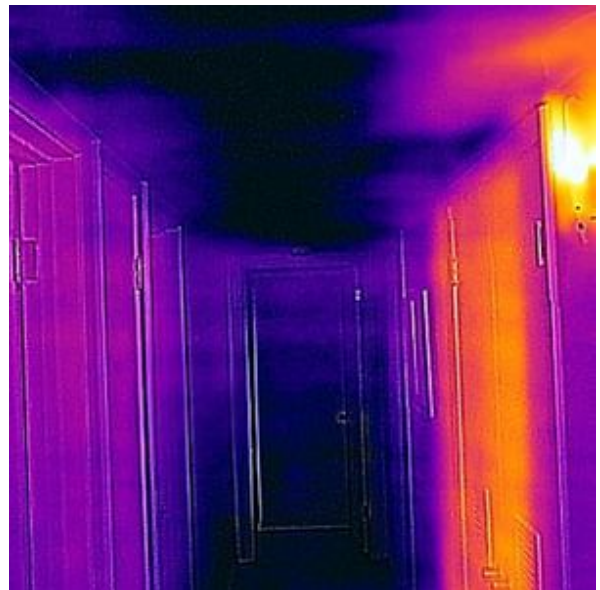
A partial thermal imaging analysis of the HVAC duct system was conducted during the inspection of the property. Areas of common air/energy loss was discovered during the limited test. The loss of air appeared to be consistent with the age of construction. Updating and servicing the duct system would be considered an improvement.

ENERGY LOSS HALL DUCT - THERMAL CAMERA

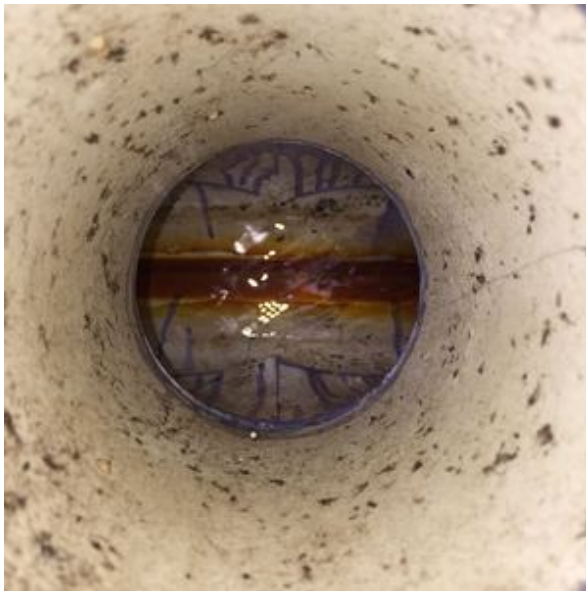
PROPER DRAIN FLOW/UPDATED PVC

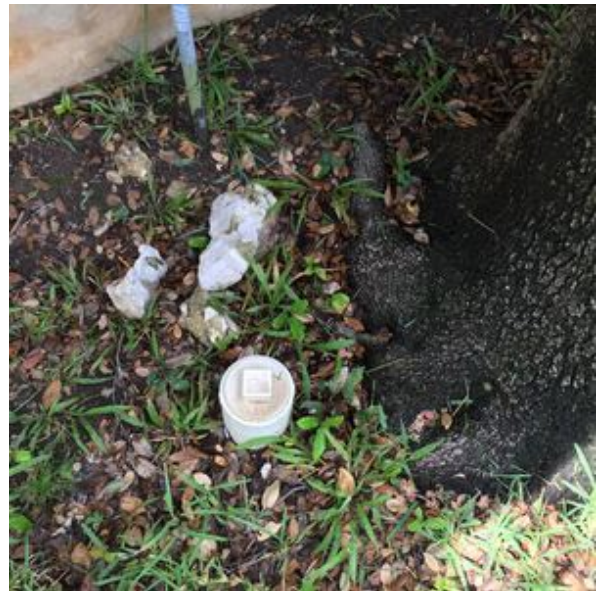
PLUMBING NEAR ROOT SYSTEM

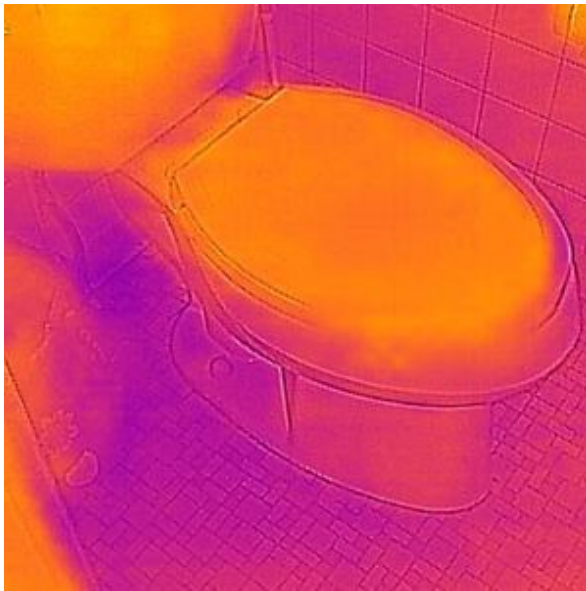
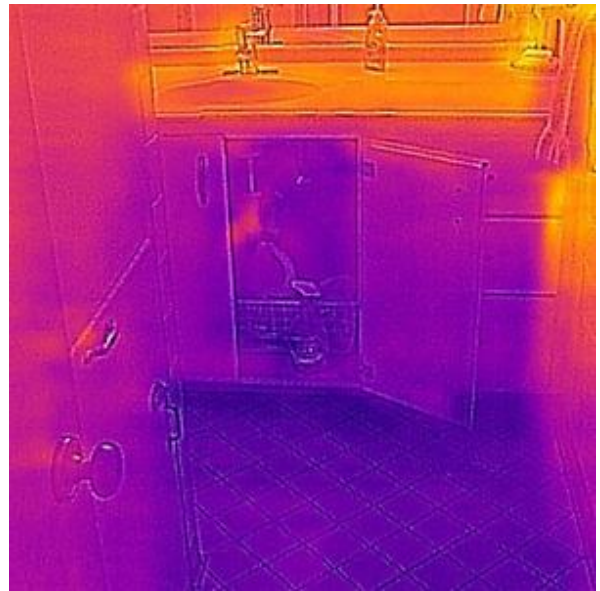
NORMAL READINGS
