Property: 2905 Richard Ln.
Austin, Texas 78703
Client: Carol Dochen
Inspection Type: Property Assessment Report
Lead Inspector: Andy Jordan #9458
Date: April 5, 2018

ADDENDUM: REPORT SYNOPSIS

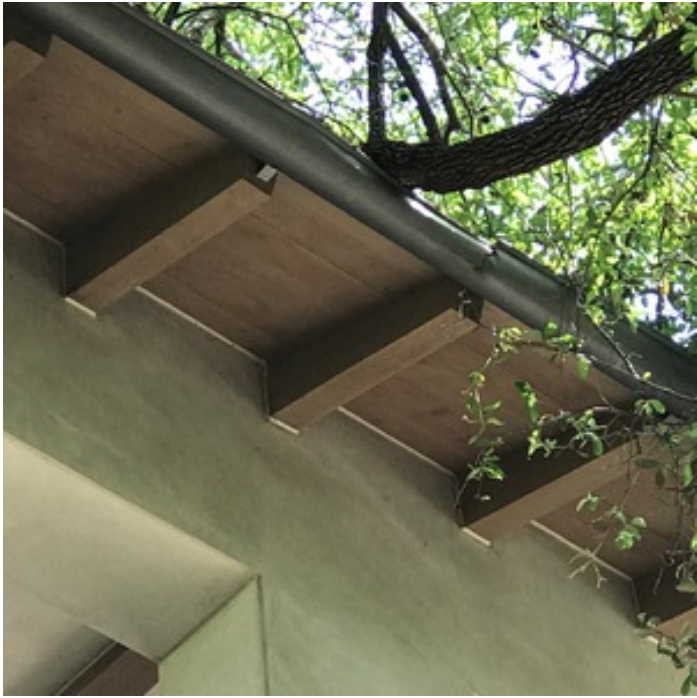
- Replace Damaged Gutters Due to Tree Contact: Left Side Structure Near Carport
- Trim Trees to Prevent Further Damage to Gutter/Structure
- Consider Gutter Screens to Reduce Tree Debris Entry/Servicing Needs

GUTTER DAMAGE - LEFT SIDE

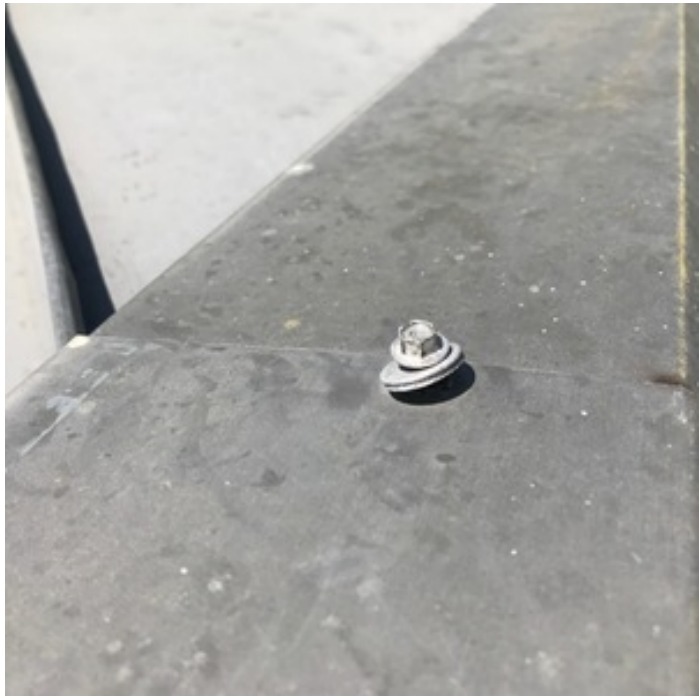
LOOSE SELF-TAPPING SCREWS

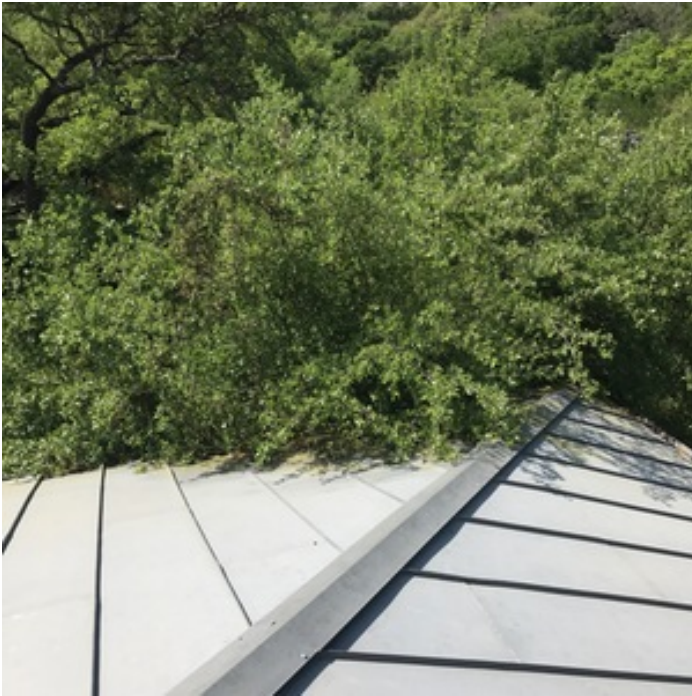
Current tree limb contact with the roof and structure was noted. At the time of inspection, no significant damage to roofing material was discovered (damage to gutters, minor roof damage/concerns). Tree contact with the roof and structure can lead to material damage in a relatively short amount of time. Additionally, tree to structure contact is a common bridge for vermin and insects to access and infest buildings. A tree specialist should address limb contact and make needed adjustments to surrounding trees/shrubs. Ensure updates and maintenance are addressed in an expeditious manner.

ELIMINATE TREE CONTACT

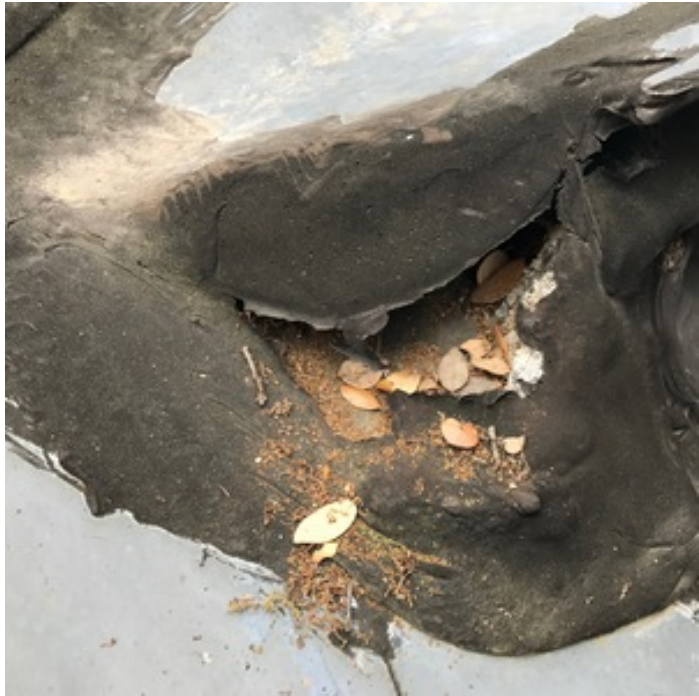
- Improper Installation of Metal Roofing at Low/Flat Sloped Portion of Roof (Right Side): Contact Roofing Specialist to Update as Needed
- Improper Installation of Roof Flashing/Metal Panels at Flat/Low Slope Roof (Right Side): Elevated Likelihood of Moisture Penetration/Issues (Contact Roofing Specialist to Update as Needed)
- Improper Installation of Roof Vent Pipe Boots/Flashing at Various Areas: Increased Likelihood of Moisture Penetration (Contact Roofing Specialist to Update as Needed)
- Excess Use of Caulking/Sealing as Primary Means of Moisture Protection (Right Side and Various Vent Boots): Contact Roofing Specialist to Update as Needed

INSTALL/MOISTURE PENETRATION CONCERNS

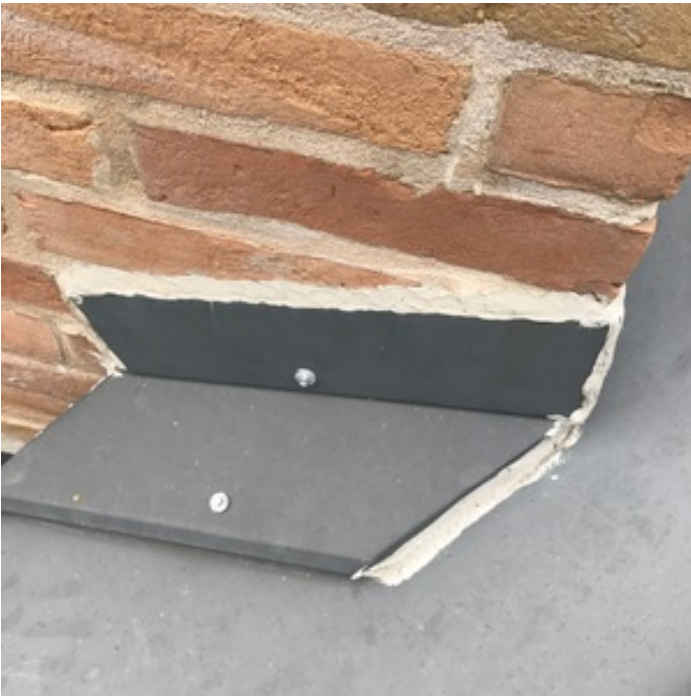
- Flashing/Install Issues and Concerns at the Right Side Low/Flat Roof
- Flashing Install Issues and Concerns at The Right Side Chimney Area
- NOTE: Consult With Subject Matter Expert On Site for Further Details and Update Recommendations/Costs

FLASHING INSTALL CONCERNS

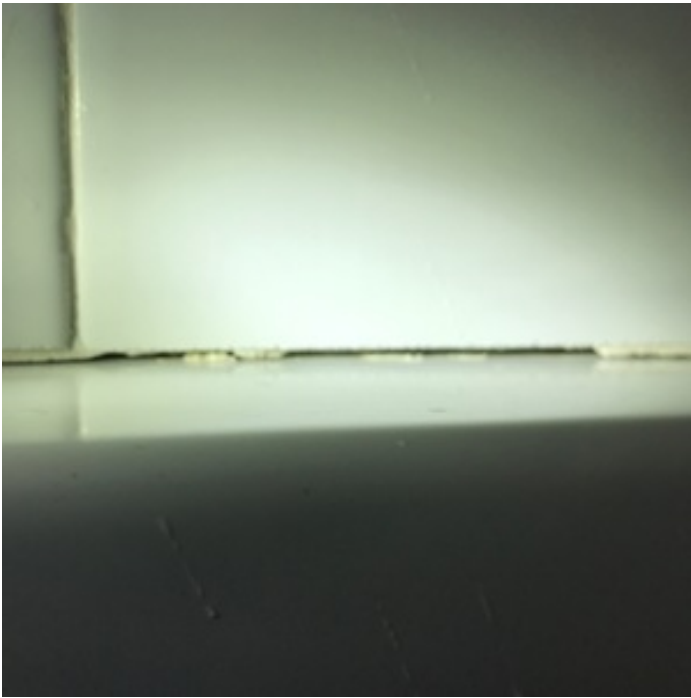
Maintenance and repair needs to reduce moisture entry points were discovered at bathroom walls. Ensure all gaps and issues at bathroom walls are eliminated and any current damage to surrounding material addressed. Areas of noted wall gaps/issues include, but are not limited to:

TILE GAPS/TUB SURROUND

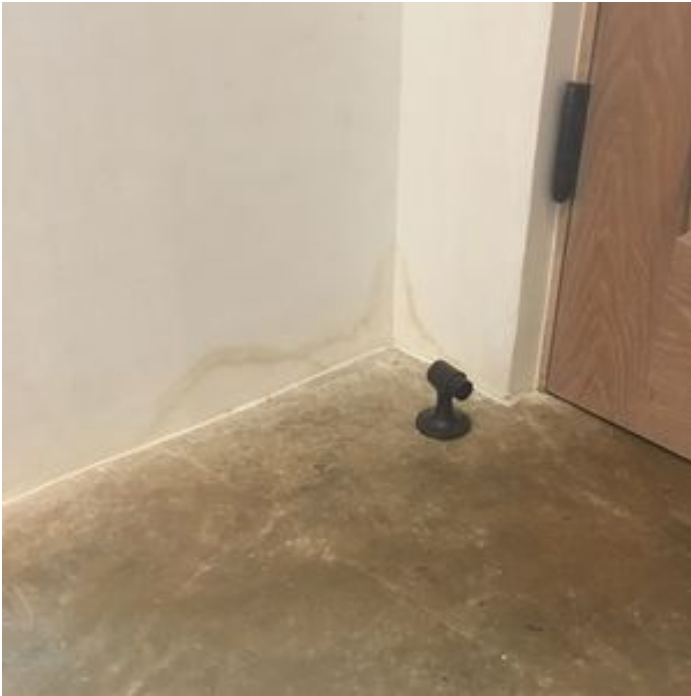
An area of moisture damage to the interior kitchen wall (near entry door) was discovered. The area of noted damage is located near/adjacent to exterior features which may be causing/promoting moisture penetration into the structure. Ensure the area of damaged wall material is removed and non-visible portions of the structure are visually assessed for additional damage. Adjust/update exterior features to prevent future damage and make all cosmetic repairs per contractual agreements.

UPDATE (2018APR13): During a return visit to the property, additional information provided by the current owners indicated that the wall damage discovered in the kitchen area was caused by the loss of power and leakage of a freezer (date of incident unknown). Additional moisture meter and thermal testing took place at the area of concern. When compared to control moisture readings (moisture percentages recorded at non-damaged areas of similar material), moisture percentages appeared to be normal at the affected area. Although the interior wall damage/issue appears to be unrelated to concerns at outdoor pavers, the recommendation to adjust exterior features remains unchanged.

MOISTURE DAMAGE - KITCHEN AREA WALL

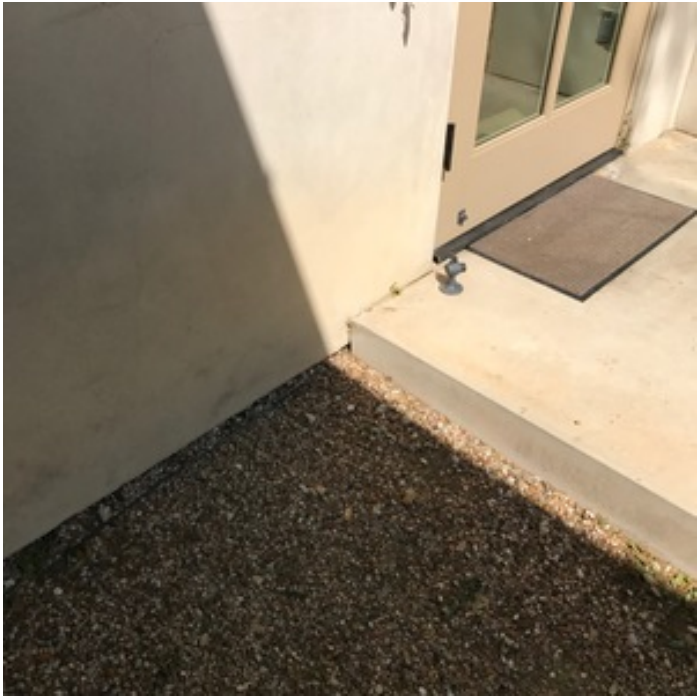
SLAB ADJACENT INTERIOR DAMAGE

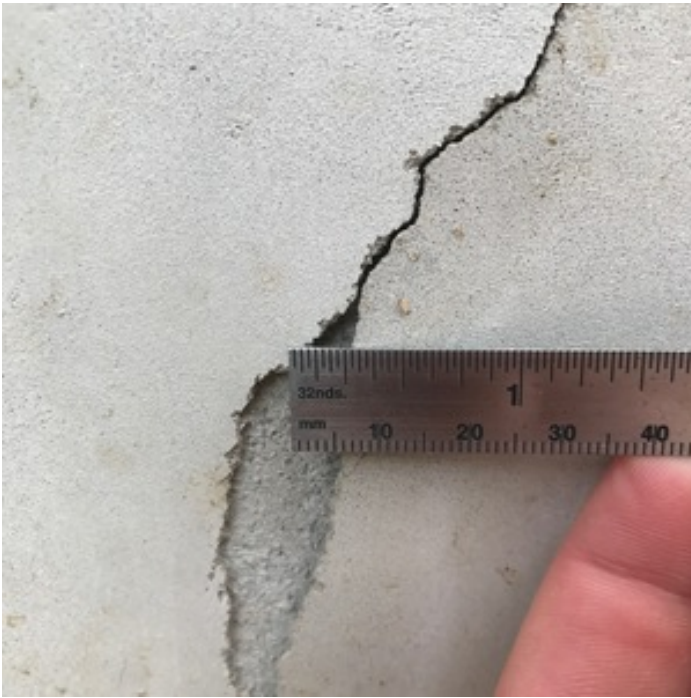
PEELING DECORATIVE FINISH

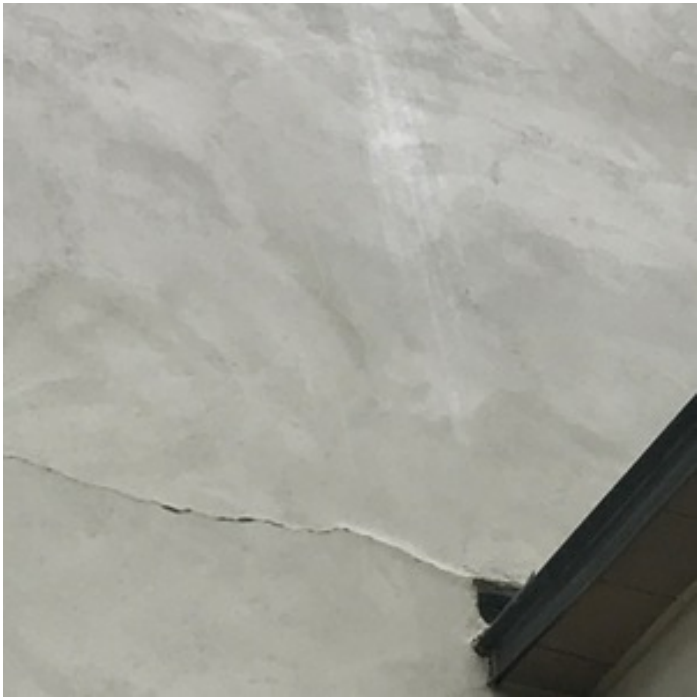
EXPANSION CRACKS/MOISTURE CASCADE

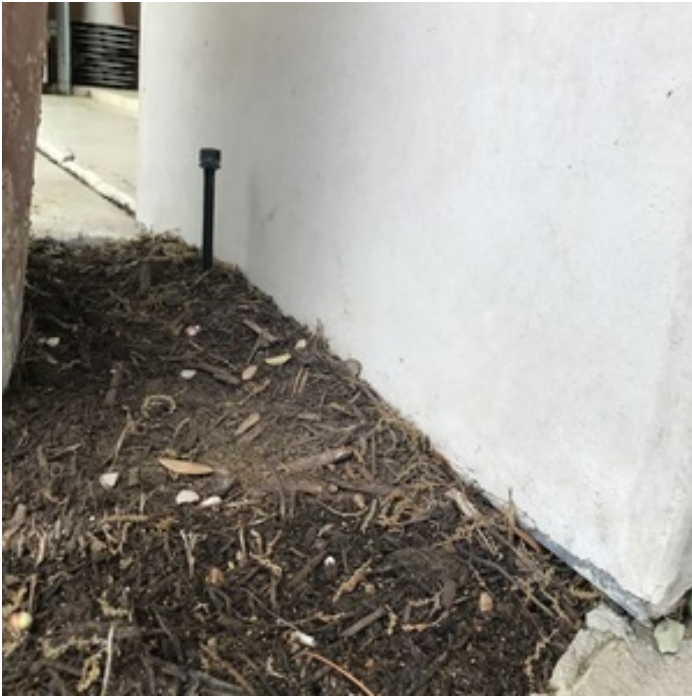
Elevated soil/material lines were noted at portions of the exterior walls (soil rises above foundation - contact w/ siding). High soil lines increase the likelihood of moisture penetration into the structure, damage to building material, and insect intrusion (to include termites). General standards call for no less than 3" of foundation wall to be visible above the soil line or landscaping material. Additionally, a 5% grade slope (6" drop per 10') away from the structure is recommended to promote natural moisture diversion. Ensure soil line issues are addressed and overall moisture diversion away from the structure meets or exceeds minimum standards. If limitations are present which prevent the ability to feasibly attain minimum soil line and/or slope standards, a landscaping/irrigation specialist should be contacted to determine what improvement options are available and warranted.

HIGH SOIL LINES/KITCHEN ENTRY

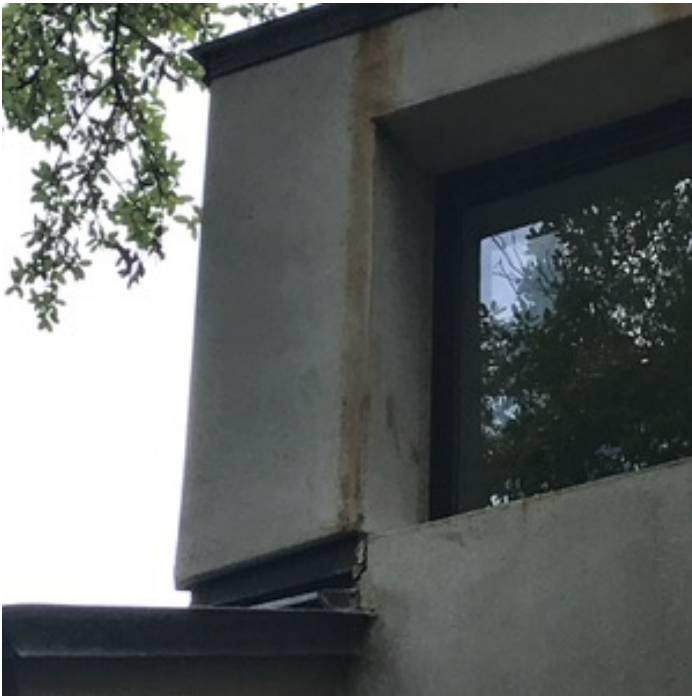
- Siding Crack at Flashing Under Flat Roof (Right Side Structure)

MOISTURE WICK NEAR FLASHING CRACKS

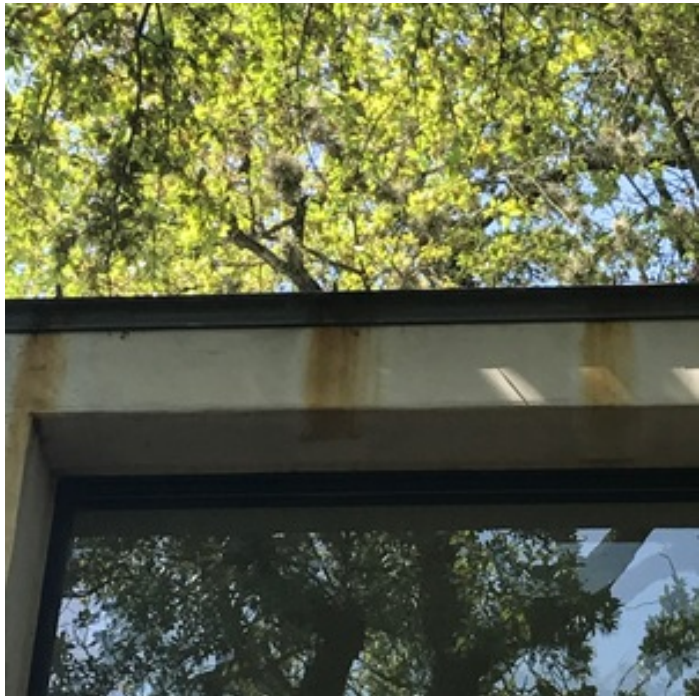
MOISTURE WICK NEAR MASTER BATH

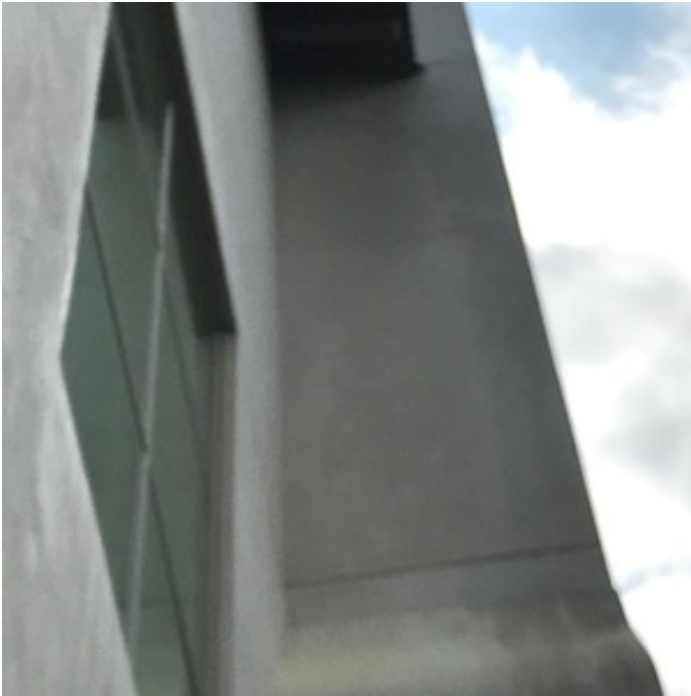
- Moisture Staining/Elevated Water Run Off at Chimney Area: Consult With Roofer to Determine if Flashing Updates are Available and Warranted
- Moisture Staining/Elevated Water Run Off at Right Side Flat Roof Area: Consult With Roofer/Address Cosmetic Issues as Needed
- Secure Loose Vermin Screen at Exhaust Cap Exit: Upper Wall Over Back Porch Roof (Maintenance Update)
- Minor Damage/Material Separation at Metal Trim Pieces: Wall Panel/Stucco Edges (Update as Needed)
- Seal All Gaps at Window/Door Frame Joints With Exterior Framing: Preventative Maintenance Update Need
- Sprinkler Overspray/Front Entry Paver Feature: Adjust Surrounding Sprinklers as Needed
- Sprinkler Overspray/Exterior Master Shower Door Paver Feature: Adjust Surrounding Sprinklers as Needed

RUN OFF AT CHIMNEY AREA

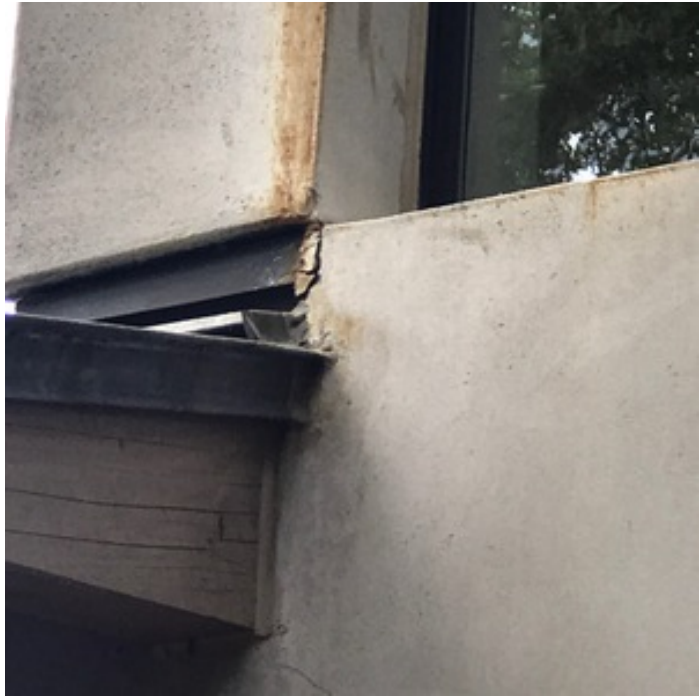
SIDING CRACK NEAR ROOF TRIM - RIGHT

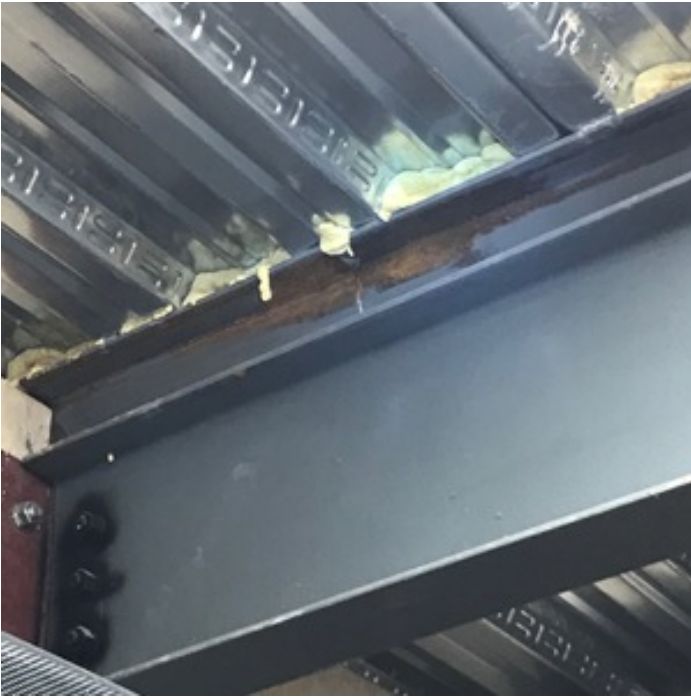
ISOLATED RUST AT I-BEAM

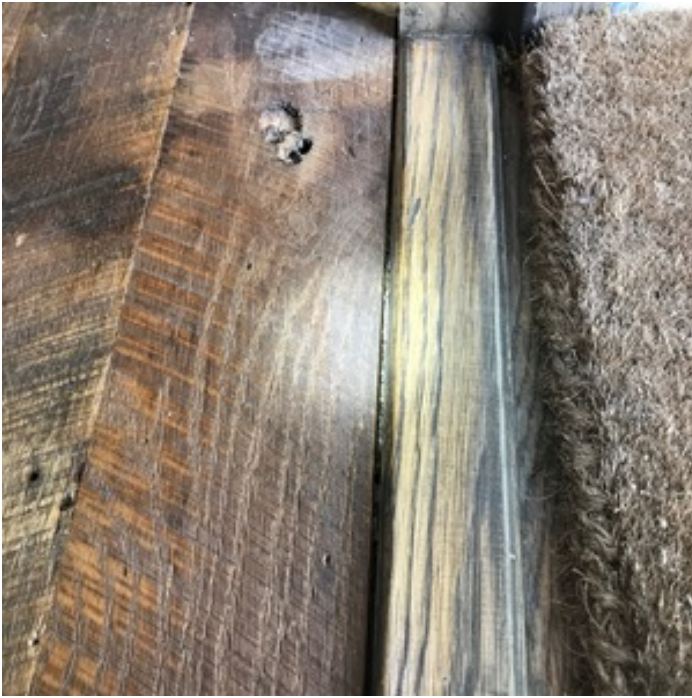
Caulking and sealing improvements at flooring gaps located in and around high moisture areas (kitchens, baths, door thresholds, etc.) is recommended to reduce moisture entry points. Excess moisture entering under and between flooring material can cause damage to floors and surrounding material.

SEAL GAP - FRONT DOOR TRANSITION

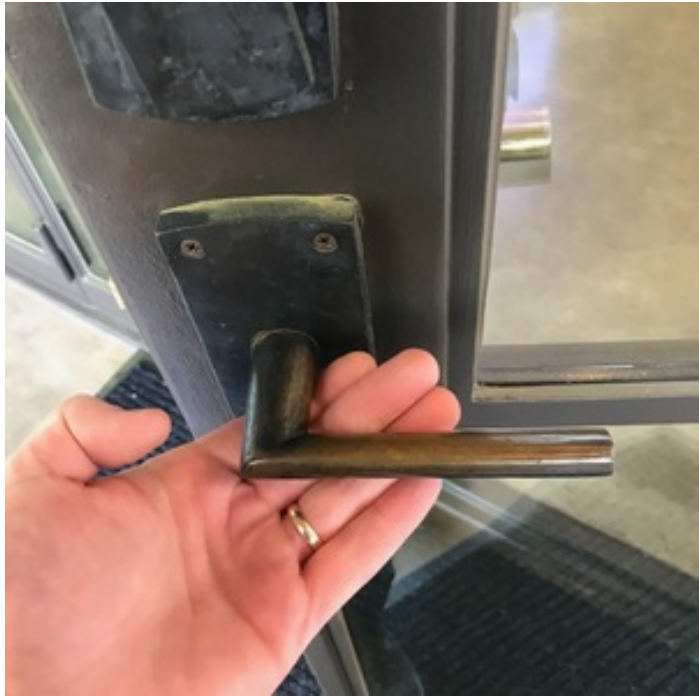
- Minor Ghosting at Door/s (Uneven - Swinging Open/Closed): Common Adjustments Needed
- Non Functional Digital Lock Pad/Carport Storage Door
- Loose Exterior Door Handle/Dining Room: Adjust/Repair Prior to Failure

LOOSE HANDLE

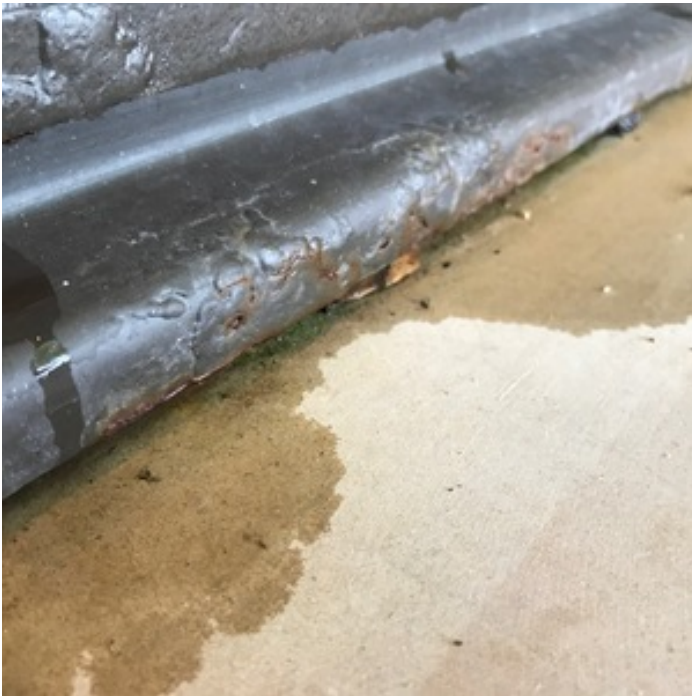
- Weather/Moisture Strip Update Needs at Exterior Master Shower Door: Water Loss and Pooling at Paver
- Minor Rust/Corrosion at Exterior Metal Doors/Door Frames: Sand/Repaint/Protect as Needed and Address Paver Issues (Pooling Water)

RUST/DAMAGE AT THRESHOLD

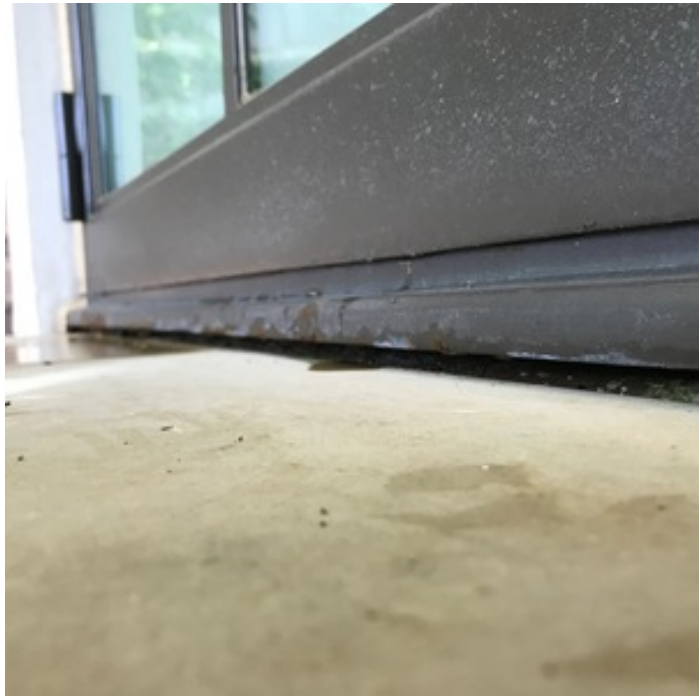
NOTE: Specific issues/concerns of current moisture entry/escape/damage were noted at the kitchen entry door (entrance at front yard) and the master shower exterior door (large gap at threshold - paver connection area).

MOISTURE ENTRY CONCERN - THRESHOLD AREAS

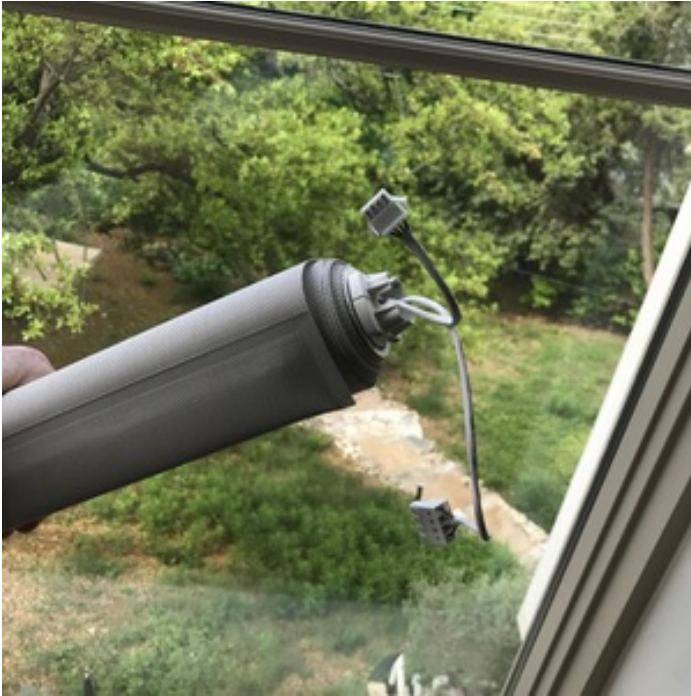
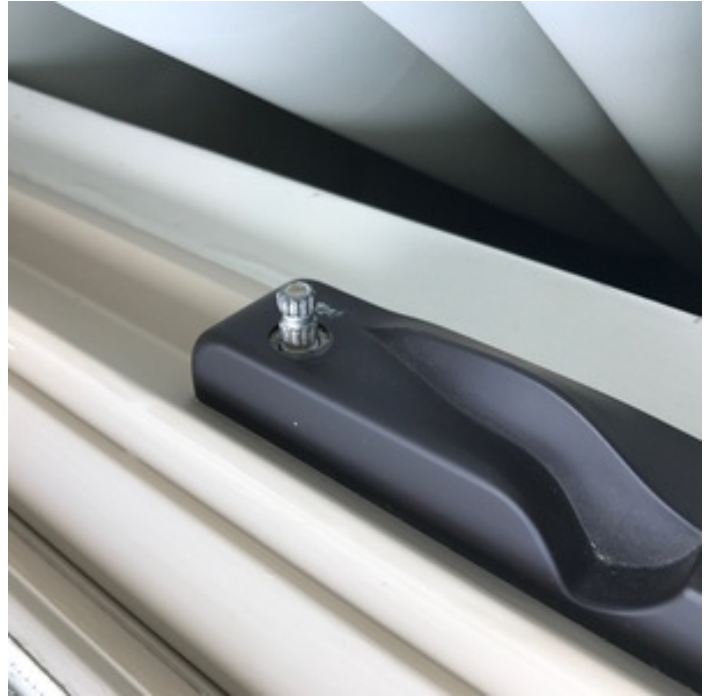
- 1x Motorized Blind Removed/Living Room: Update/Repair as Needed
- Missing Hand Cranks at Bedroom Windows (2): Replace All Missing Cranks as Needed

REMOVED MOTORIZED BLIND

MISSING CRANKS

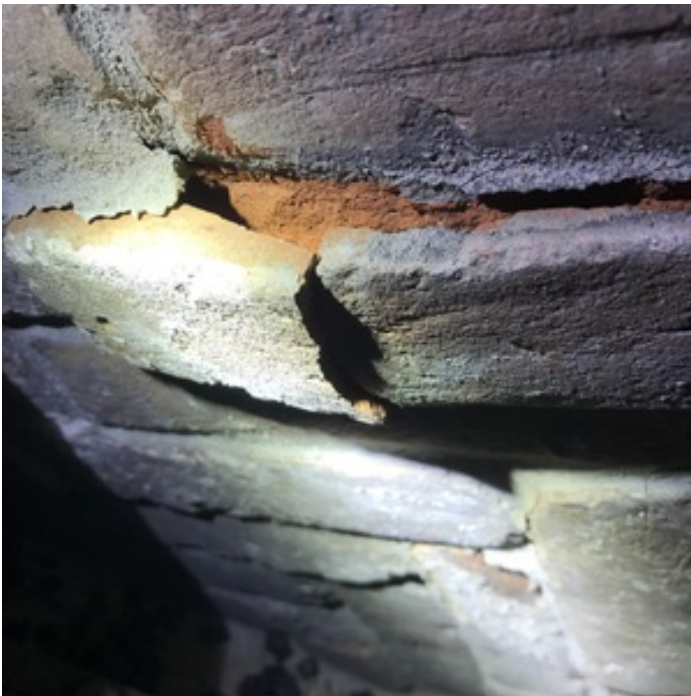
LOOSE MATERIALS/FIRE BOX (MINOR CONCERN)

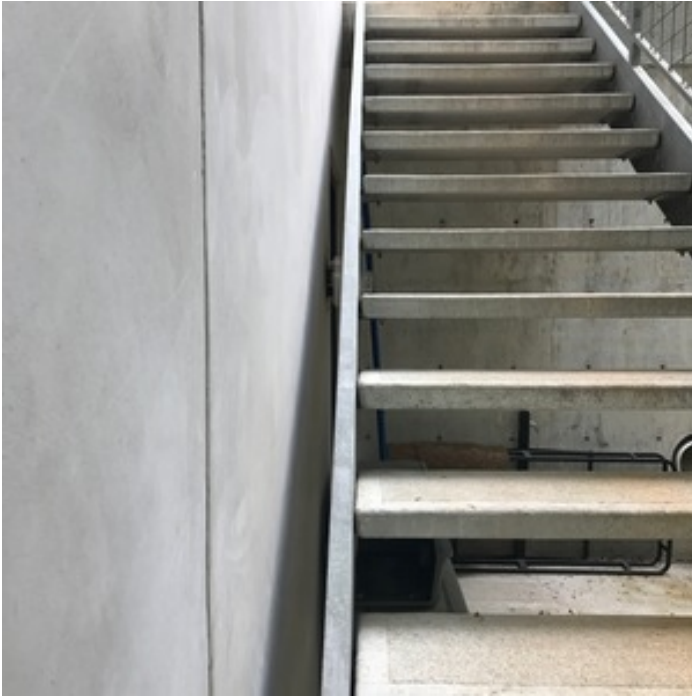
Excess give and minimal/no supplemental support (tie-ins at adjacent wall) at the outdoor stair stringer was noted (left yard under carport). Further assessment and evaluation by an engineering or installation specialist is recommended to determine if additional stair support is required. Common load and deflection standards for metal construction material are produced/published by the National Association of Architectural Metal Manufacturers and various code associations (ICC, IRC).

MINIMAL STRINGER BRACING/SUPPORT

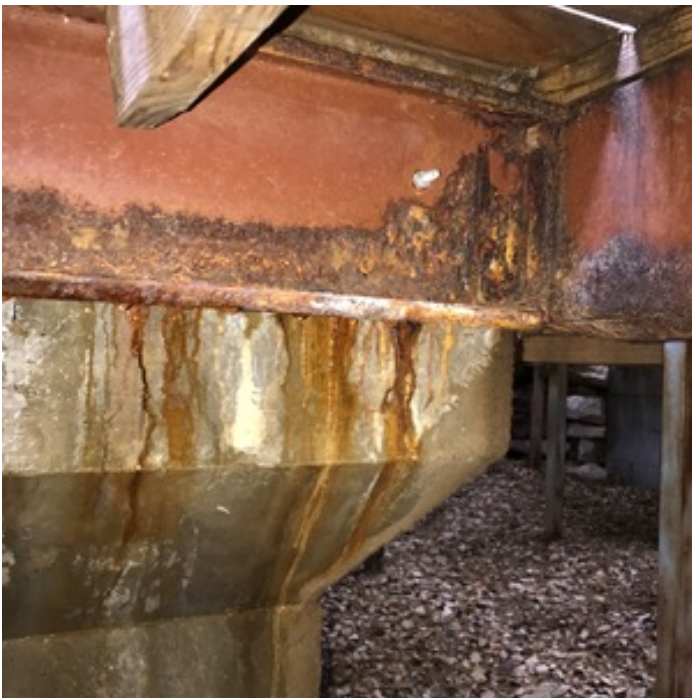
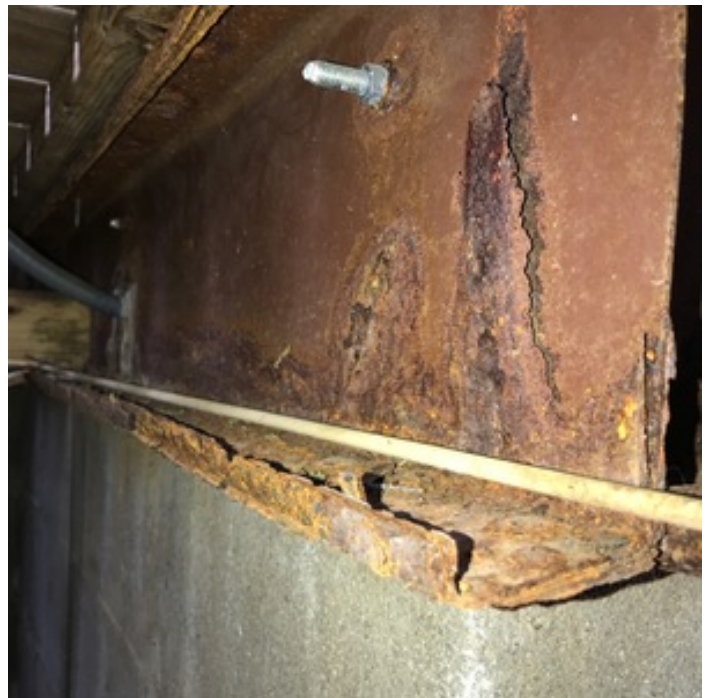
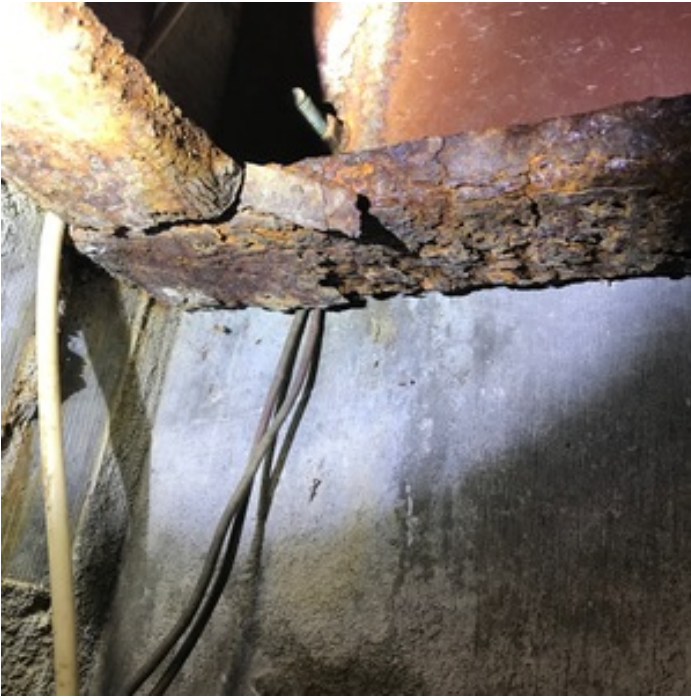
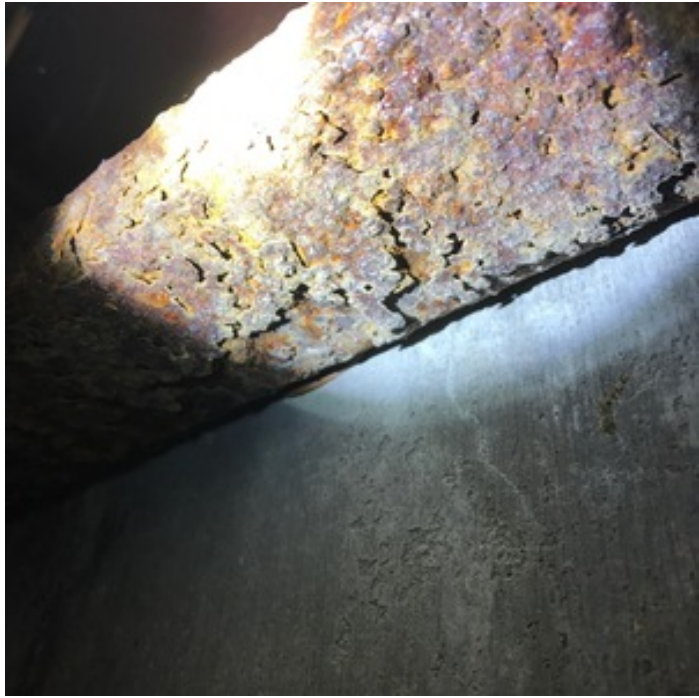
Leakage at pool coping stones (and general aging/exposure) has resulted in points of excess deterioration and rusting of the steel I-beams serving as support framing for the pool framing. Due to the relatively thin gauge (metal thickness) of the beams, repair may not be possible (welding in new material may be required). Addressing all leakage at pool equipment is needed to eliminate excess moisture issues causing the damage. Contacting a welding specialist is recommended to repair/replace damaged steel beams and ensure any additional issues with steel framing material are eliminated.

POOL LEAK/BEAM DAMAGE

BEAM DAMAGE - POOL DECK

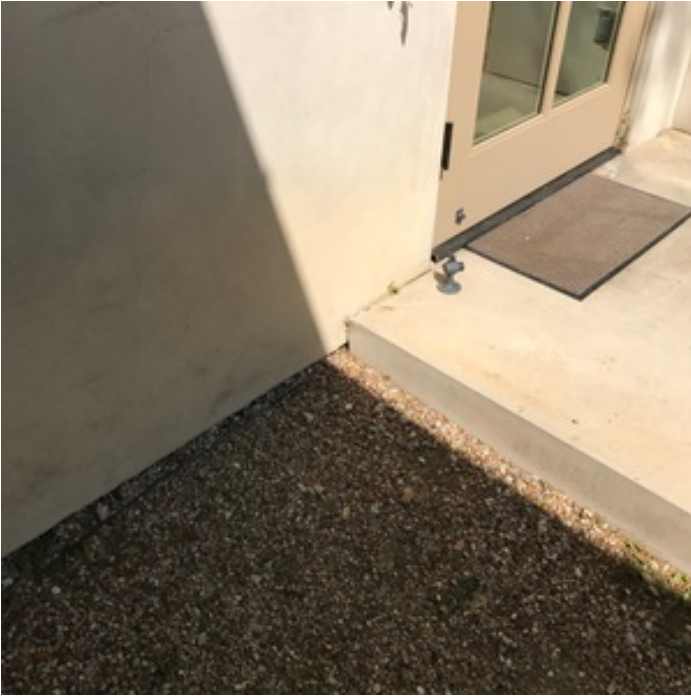
- Pavers Installed in Manner That Prevents Visual Assessment of Adjacent Foundation Wall: Reduced Ability to Monitor/Address Issues
- Slope and Paver Height Issue at Kitchen Area Door: Evidence of Moisture Penetration (Wall Damage) at Interior Wall

EXTERIOR FEATURES COVER FOUNDATION

- Recommendation: Adjust Pavers Such That Foundation Wall is Partially Visible (for Monitoring/Reduced Likelihood of Undiscovered Issues)
- Recommendation: Address All Material Damage Due to Moisture Entry/Pooling

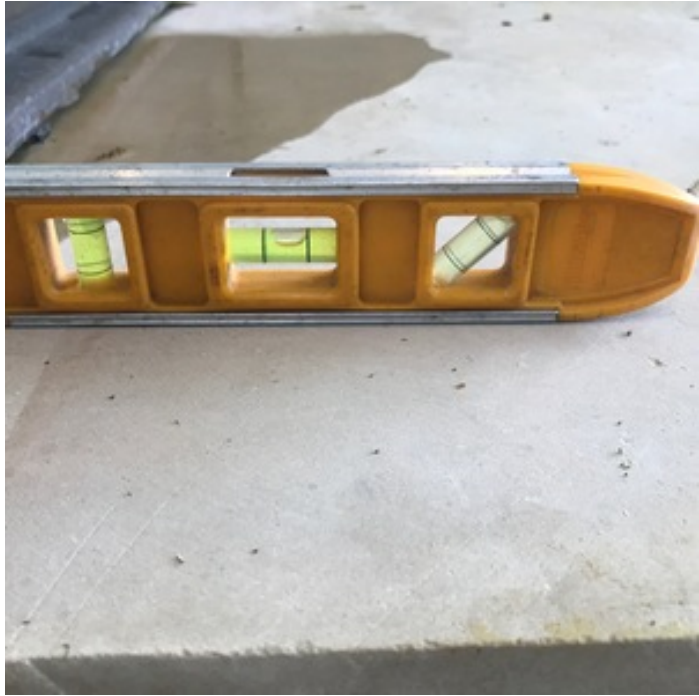
SLOPE CONCERN AT DOOR PAVERS

- Recommendation: Ensure Pavers Sloped at No Less Than 2% Grade Away From Structure
- Recommendation: Ensure Pavers are Adjusted to Create an Adequate Drop in Height (to Prevent Moisture Penetration -Currently Flush With Wall/Door Threshold)

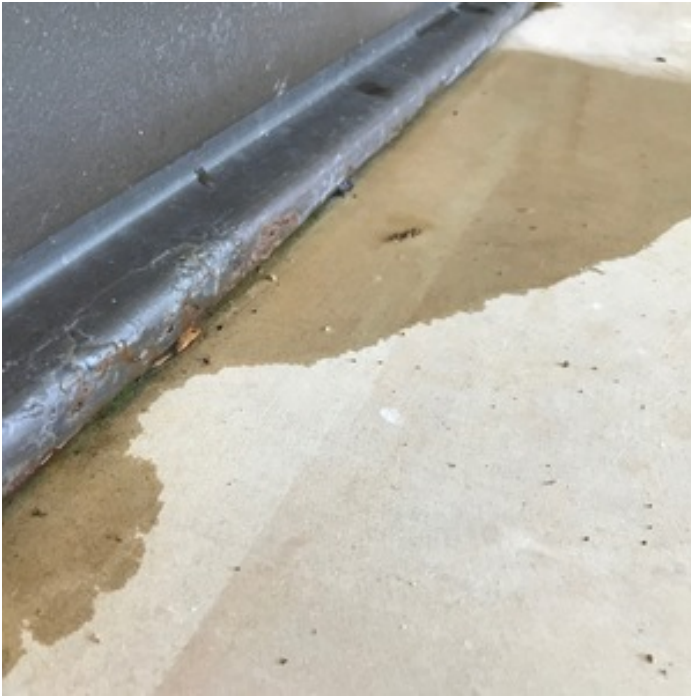
- Leakage and Pooling Water Due to Slope Issue at Master Shower Door: Rust Damage and Moisture Penetration Concern Near Door Threshold
- Pooling Concern at Various Paver/Door Areas: Rust at Door Framing/Increased Likelihood of Moisture Penetration

MOISTURE POOLING - SHOWER DOOR

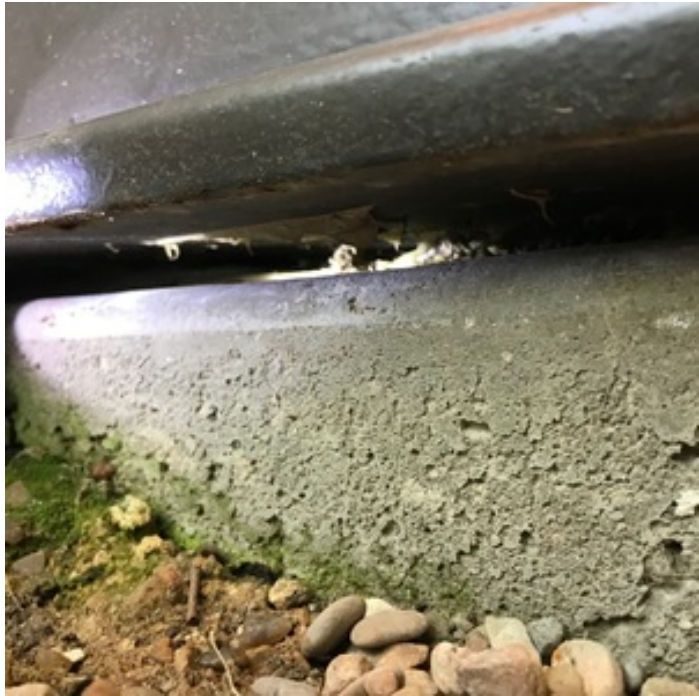
MOISTURE ENTRY - PAVER/THRESHOLD

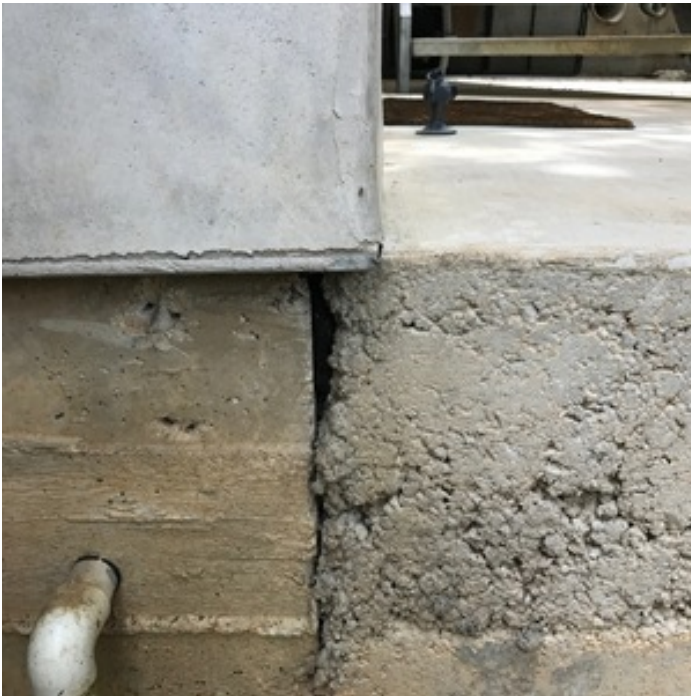
SLAB FLUSH WITH WALL

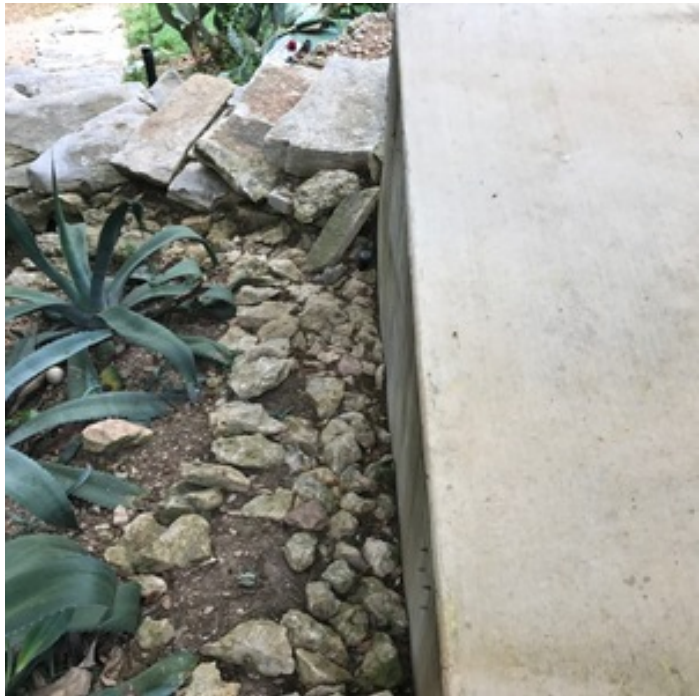
MISSING RAILING

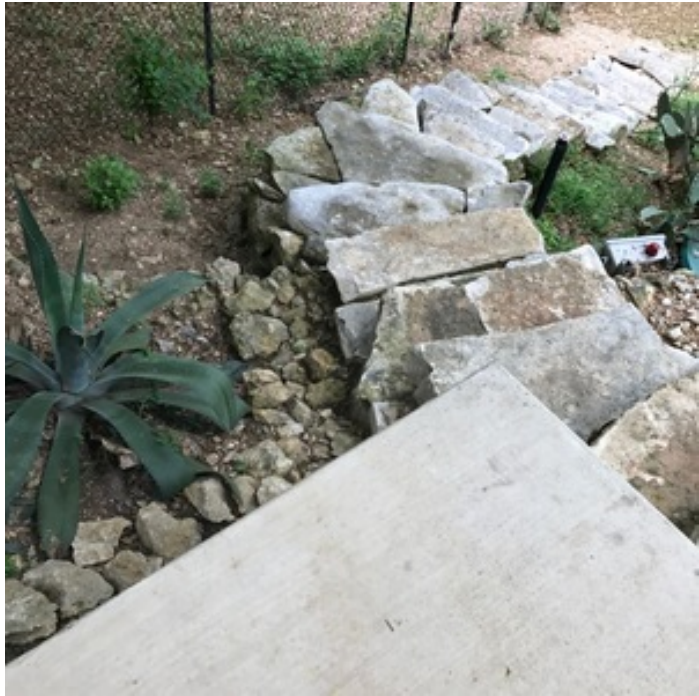
MISSING RAILING/UNEVEN STONE STEPS

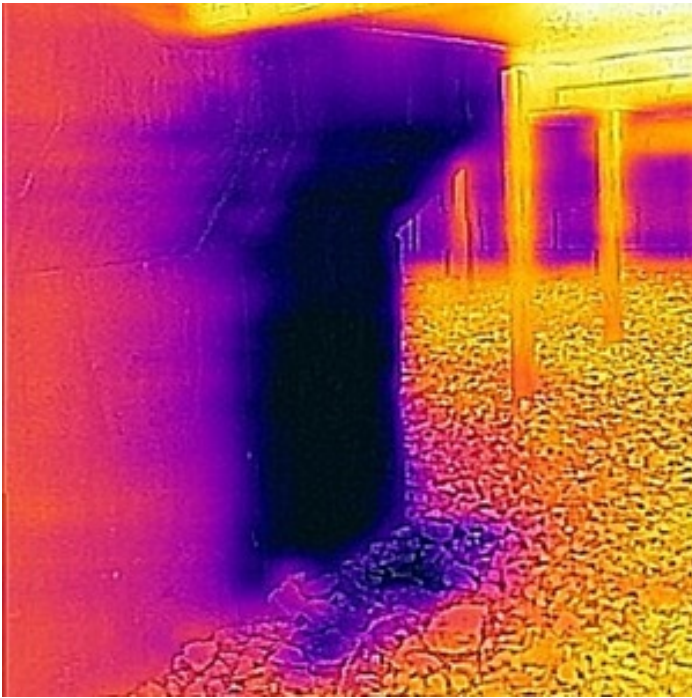
- Address Leakage at Pool Wall: See 'Porches, Decks, Balconies, Carports' Chapter
- Address Pooling at Pavers/Exterior Doors: Moisture Entry Concern

LEAK AT POOL WALL

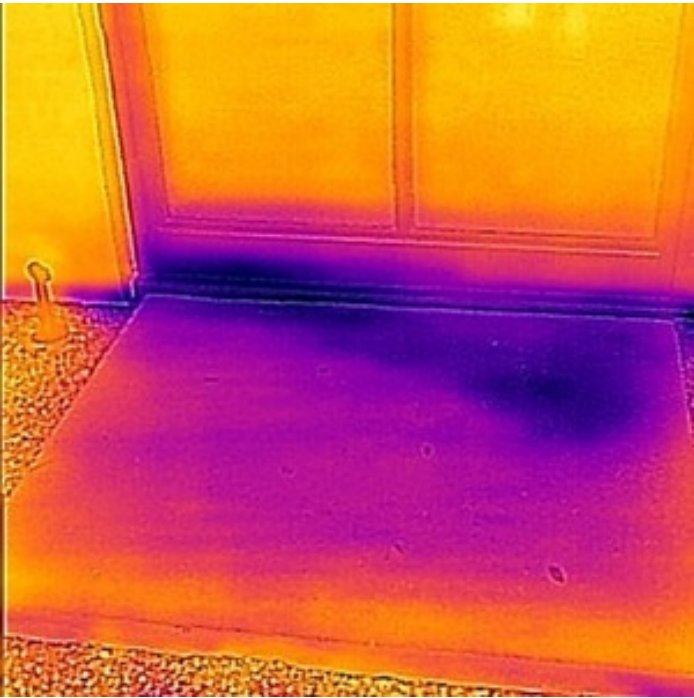
POOLING AT PAVERS

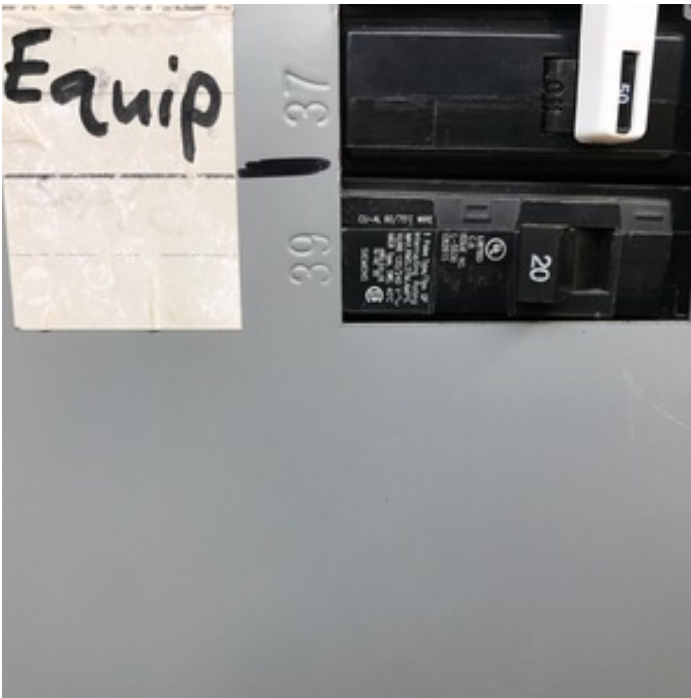
- Failed Breaker Servicing Sewage Pump/Tank: Repair/Replace as Needed
- NOTE: Information provided by the current owner indicates that this issue had been resolved (breaker replaced following inspection)

FAILED BREAKER - SEWER PUMP

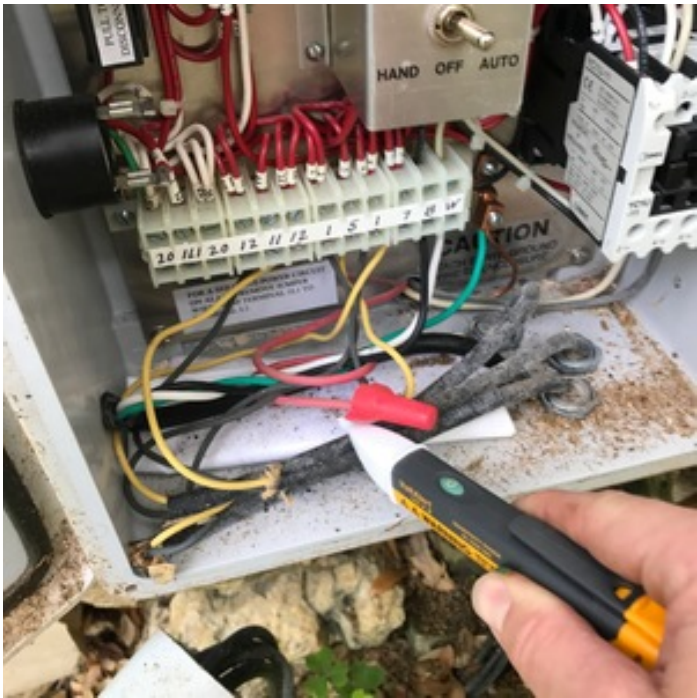
NO POWER AT PUMP

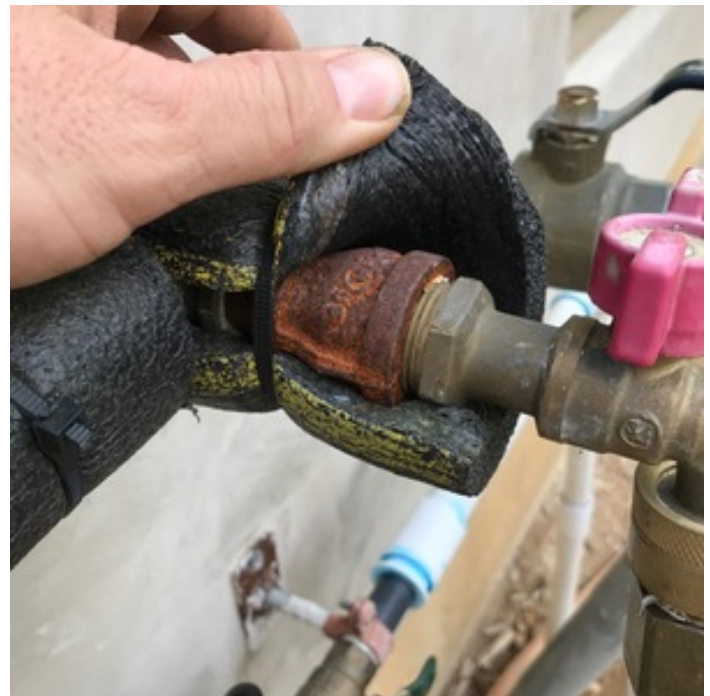
MINOR CORROSION AT BRASS/STEEL CONNECTION
