Property: 2905 Richard Ln.
Austin, Texas 78703
Client: Carol Dochen
Inspection Type: Property Assessment Report
Lead Inspector: Andy Jordan #9458
Date: April 5, 2018

ADDENDUM: REPORT SYNOPSIS

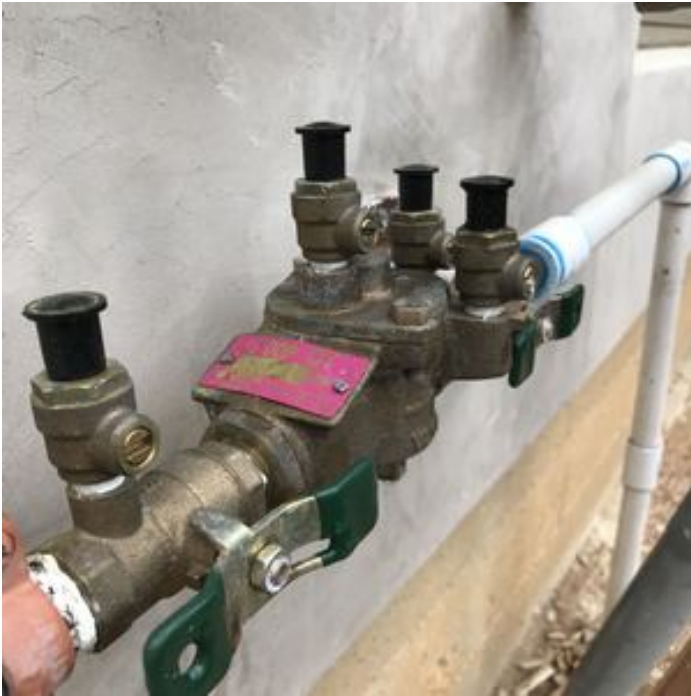
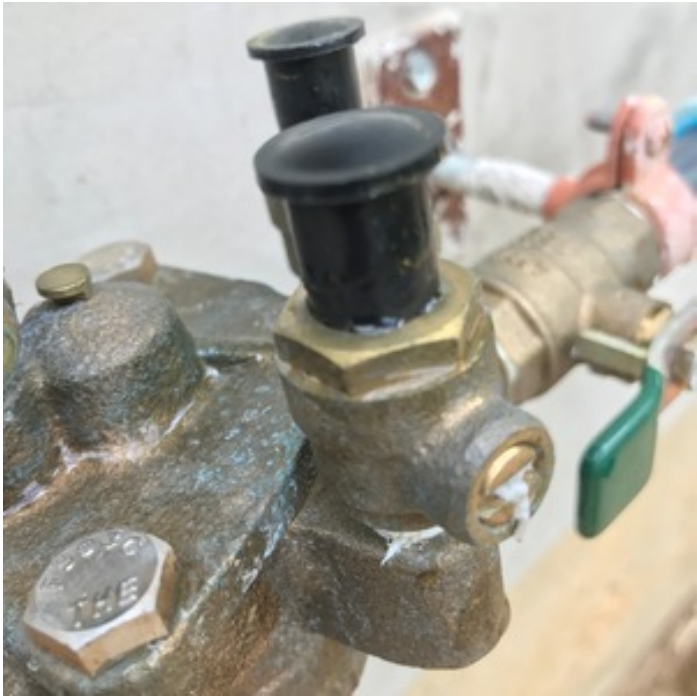
- Leak Discovered/Reduced Pressure Zone Assembly (Rear Wall): Eliminate All Leaks/Consult Licensed Plumber
- Insulate/Protect All Exposed Supply Piping at Exterior Portions of Structure: Reduced Likelihood of Damage/Freezing
- Consider Replacing Pressure Gauge at Water Tank System: Gauge Cracked/Difficult to Read
- Rust/Corrosion at Gas Line Back Exterior Wall Pipe Connection (Brass to Steel Connection): Update/Protect Material to Prevent Further Corrosion/Leakage (Minor Damage at Time of Inspection)

ACTIVE LEAK - PRESSURE VALVE

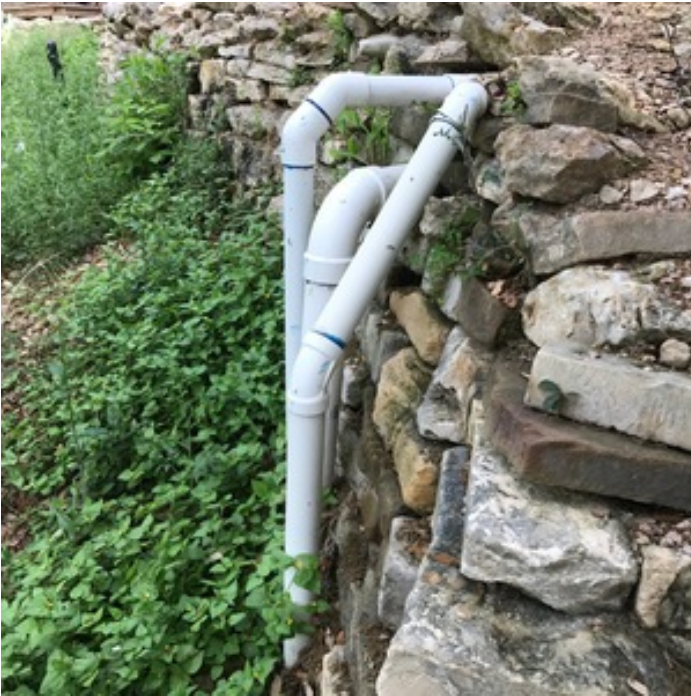
- Paint and/or Protect All Outdoor Exposed Portions of Piping (Various Areas): Improved Sun and Damage Protection
- Recover/Seal Exposed Portion of Piping at Back Foundation Wall: Minor Update/Maintenance Improvement

PROTECT EXPOSED PIPES

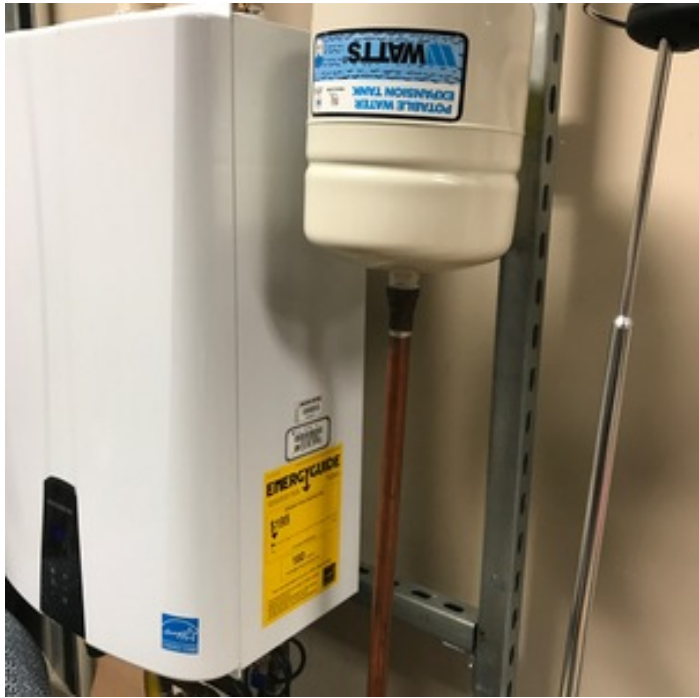
SECURE/LEAK PROTECT EXPANSION TANK

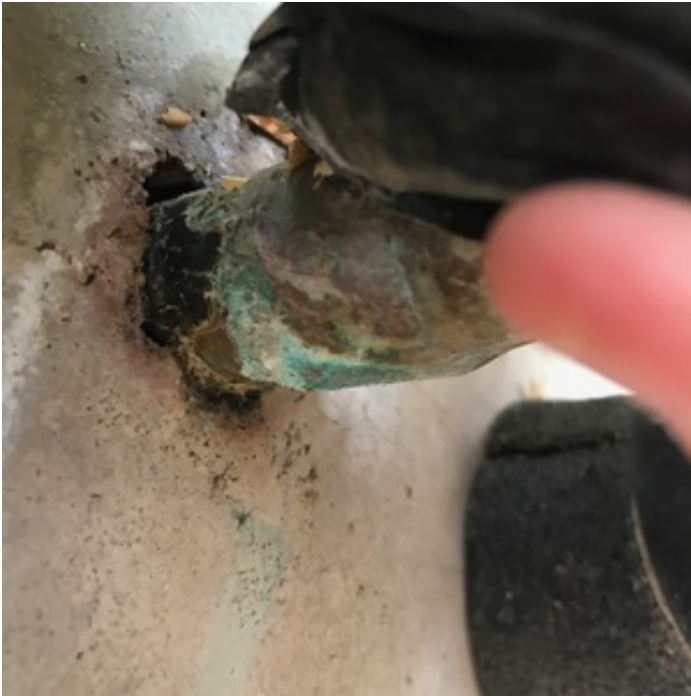
SUPPLY PIPE CORROSION

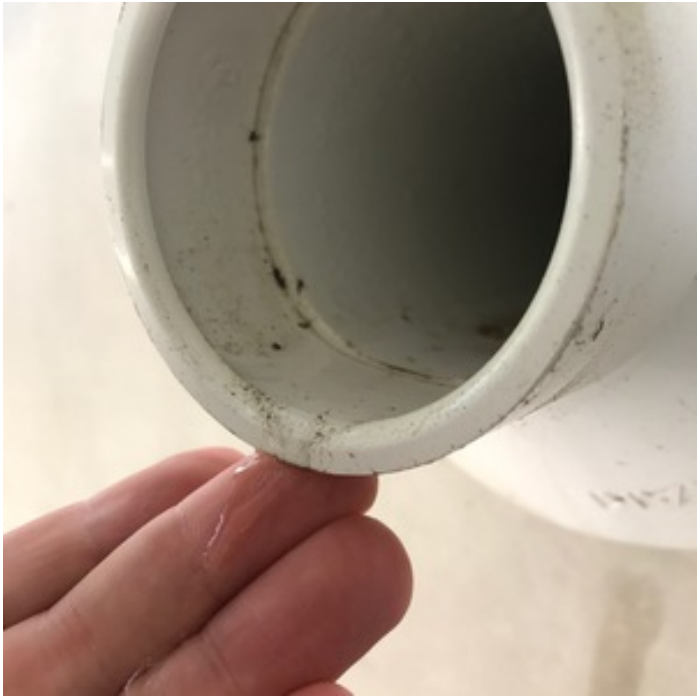
EXCESS CONDENSATE/EXHAUST FLUE

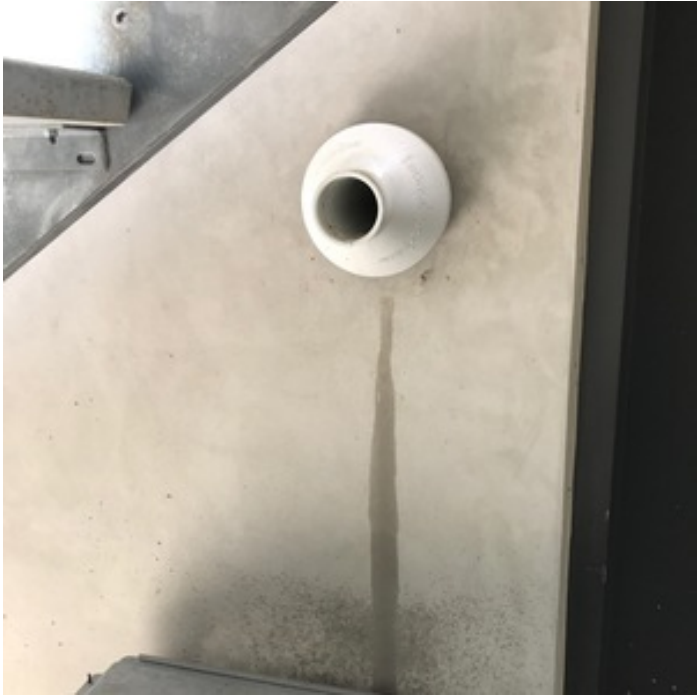
EXCESS EXHAUST MOISTURE

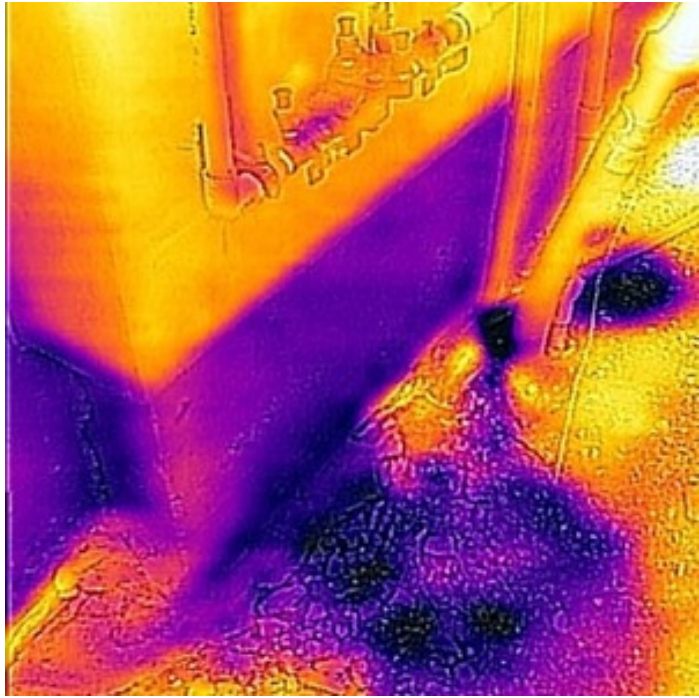
LEAK AT PRESSURE VALVE

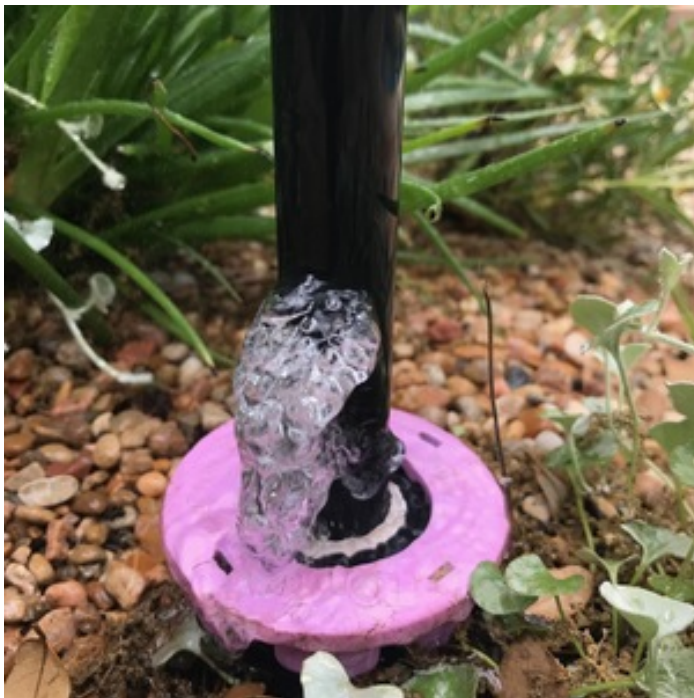
HEAD LEAK

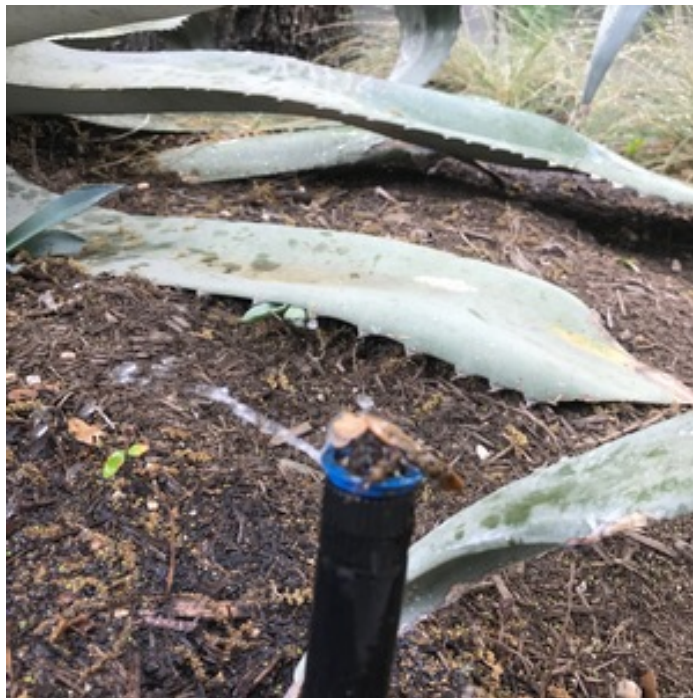
LOW PRESSURE

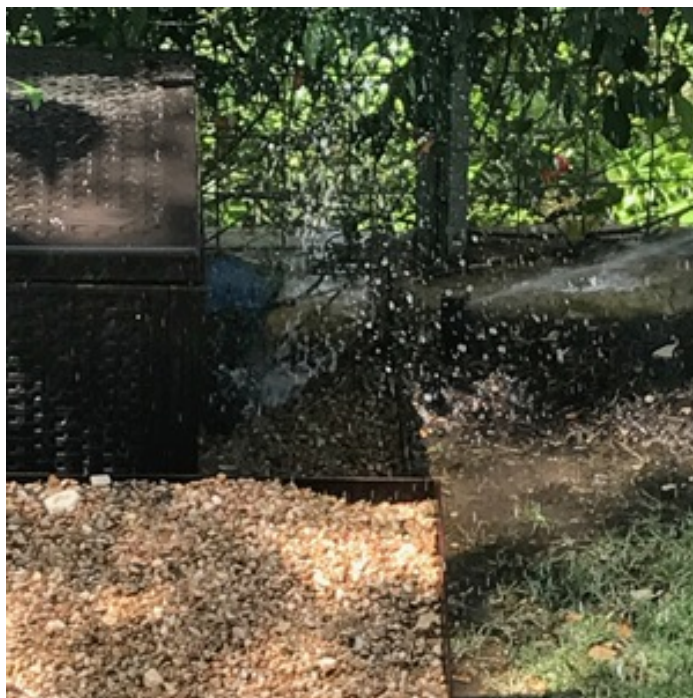
RUPTURED HEAD

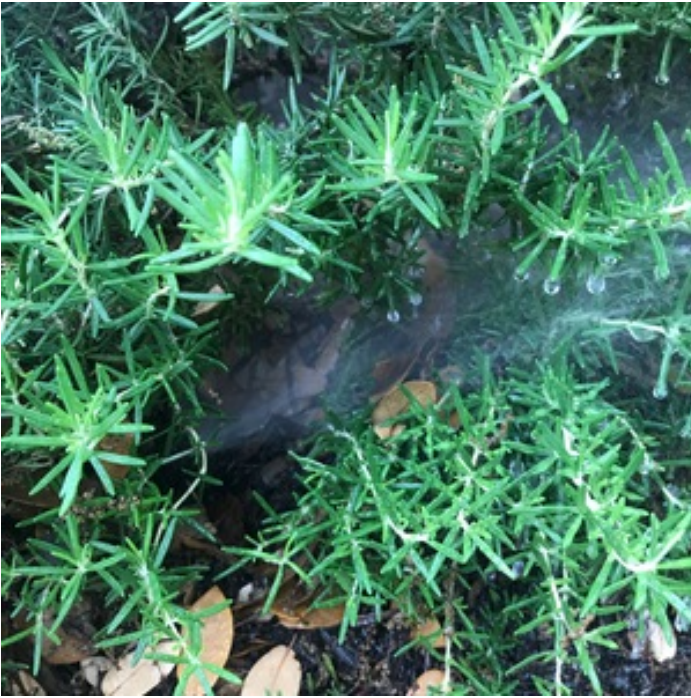
HEADS BLOCKED BY LANDSCAPING
