PROPERTY INSPECTION REPORT

Prepared For:	Carol Dochen (Name of Clie	ent)
Concerning:	2905 Richard Ln. Austin, Texas 78703	
	(Address or Other Identification	of Inspected Property)
By:	Andy Jordan, Lic #9458	April 5, 2018
	(Name and License Number of Inspector)	(Date)
	(Name License Number of Sponsoring Inspecto	or)

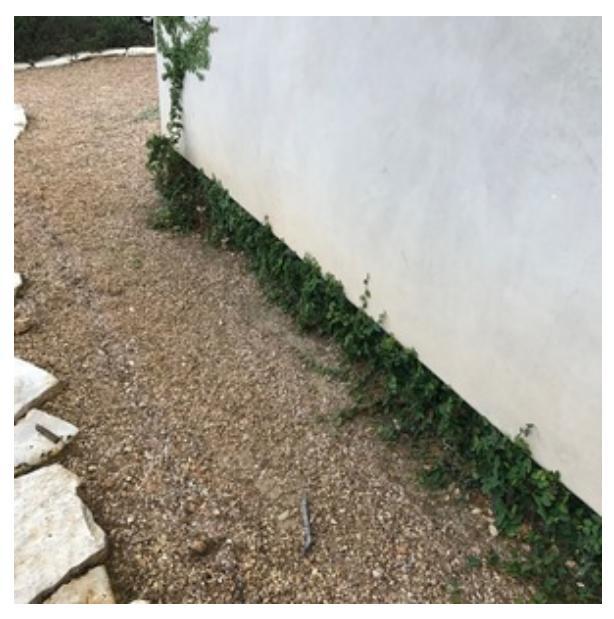
VISUAL LIMITATIONS DUE TO FOLIAGE

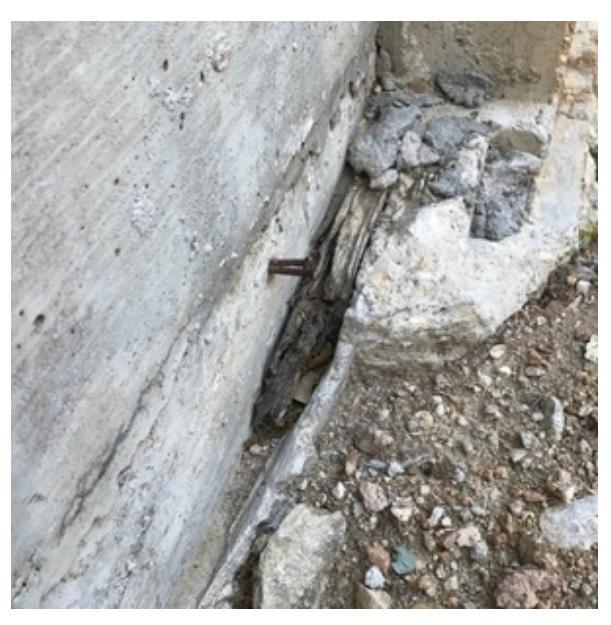
-Protruding Nails at Back Foundation/Decking Walls: Remove Protruding Nails to Reduce Risk of Injury -Portions of Form Boards Left in Place (Back Wall): Remove Wood Debris Near Foundation to Prevent Termite Attraction

REMOVE FORM BOARD DEBRIS

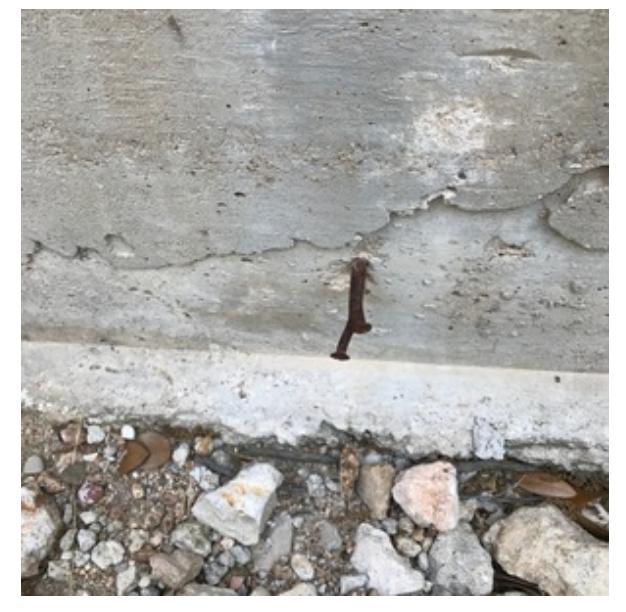
REMOVE PROTRUDING NAILS

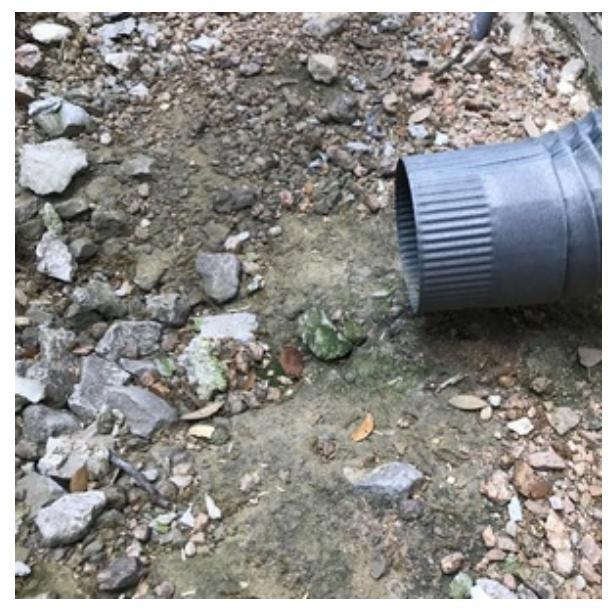
INSTALL SPLASH STONES

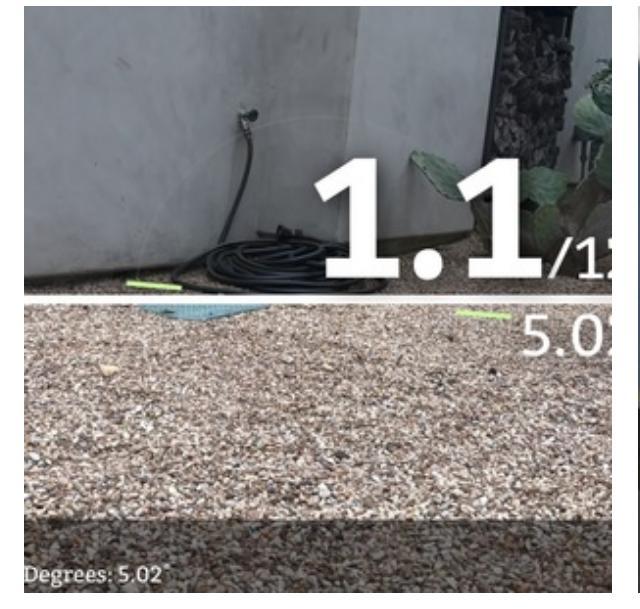
Overall, the grading and drainage at/around the building appeared to promote moisture diversion away from the structure to an adequate degree. Isolated areas of marginal grading/drainage, or areas that may benefit from grading/drainage updates were noted. It is recommended that the following areas be monitored and/or updated as needed. Areas of general, minor concern noted at the time of inspection include, but are not limited to: -Consider Installing Splash Stones/All Gutter Exits: Prevent Soil Erosion/Improves Water Diversion -Negative Slope Towards Structure/Right Side Yard: Monitor for Pooling Near Foundation/Address as Needed

MONITOR NEGATIVE GRADE - RIGHT

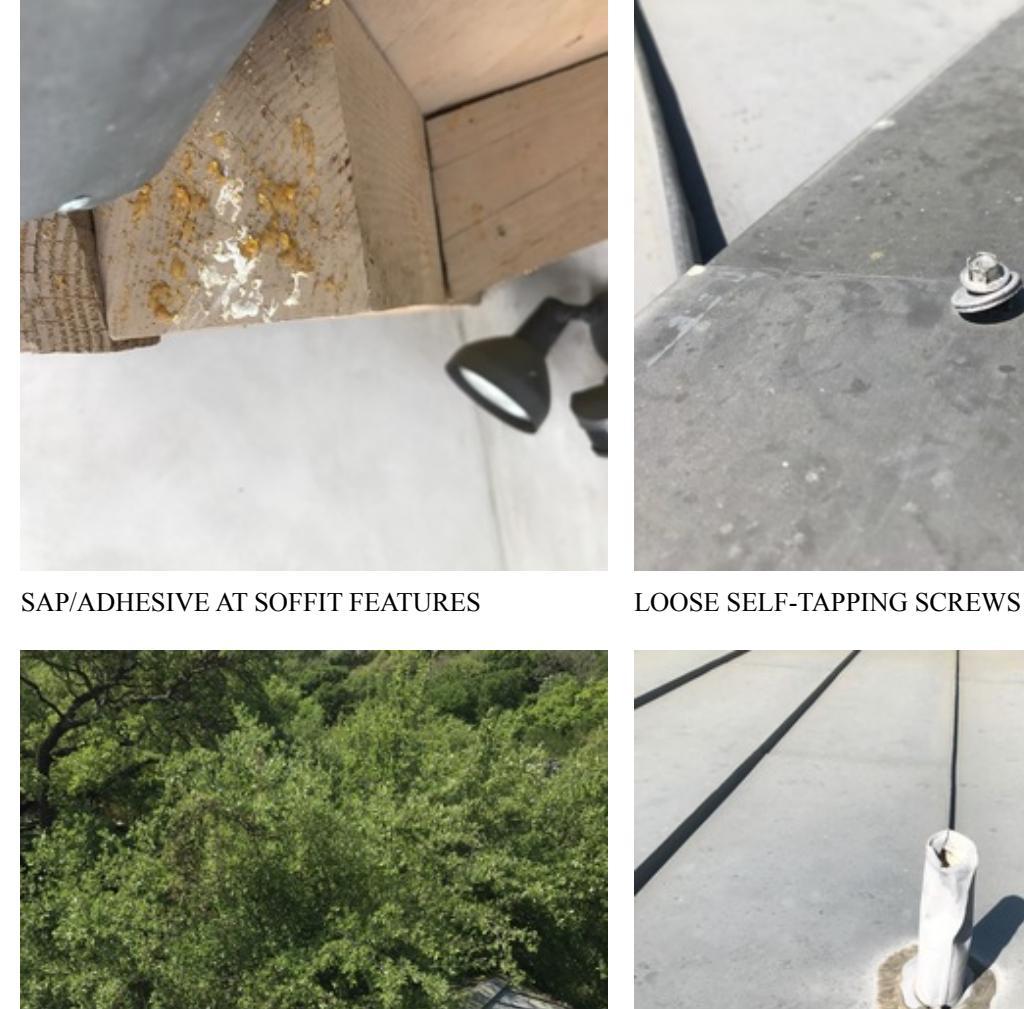
COMMON ISSUES	
			 TREE LIMB CONTACT NOTED - NO SIGNIFICANT DAMAGE: Current tree limb contact with the roof and structure was noted. At the time of inspection, no significant damage to roofing material was discovered (damage to gutters, minor roof damage/concerns). Tree contact with the roof and structure can lead to material damage in a relatively short amount of time. Additionally, tree to structure contact is a common bridge for vermin and insects to access and infest buildings. A tree specialist should address limb contact and make needed adjustments to surrounding trees/shrubs. Ensure updates and maintenance are addressed in an expeditious manner. 	
			 MAINTENANCE/REPAIR RECOMMENDATIONS AND CONCERNS: Areas of common flaws, adjustment needs, and/or general concern were discovered during the roof assessment. Ensure all recommendations and concerns are professionally addressed as needed. Areas of concern noted at the time of inspection include, but are not limited to: Self Tapping Screws Utilized at Porch Roof and Ridge Caps: Monitor and Update as Needed (Re- SecureCaulk/Seal Every 5-7 Years) Ensure All Standing Seams Properly Crimped: 1' Un-crimped Section Over Car Port (Minor Issue) Excess Tree Sap and/or Construction Adhesive at Exposed Rafter Ends/Soffit Features (Various Areas): Cosmetic Issue Only (Update as Needed/Desired)

ELIMINATE TREE CONTACT

-Trim Trees to Prevent Further Damage to Gutter/Structure

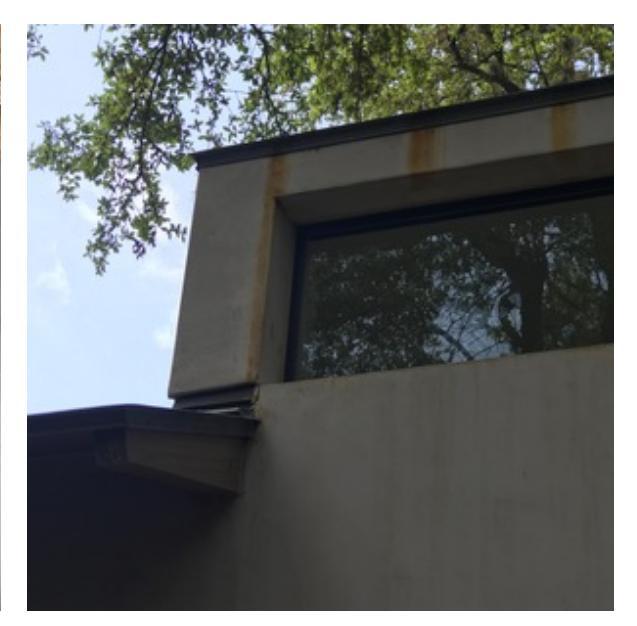
-Improper Installation of Metal Roofing at Low/Flat Sloped Portion of Roof (Right Side): Contact Roofing Specialist to Update as Needed

INSTALL CONCERN - RIGHT FLAT ROOF

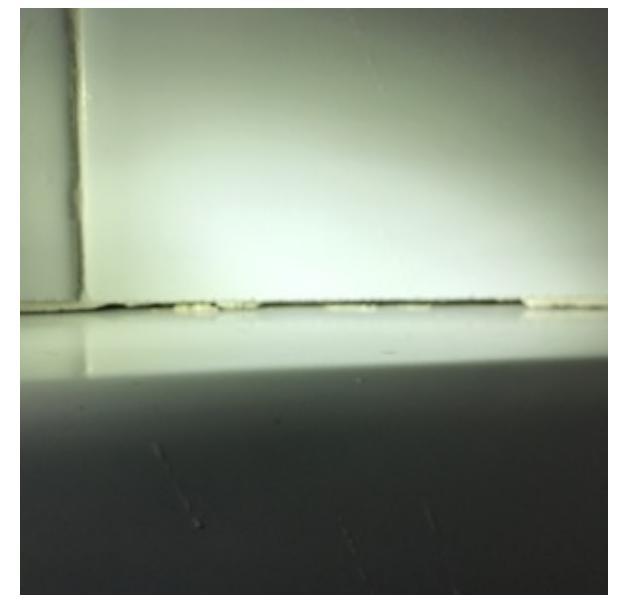
TILE GAPS/TUB SURROUND

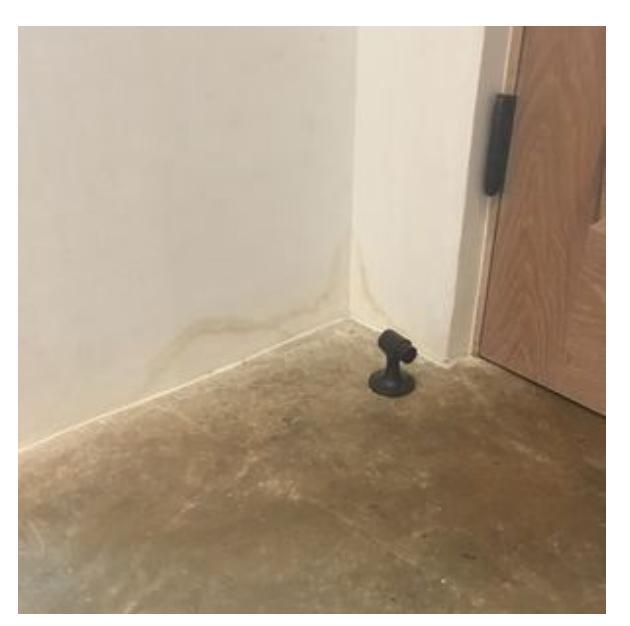
UPDATE (2018APR13): During a return visit to the property, additional information provided by the current owners indicated that the wall damage discovered in the kitchen area was causes by the loss of power and leakage of a freezer (date of incident unknown). Additional moisture meter and thermal testing took place at the area of concern. When compared to control moisture readings (moisture percentages recorded at non-damaged areas of similar material), moisture percentages appeared to be normal at the affected area. Although the interior wall damage/issue appears to be unrelated to concerns at outdoor pavers, the recommendation to adjust exterior features remains unchanged.

MOISTURE DAMAGE - KITCHEN AREA WALL

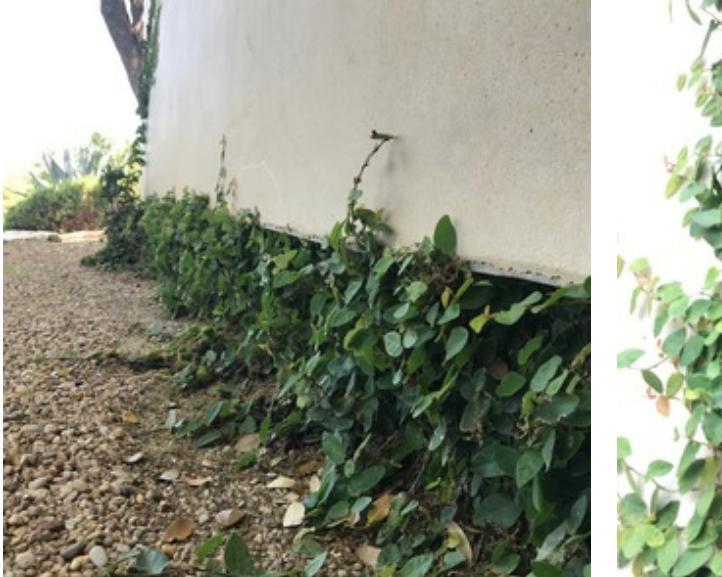
VISUAL LIMITATIONS

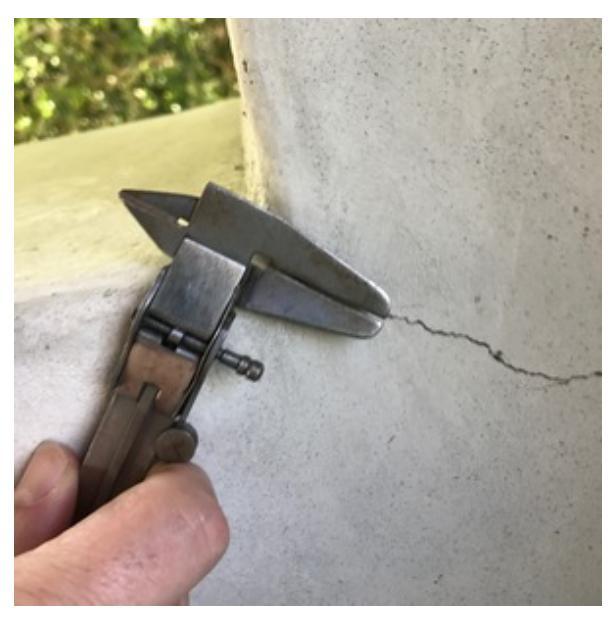
MONITOR NORMAL CRACKING

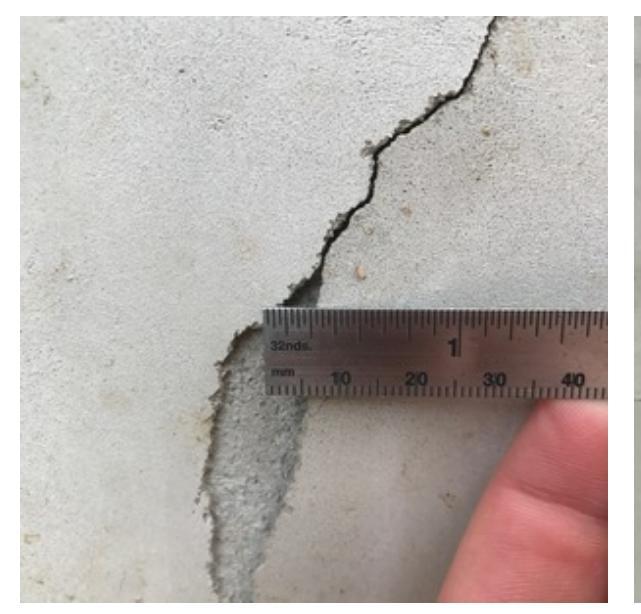
PEELING DECORATIVE FINISH

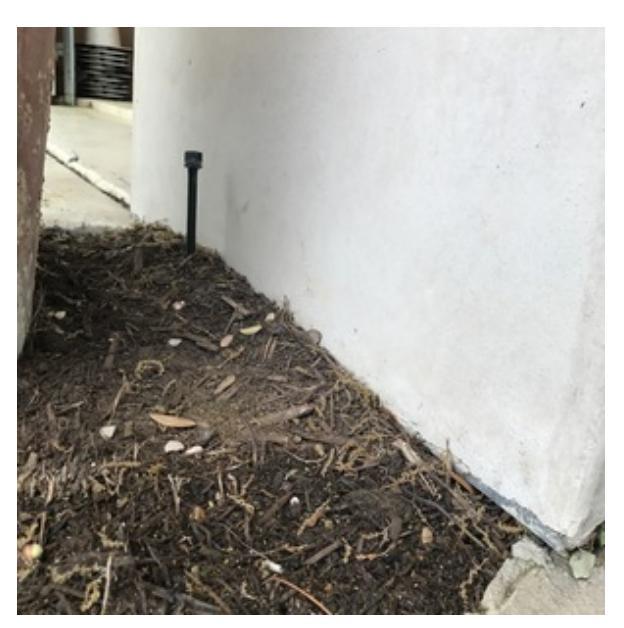
Elevated soil/material lines were noted at portions of the exterior walls (soil rises above foundation - contact w/ siding). High soil lines increase the likelihood of moisture penetration into the structure, damage to building material, and insect intrusion (to include termites). General standards call for no less that 3" of foundation wall to be visible above the soil line or landscaping material. Additionally, a 5% grade slope (6" drop per 10') away from the structure is recommended to promote natural moisture diversion. Ensure soil line issues are addressed and overall moisture diversion away from the structure meets or exceeds minimum standards. If limitations are present which prevent the ability to feasibly attain minimum soil line and/or slope standards, a landscaping/irrigation specialist should be contacted to determine what improvement options are available and warranted.

HIGH SOIL LINES/KITCHEN ENTRY

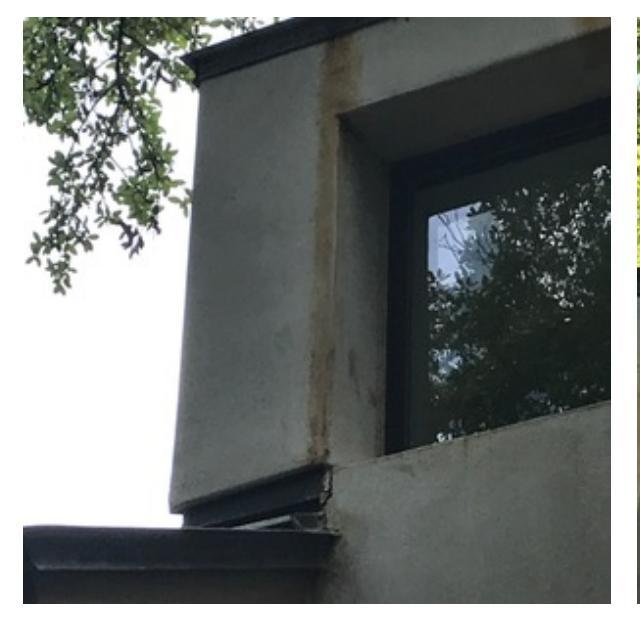
MOISTURE WICK NEAR FLASHING CRACKS

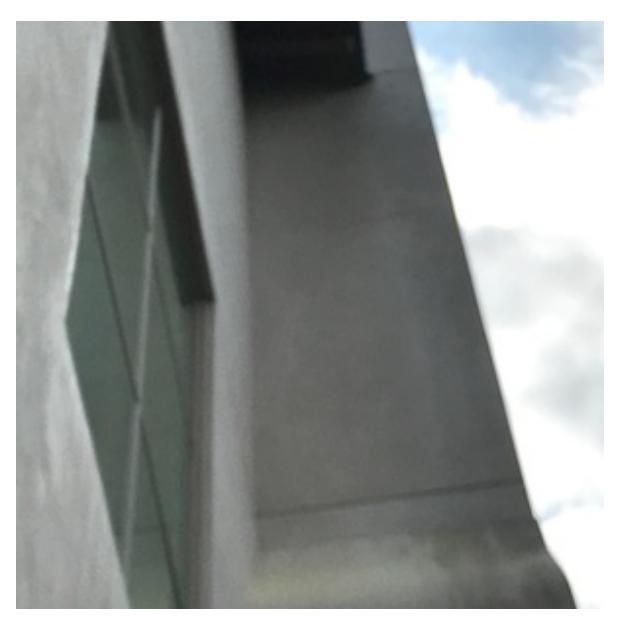
RUN OFF AT CHIMNEY AREA

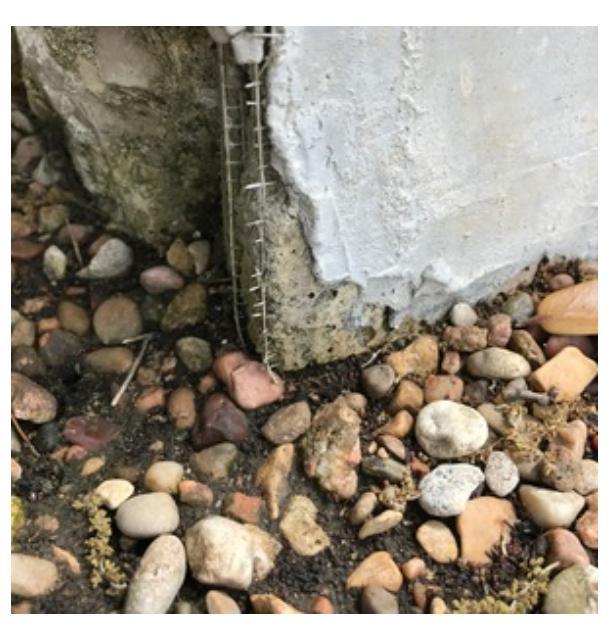
BACKER BOARD AT EXTERIOR WALL

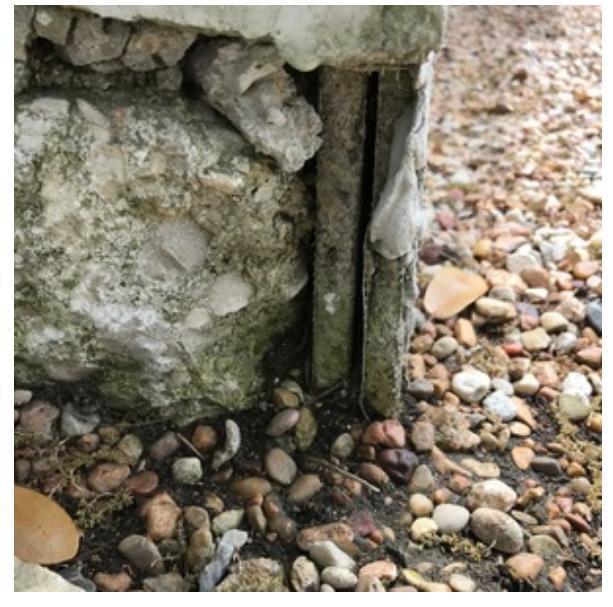
BACKER BOARD AT EXTERIOR WALL

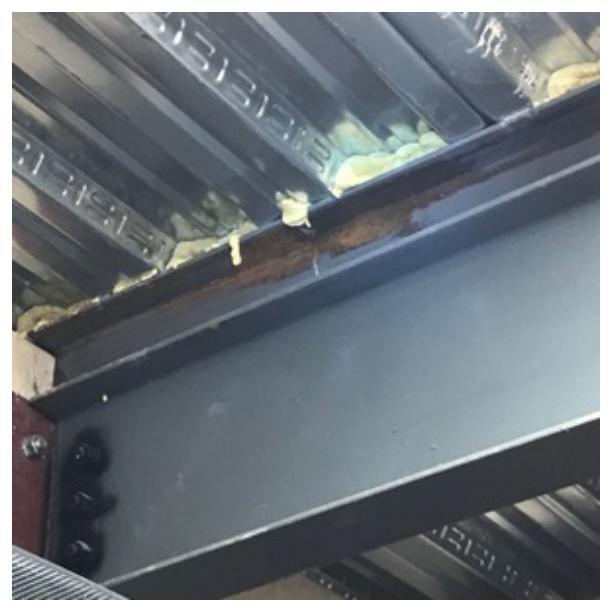
Exposed steel beam ceiling joists are present at the lower level storage closet. At the time of inspection, an isolated section of rust was discovered at a center beam (near connection with concrete wall). Although further investigation did not reveal indicators of leak/moisture issues, it is recommended that the area be regularly monitored to ensure the area of rusting does not increase in size or significance (minor surface rust at time of inspection).

ISOLATED RUST AT I-BEAM

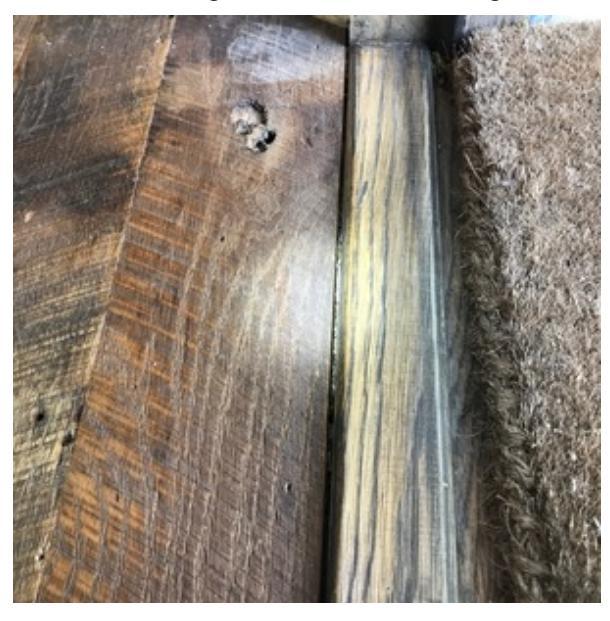
COMMON FLOORING ISSUES AT HIGH MOISTURE AREAS - EXTERIOR DOOR TRANSITIONS: Caulking and sealing improvements at flooring gaps located in and around high moisture areas (kitchens, baths, door thresholds, etc.) is recommended to reduce moisture entry points. Excess moisture entering under and between flooring material can cause damage to floors and surrounding material.

SEAL GAP - FRONT DOOR TRANSITION

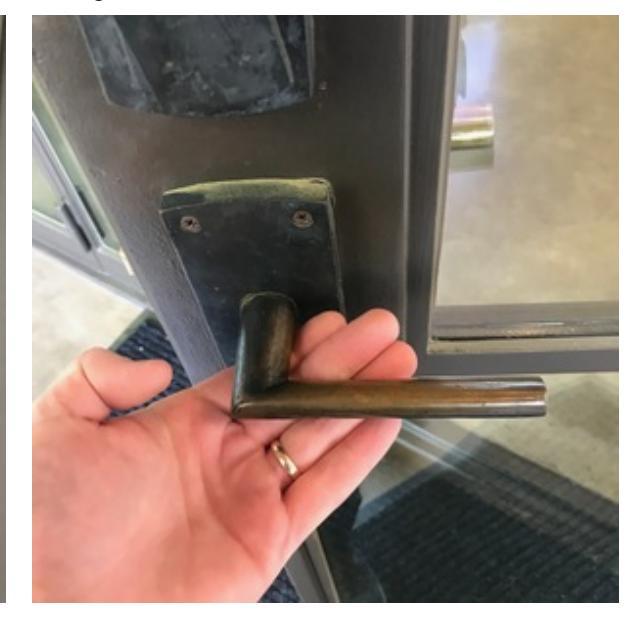
LOOSE HANDLE

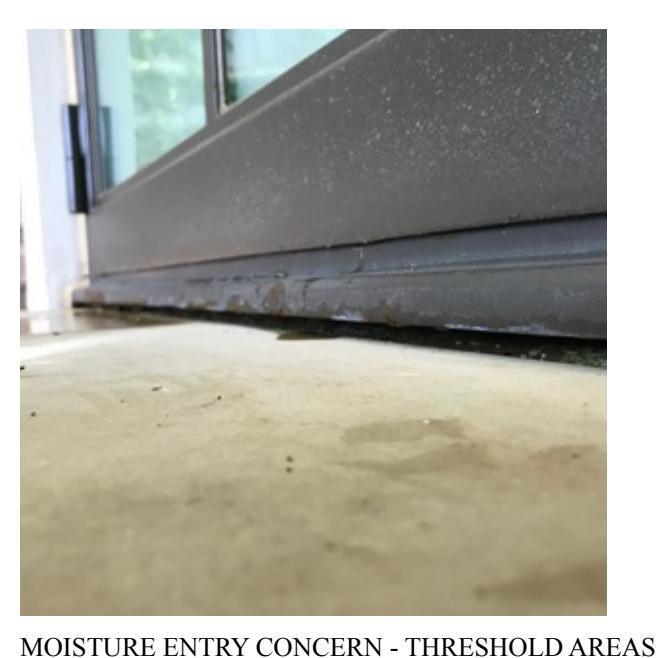
RUST/DAMAGE AT THRESHOLD

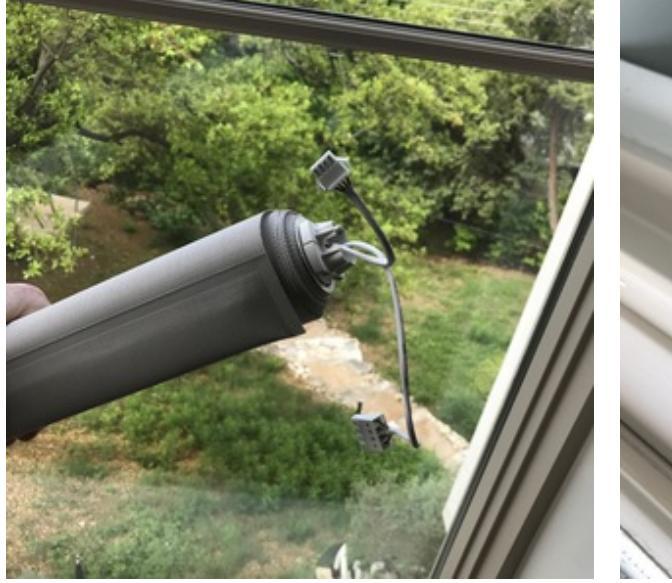
-Missing Hand Cranks at Bedroom Windows (2): Replace All Missing Cranks as Needed

REMOVED MOTORIZED BLIND

MISSING CRANKS

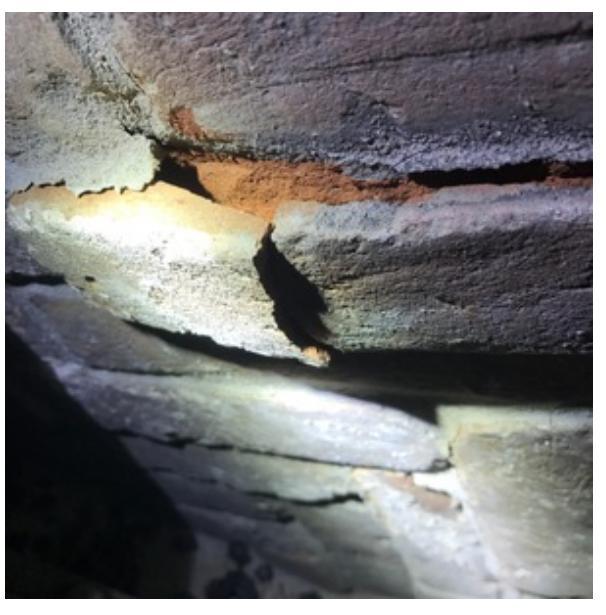
Damage to the chimney firebox was noted. The damage appears to be caused by general aging and/or structural shifting. At the time of inspection, the damage appeared to be minimal, it is recommended that the area be monitored. If additional damage/shifting occurs, further evaluation and repair will be needed.

LOOSE MATERIALS/FIRE BOX (MINOR CONCERN)

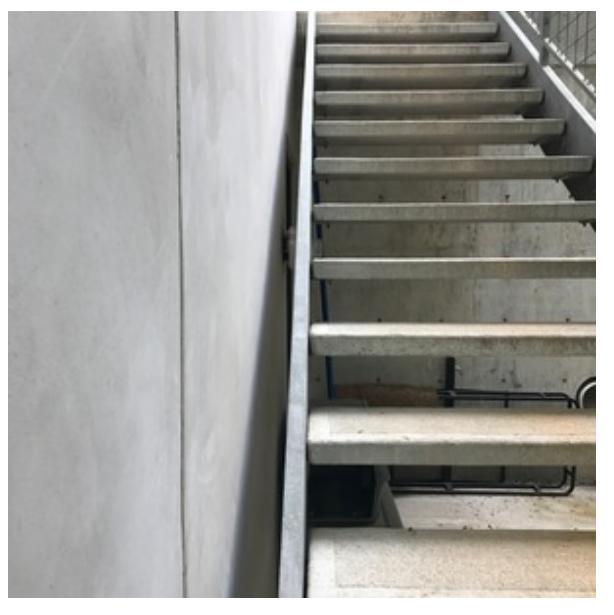
MINIMAL STRINGER BRACING/SUPPORT

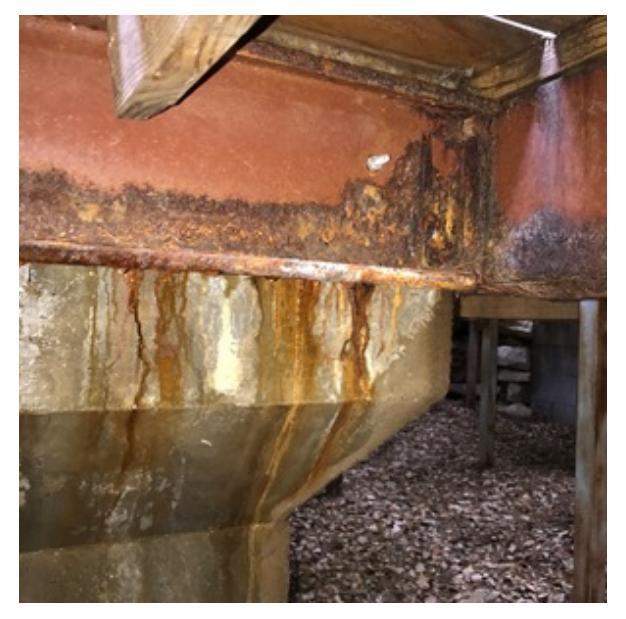
POOL LEAK/BEAM DAMAGE

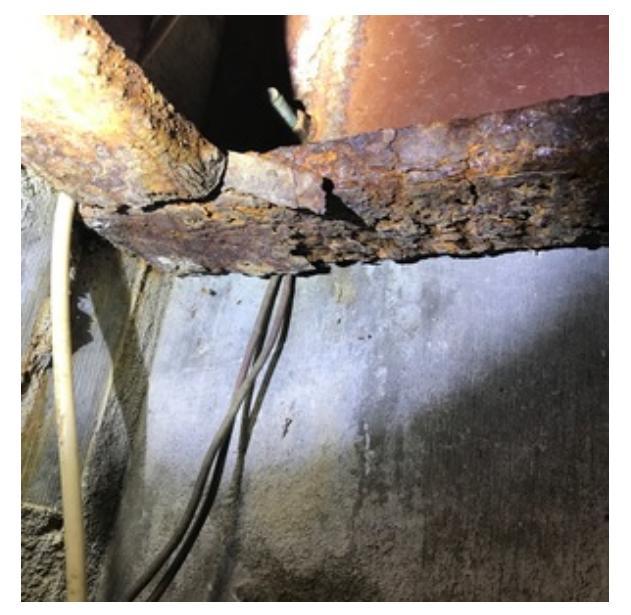
BEAM DAMAGE - POOL DECK

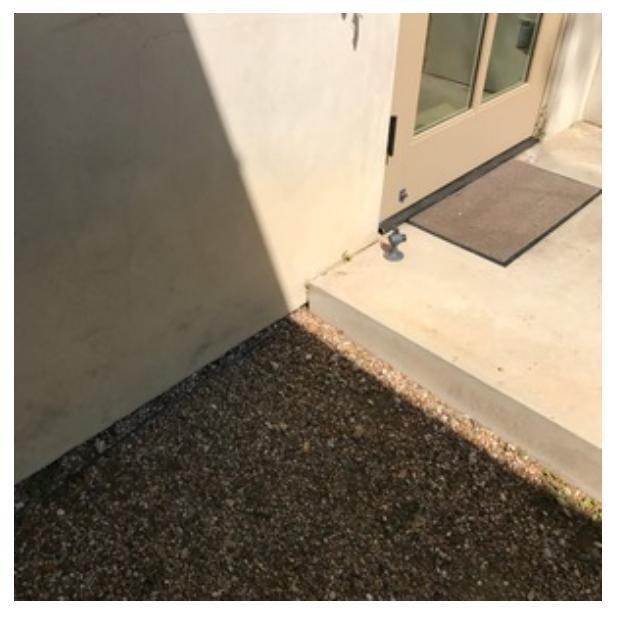
EXTERIOR FEATURES COVER FOUNDATION

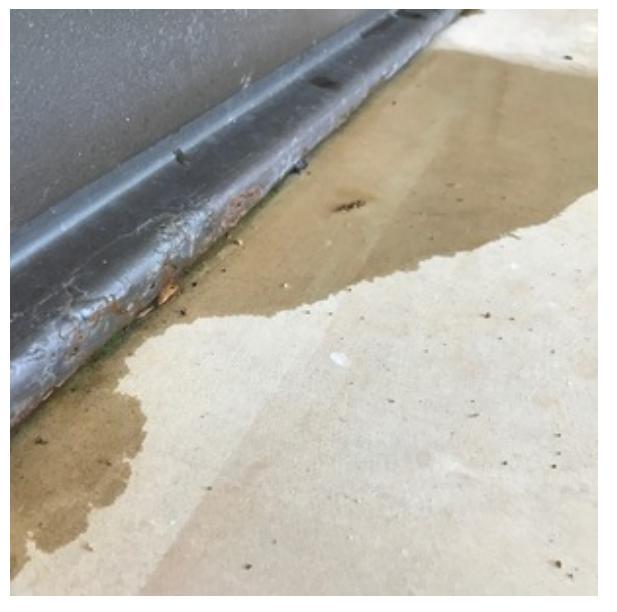
MOISTURE POOLING - SHOWER DOOR

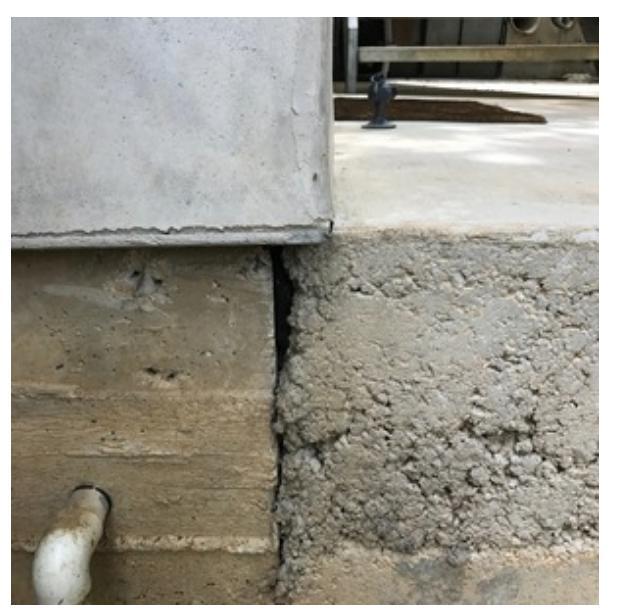
SLAB FLUSH WITH WALL

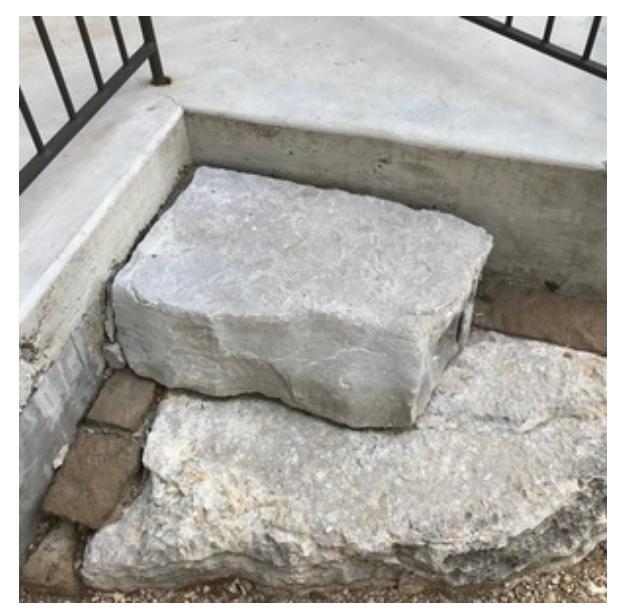
-Uneven Steps (Natural Stone) at Back Decks

UNEVEN STEP AT PORCH

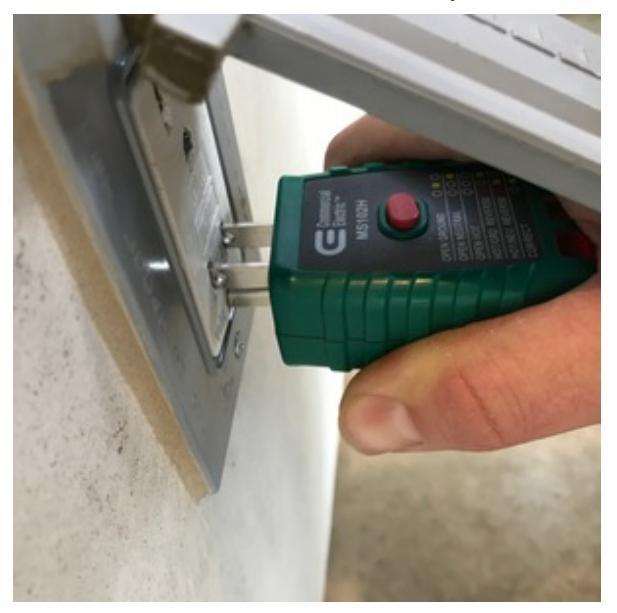
-Damage to Main Back Patio Outlet (Safety Covers at Power Insert Preventing Use): Replace/Update as Needed -Non Functional Doorbell: Consult Electrician/Update as Needed

ISSUE AT OUTLET INSERT

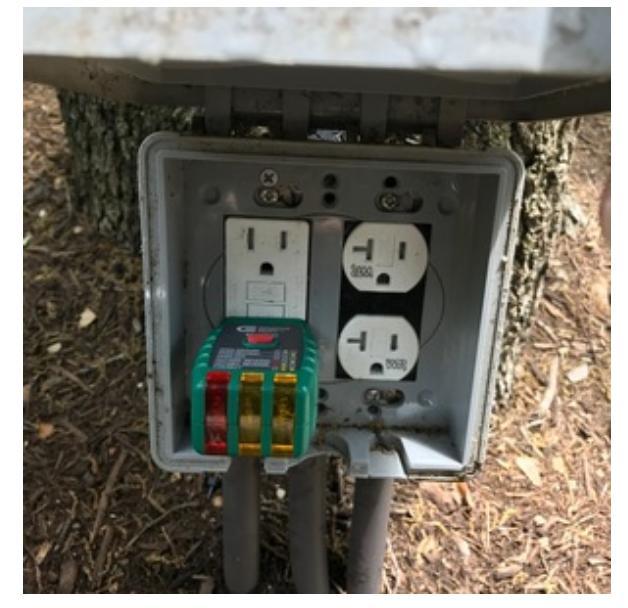
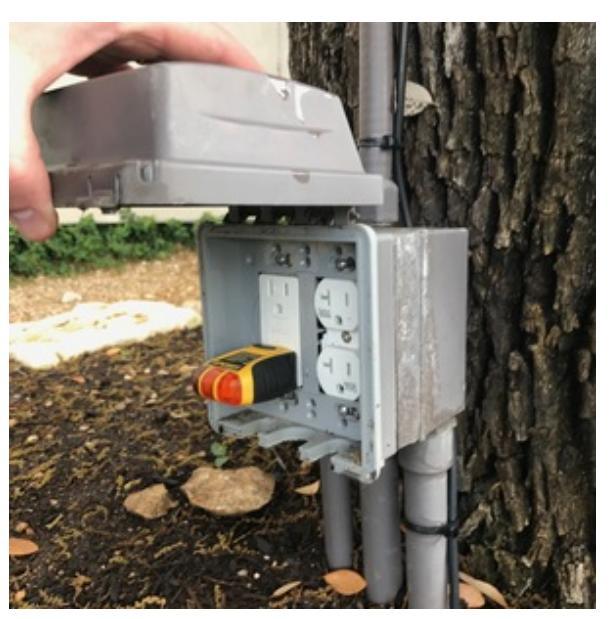
-NOTE: Various Outdoor Outlets/Lights/Electrical Features Not Functional at Time of Inspection: Contact Electrician to Address All Functionality Issues

NON FUNCTIONAL LANDSCAPE OUTLETS

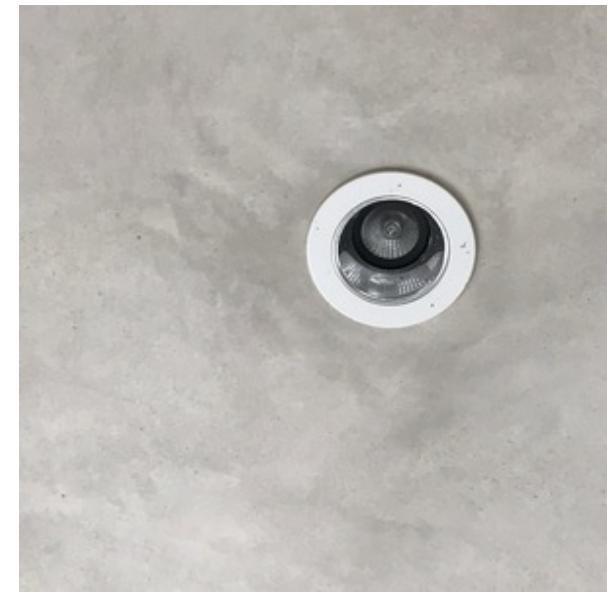
-Right Side Exterior Yard Light/Above Wood Storage Attached to House -Carport Exterior Motion Light

NON FUNCTIONAL LIGHTS

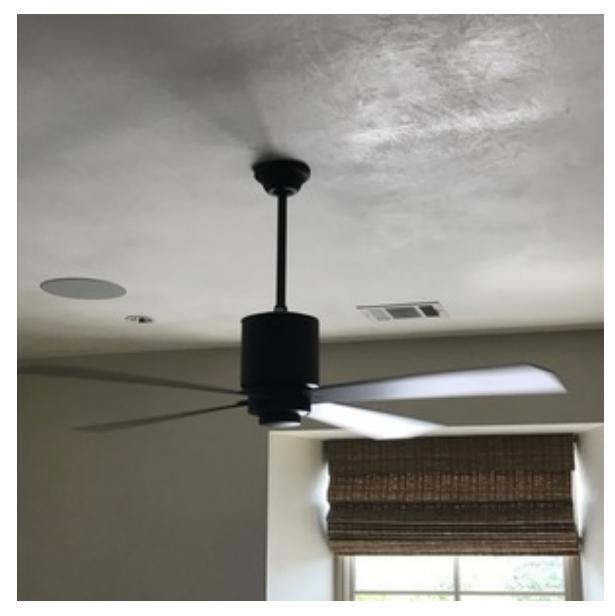
EXCESS WOBBLE

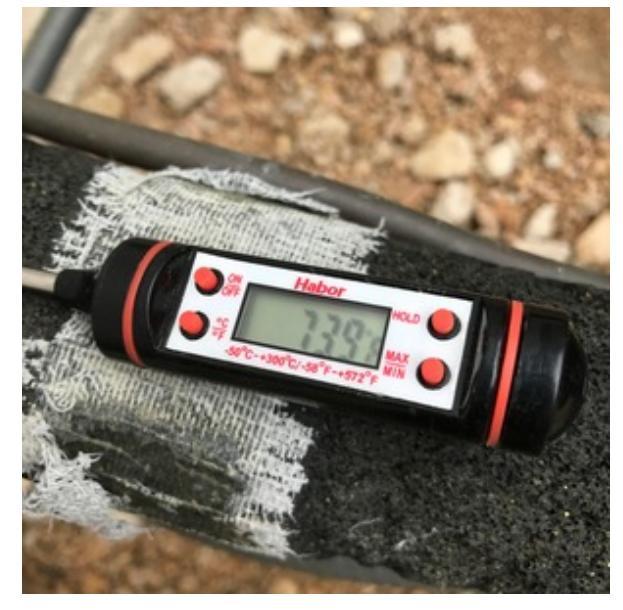
ELEVATED SUCTION LINE TEMP

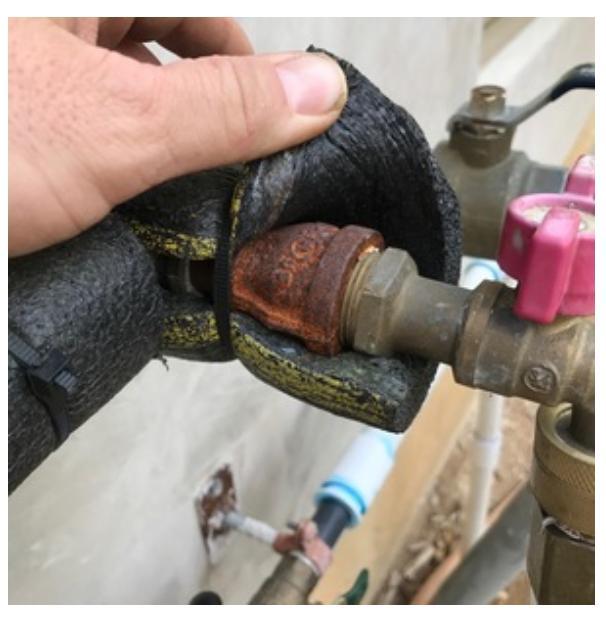
MINOR CORROSION AT BRASS/STEEL CONNECTION

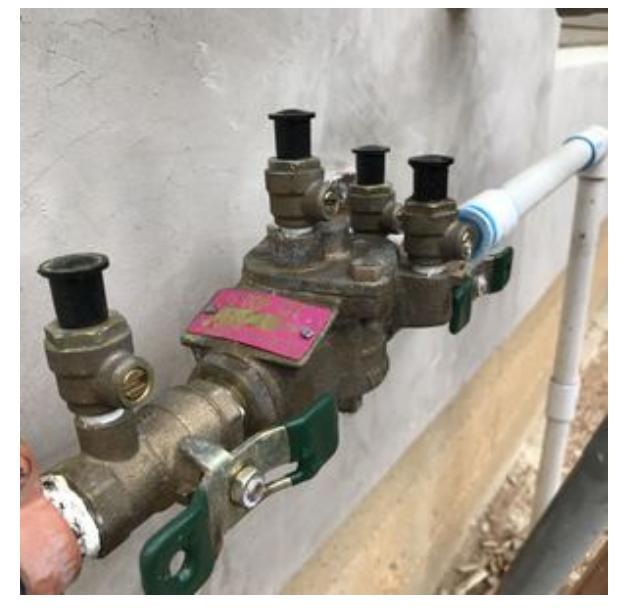
ACTIVE LEAK - PRESSURE VALVE

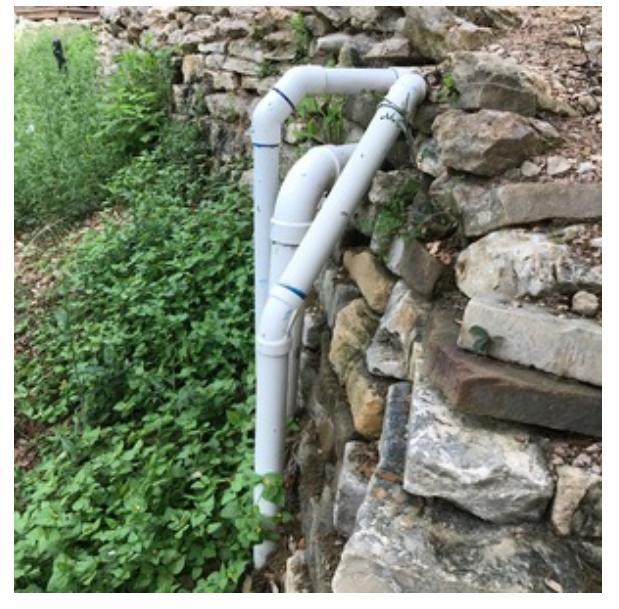
PROTECT EXPOSED PIPES

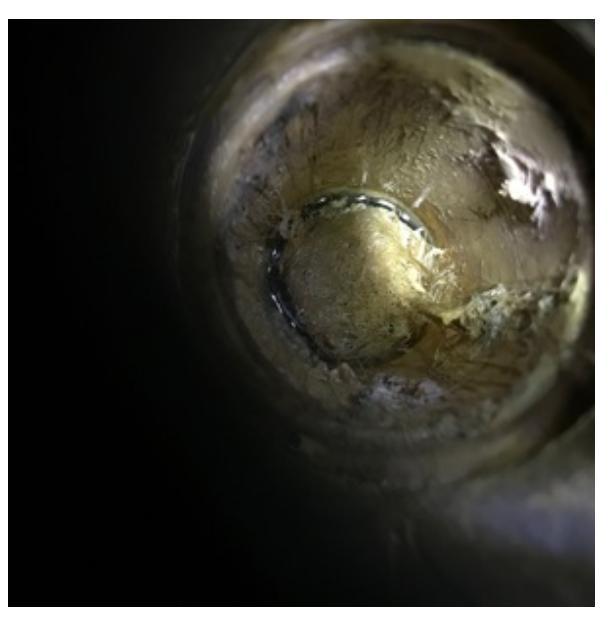
CLEAR SHOWER TRAP

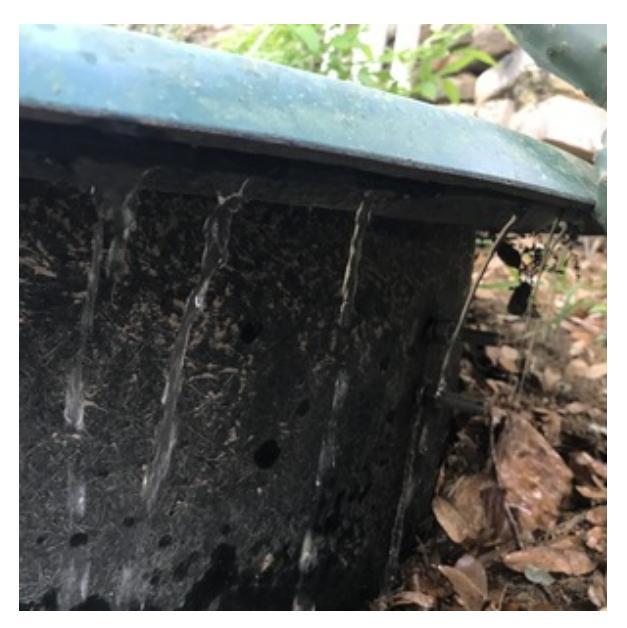
NON FUNCTIONAL/SUMP TANK OVERFLOW

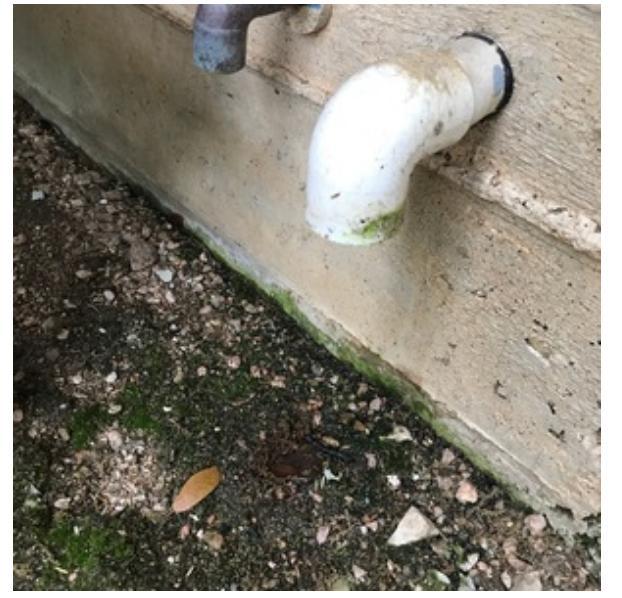
EXTEND CONDENSATE DRAINS

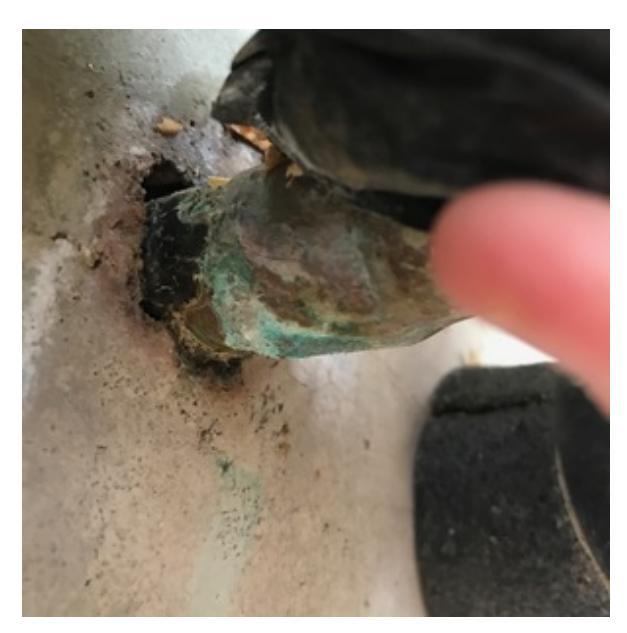
SUPPLY PIPE CORROSION

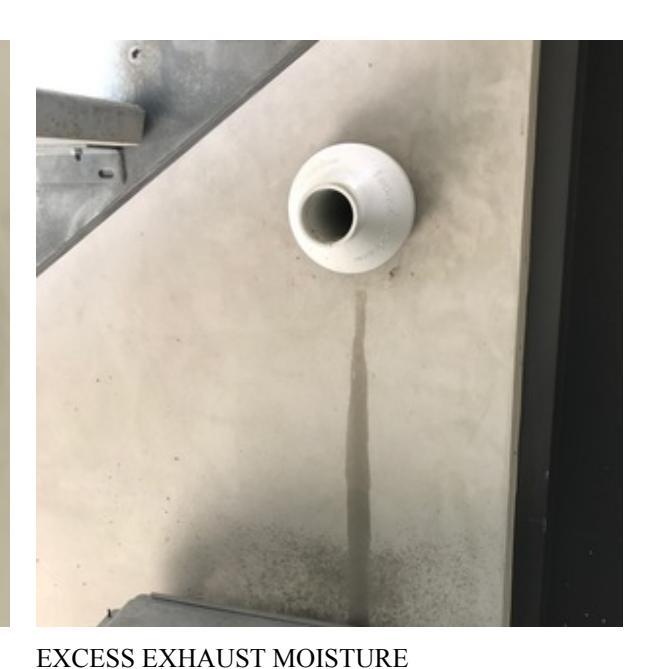
EXCESS CONDENSATE POOLING

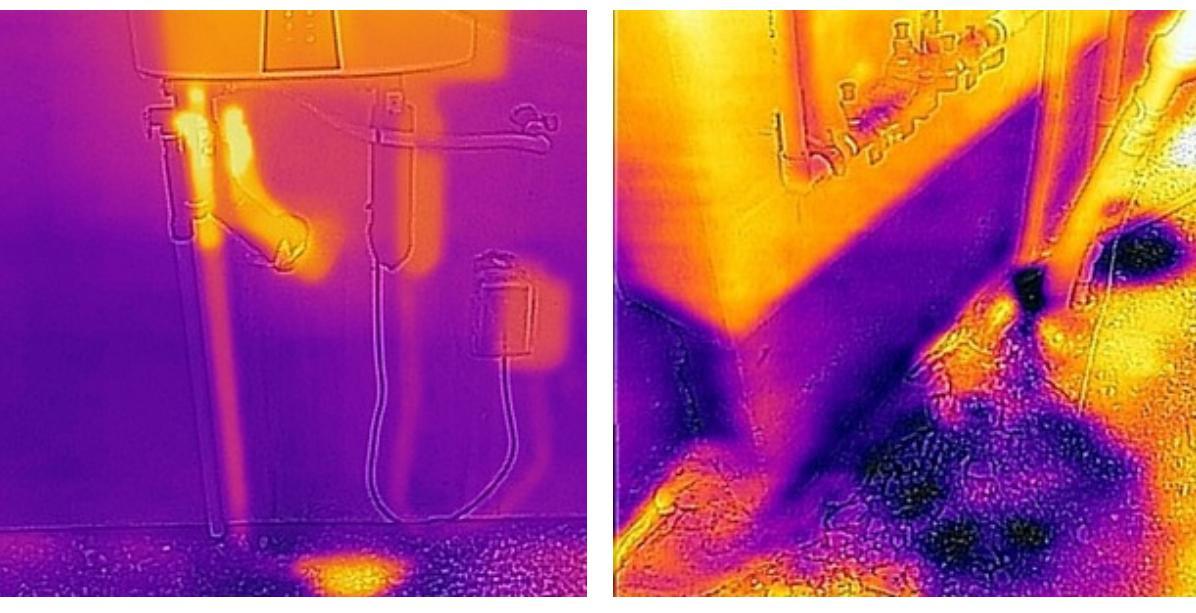
LEAK AT PRESSURE VALVE

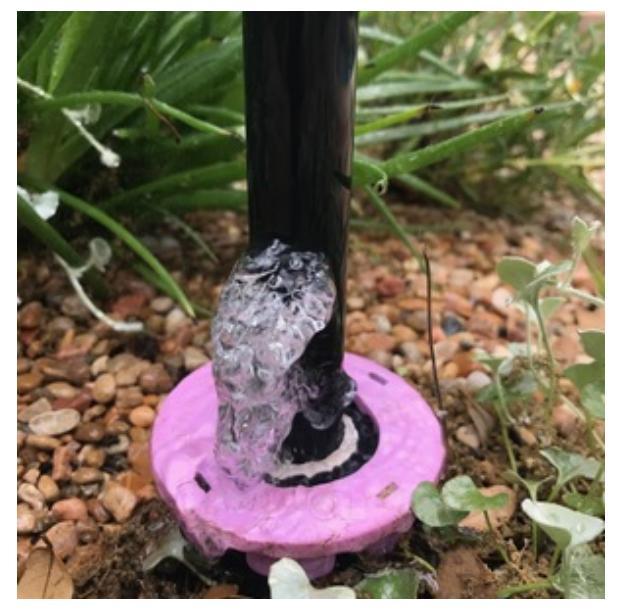
HEAD LEAK

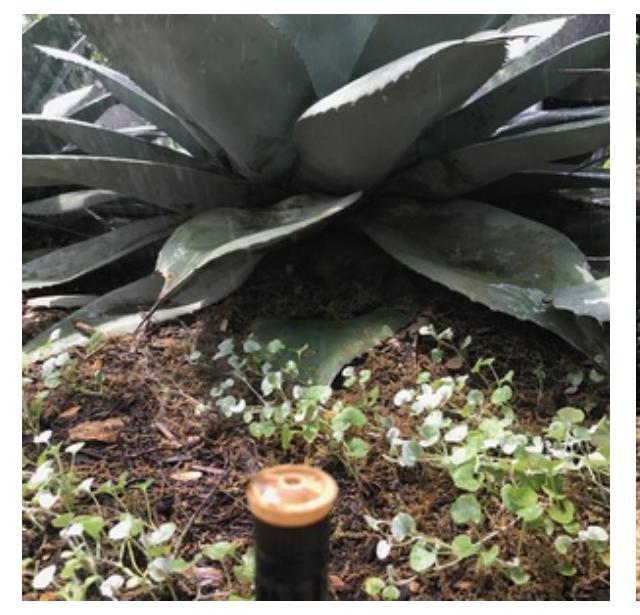
NON FUNCTIONAL HEAD

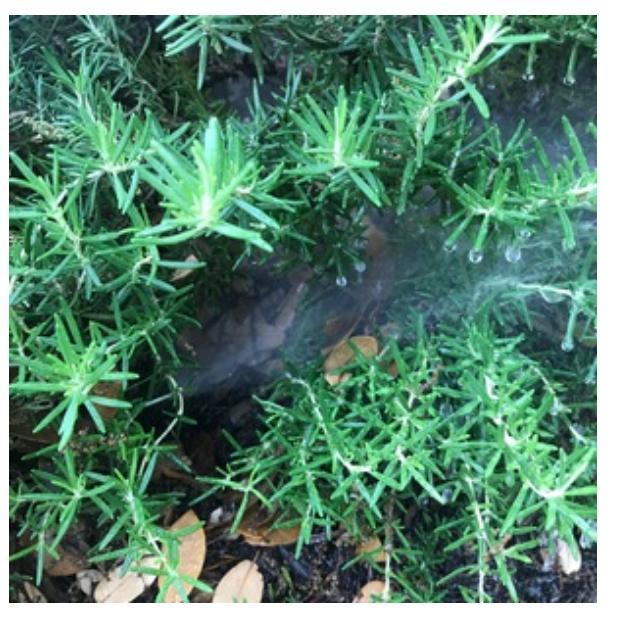
ZONE #10: Right Rear Side Yard Planters Beds / 10x Stationary Sprayers / 2x Heads Blocked by Landscaping / Poor Coverage

HEADS BLOCKED BY LANDSCAPING
