Property: 2905 Richard Ln.
Austin, Texas 78703
Client: Carol Dochen
Inspection Type: Property Assessment Report
Lead Inspector: Andy Jordan #9458
Date: April 5, 2018

ADDENDUM: REPORT SYNOPSIS

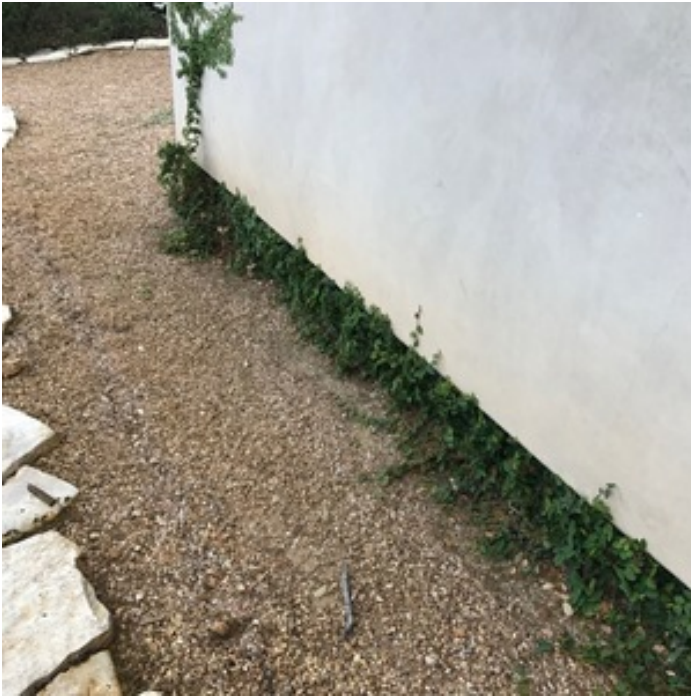
VISUAL LIMITATIONS DUE TO FOLIAGE

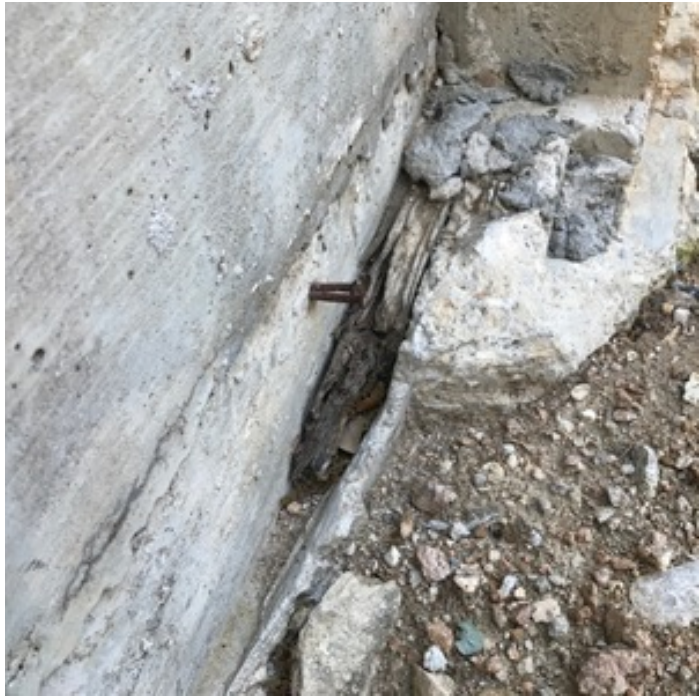
REMOVE FORM BOARD DEBRIS

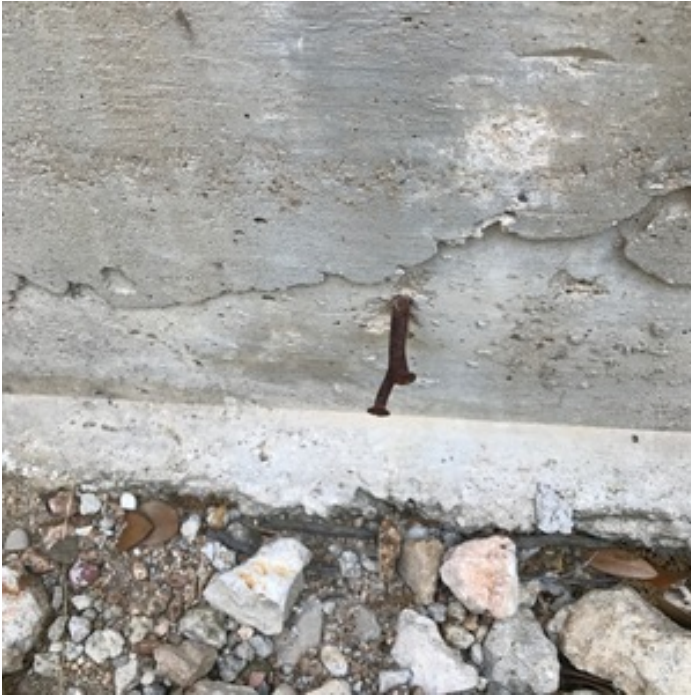
REMOVE PROTRUDING NAILS

- Portions of Foundation Wall Not Finished With Parging Material: Common Cosmetic Finish (Not a Structural Feature - Update as Needed/Desired)
- Protruding Nails at Back Foundation/Decking Walls: Remove Protruding Nails to Reduce Risk of Injury
- Portions of Form Boards Left in Place (Back Wall): Remove Wood Debris Near Foundation to Prevent Termite Attraction
- Exposed Plumbing at Back Foundation Wall: Install Foundation Parging to Improve Material Protection

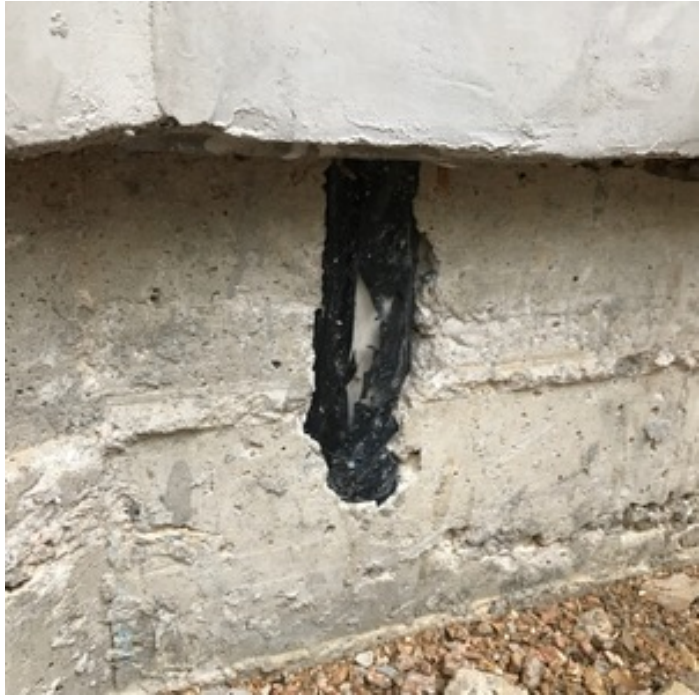
EXPOSED PLUMBING - BACK WALL

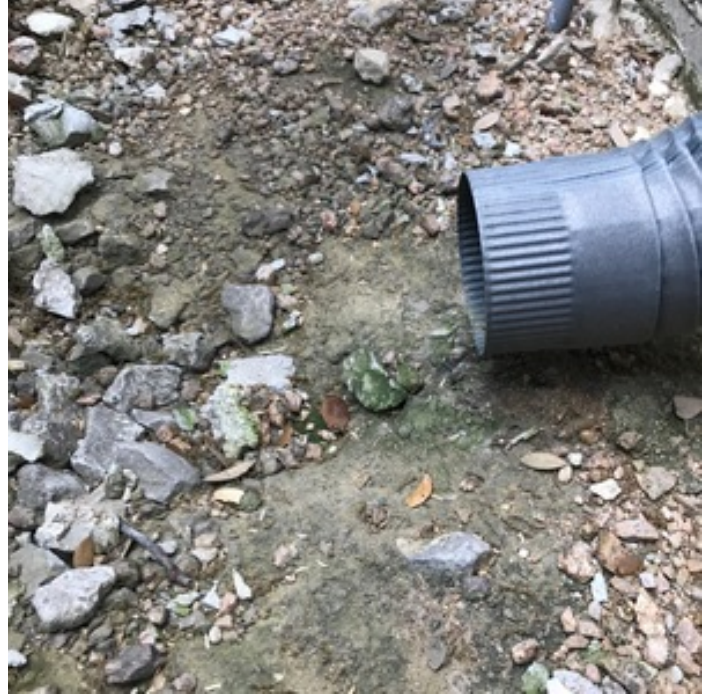
INSTALL SPLASH STONES

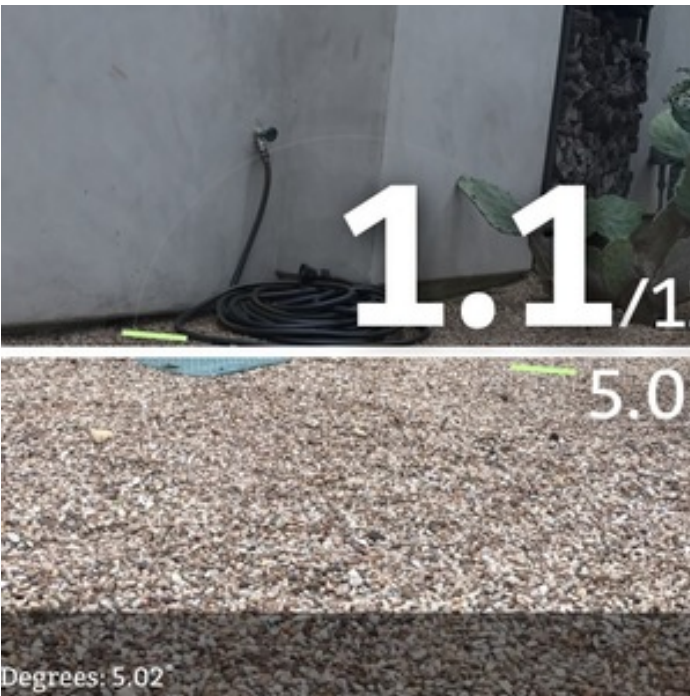
MONITOR NEGATIVE GRADE - RIGHT

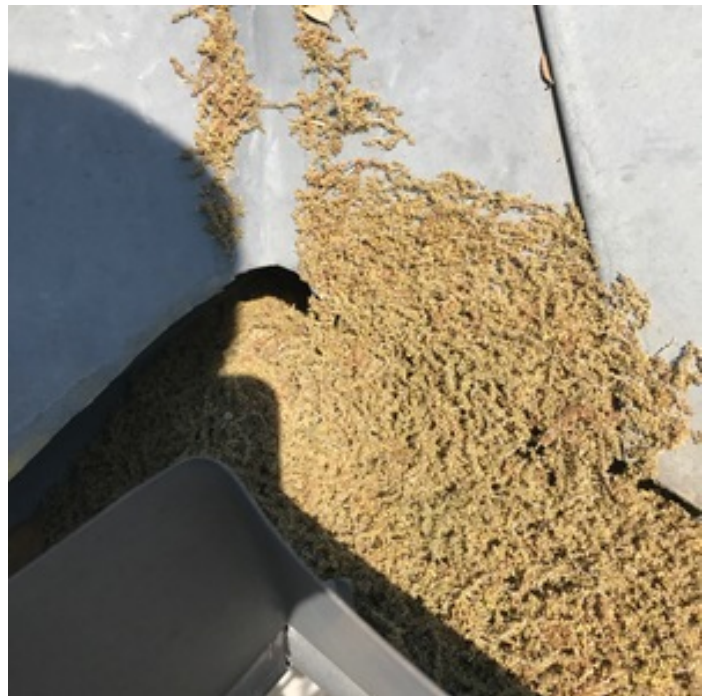
Common gutter servicing and repair needs were discovered during the inspection process (debris build up/loose or damaged material/leaks at joint connections/gutter exit update needs/etc.). Contacting a gutter specialist is recommended to service and update the gutter system as needed. Gutter issues noted at the time of inspection include, but are not limited to:

SERVICE/CLEAR GUTTERS

- Replace Damaged Gutters Due to Tree Contact: Left Side Structure Near Carport
- Trim Trees to Prevent Further Damage to Gutter/Structure
- Consider Gutter Screens to Reduce Tree Debris Entry/Servicing Needs

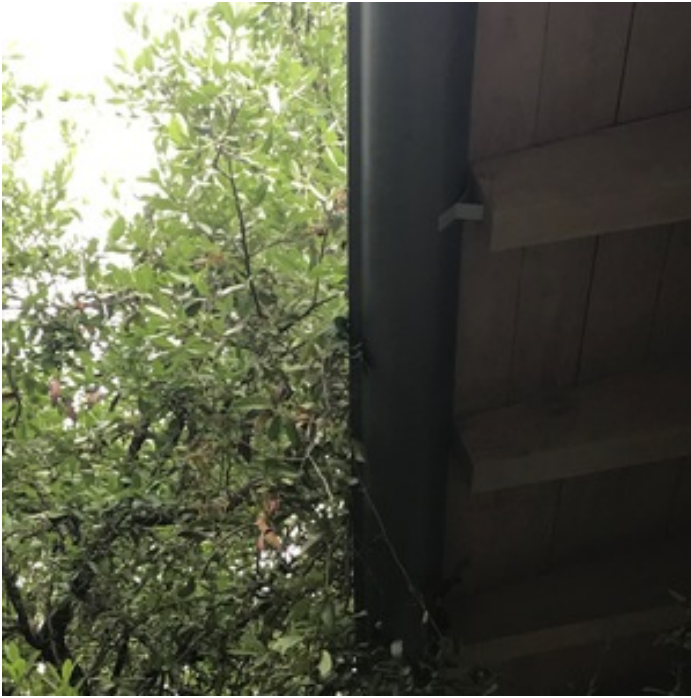
Current tree limb contact with the roof and structure was noted. At the time of inspection, no significant damage to roofing material was discovered (damage to gutters, minor roof damage/concerns). Tree contact with the roof and structure can lead to material damage in a relatively short amount of time. Additionally, tree to structure contact is a common bridge for vermin and insects to access and infest buildings. A tree specialist should address limb contact and make needed adjustments to surrounding trees/shrubs. Ensure updates and maintenance are addressed in an expeditious manner.

TREES IN CONTACT WITH GUTTERS/ROOF

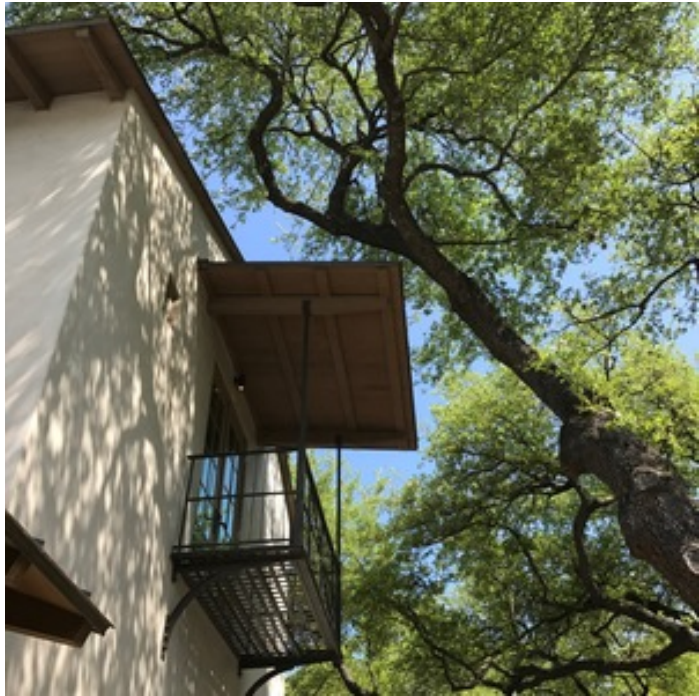
BRANCHES OVERHANG ROOF

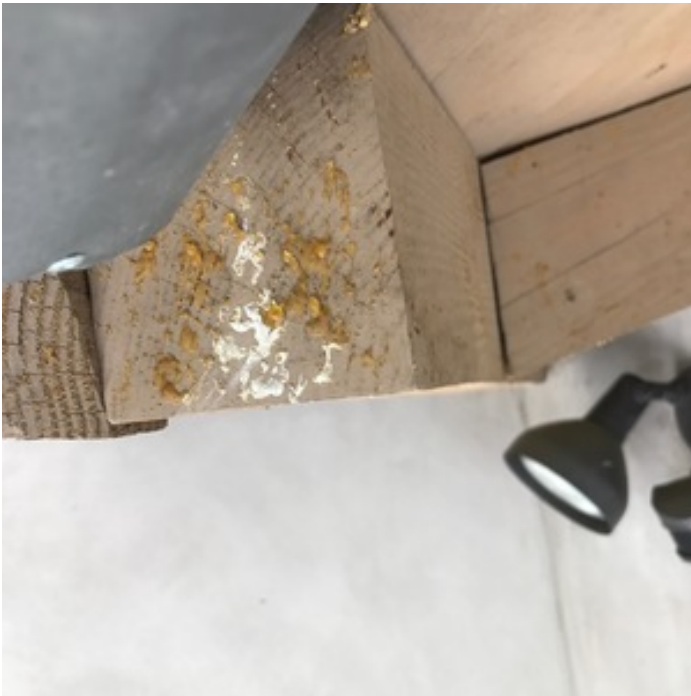
SAP/ADHESIVE AT SOFFIT FEATURES

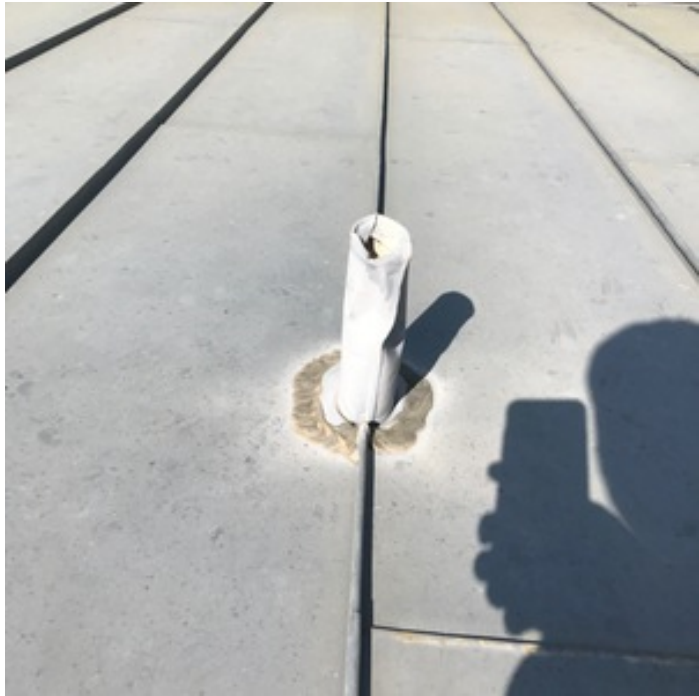
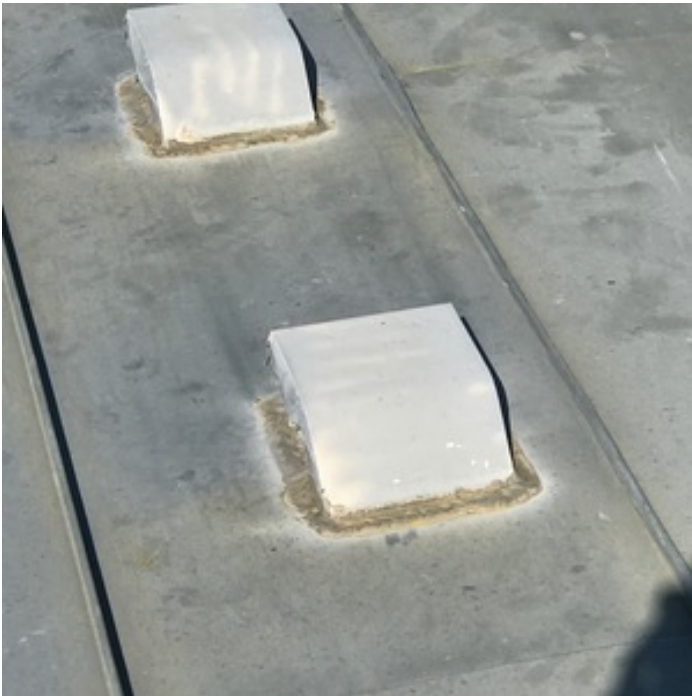
INSTALL CONCERN AT BOOTS

- Improper Installation of Metal Roofing at Low/Flat Sloped Portion of Roof (Right Side): Contact Roofing Specialist to Update as Needed
- Improper Installation of Roof Flashing/Metal Panels at Flat/Low Slope Roof (Right Side): Elevated Likelihood of Moisture Penetration/Issues (Contact Roofing Specialist to Update as Needed)
- Improper Installation of Roof Vent Pipe Boots/Flashing at Various Areas: Increased Likelihood of Moisture Penetration (Contact Roofing Specialist to Update as Needed)
- Excess Use of Caulking/Sealing as Primary Means of Moisture Protection (Right Side and Various Vent Boots): Contact Roofing Specialist to Update as Needed

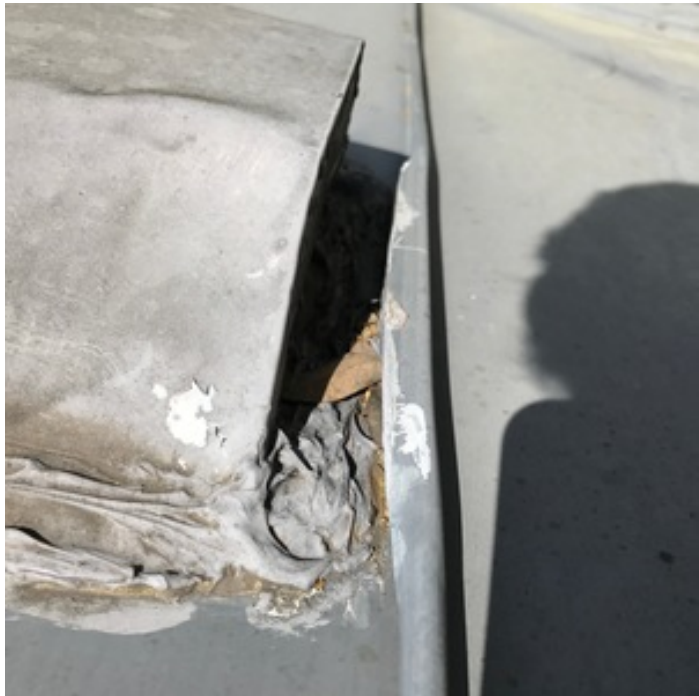
BOOT/SEAM CONCERN - LEFT SLOPE

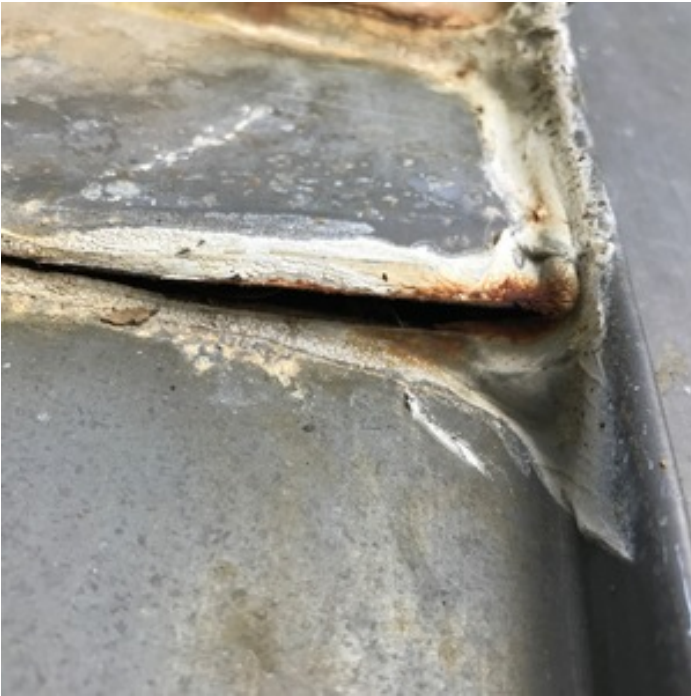
Flashing issues and/or areas of minimal moisture diversion were noted. Improper flashing is a common point of moisture entry and damage to a structure. Flashing improvements are recommended to eliminate or prevent issues associated with improper roof run-off diversion. Areas of concern noted at the time of inspection include, but are not limited to:

FLASHING/PANEL ISSUES - RIGHT SIDE

- Flashing/Install Issues and Concerns at the Right Side Low/Flat Roof
- Flashing Install Issues and Concerns at The Right Side Chimney Area
- NOTE: Consult With Subject Matter Expert On Site for Further Details and Update Recommendations/Costs

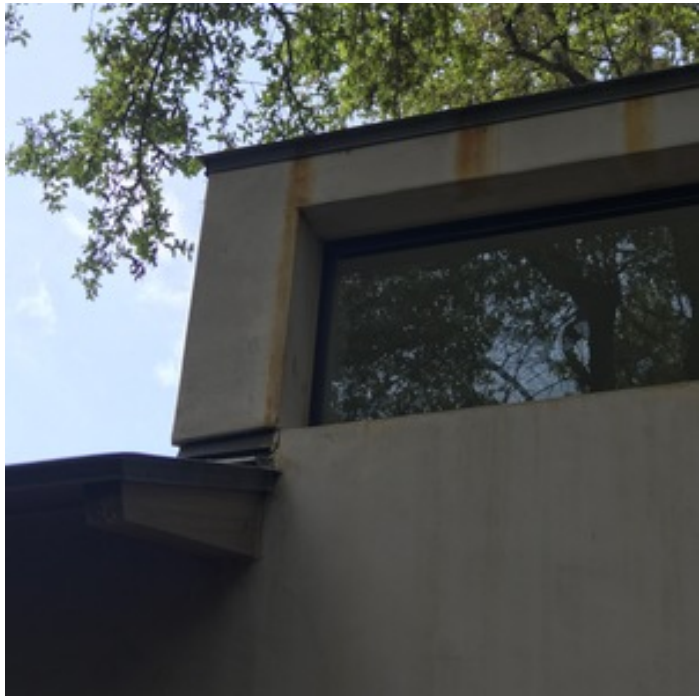
INSTALL CONCERN - RIGHT FLAT ROOF

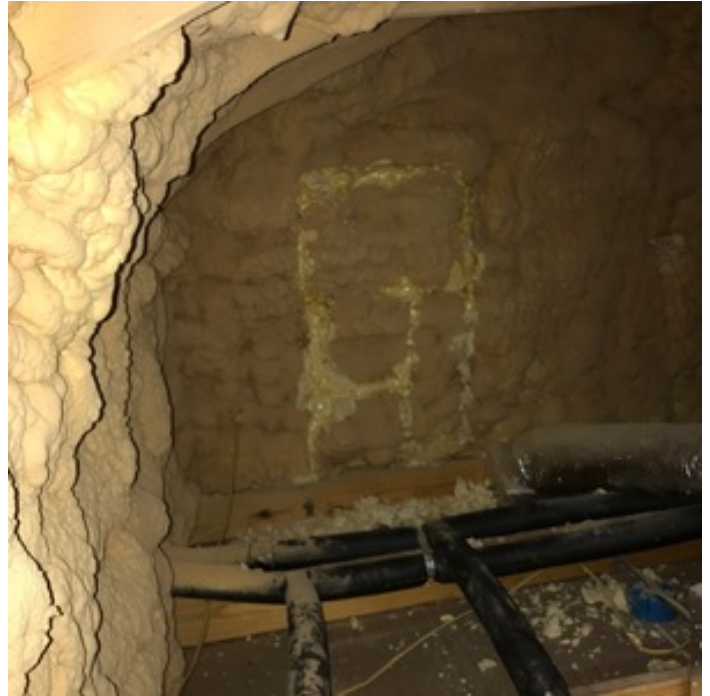
FOAM INSULATION AND PATCH

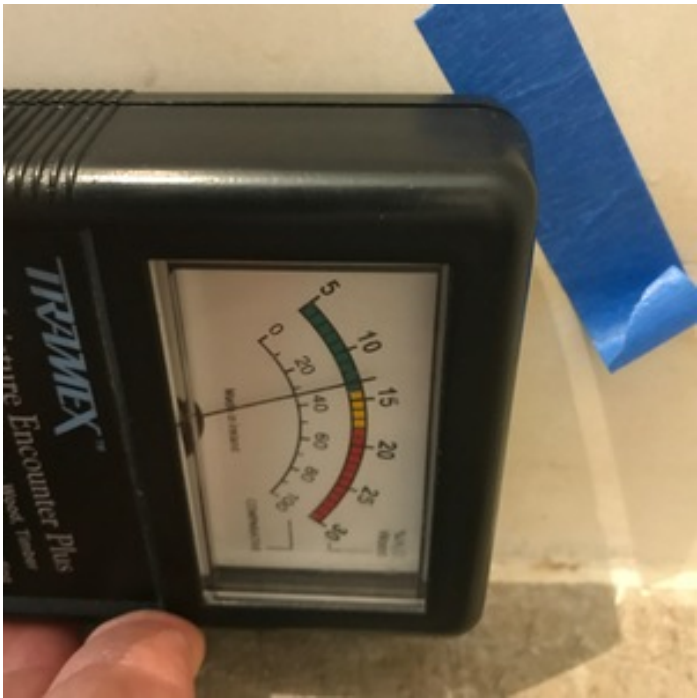
NORMAL READING - PREVIOUS LEAK DAMAGE

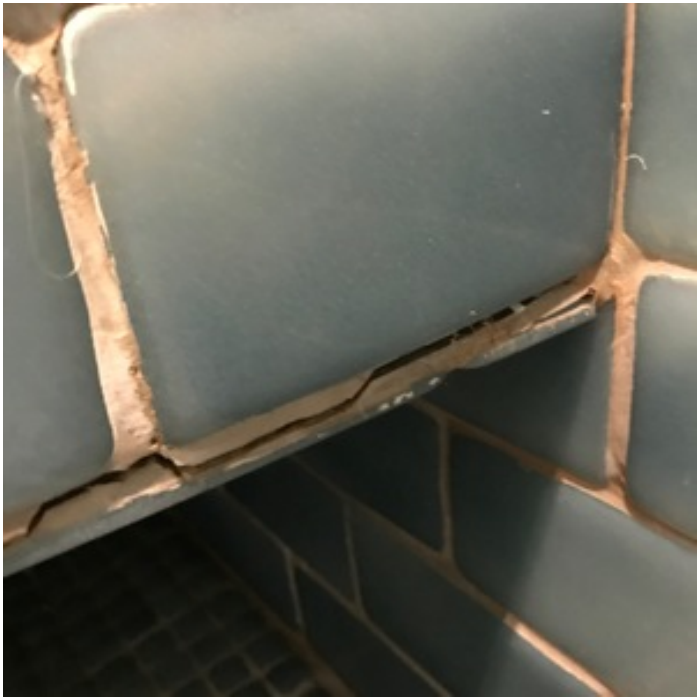
-NOTE: Gaps at shower pedestals (sitting areas) is a common area of discovered damage and moisture issues within structures. An elevated degree of maintenance and monitoring is required at these areas to prevent damage to interior framing and possible air quality/organic growth.

GAP AT SHOWER PEDESTAL

Maintenance and repair needs to reduce moisture entry points were discovered at bathroom walls. Ensure all gaps and issues at bathroom walls are eliminated and any current damage to surrounding material addressed. Areas of noted wall gaps/issues include, but are not limited to:

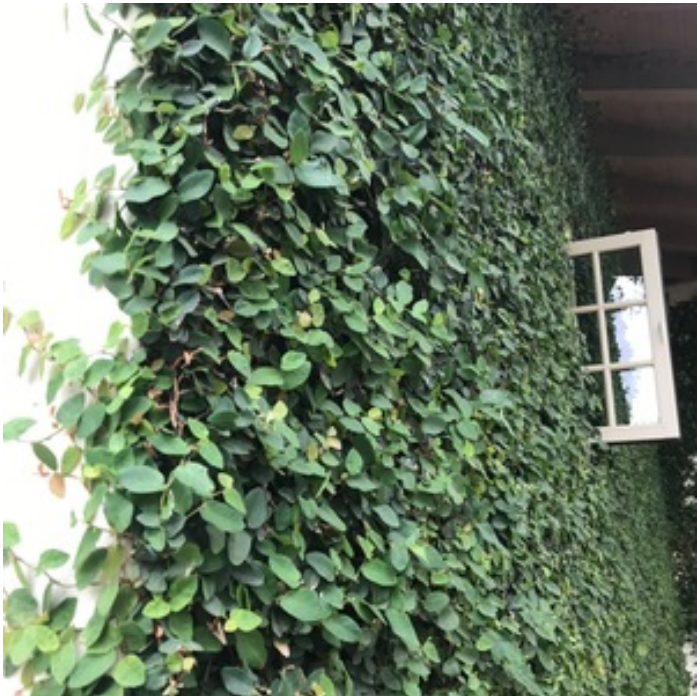
HEAVY FOLIAGE CONTACT

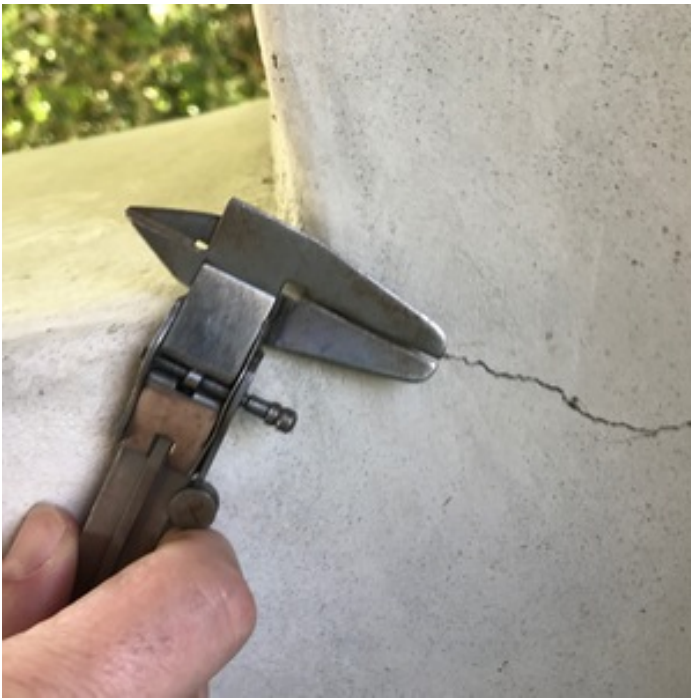
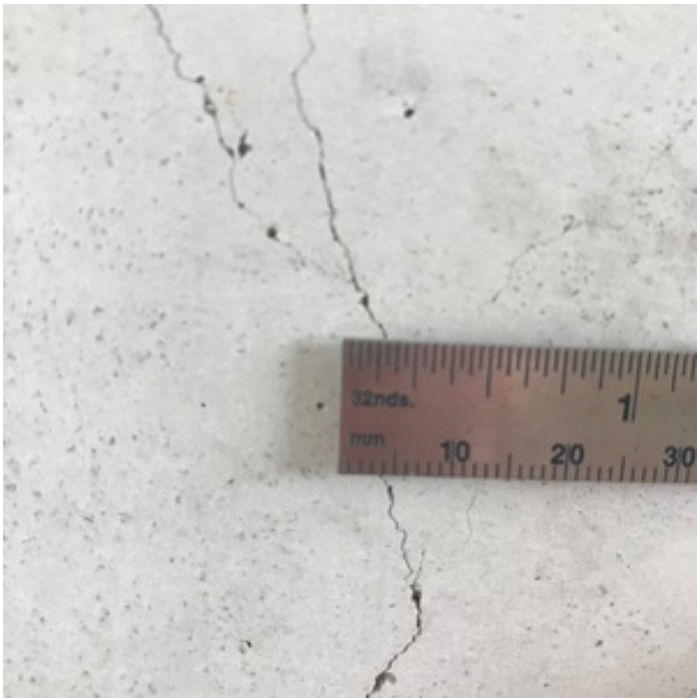
MONITOR NORMAL CRACKING

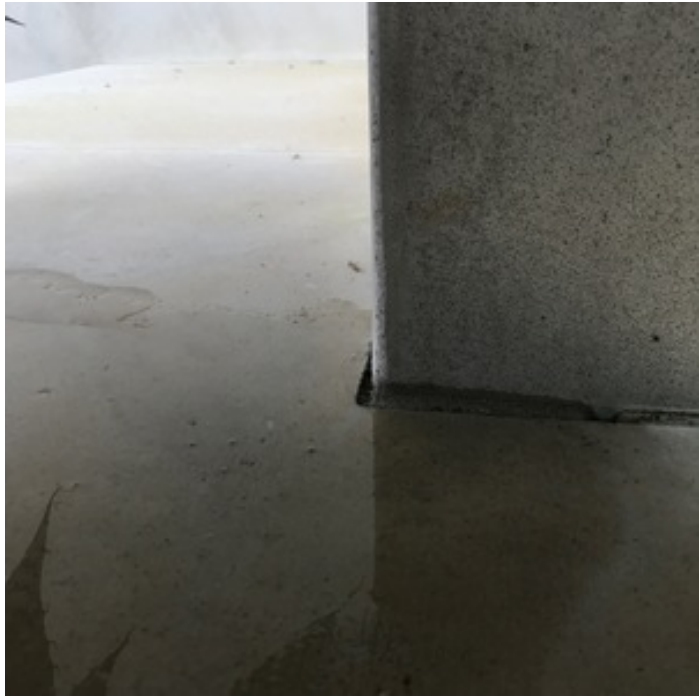
SPRINKLER OVERSPRAY/FRONT DOOR

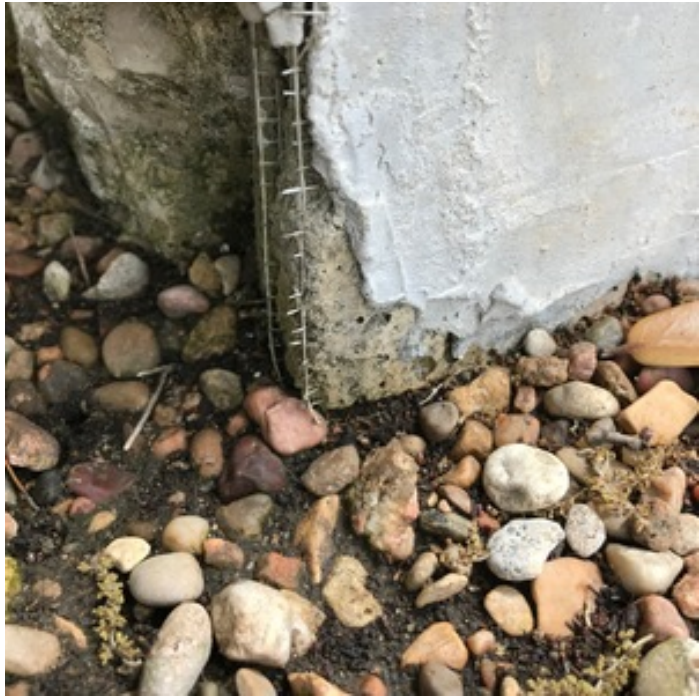
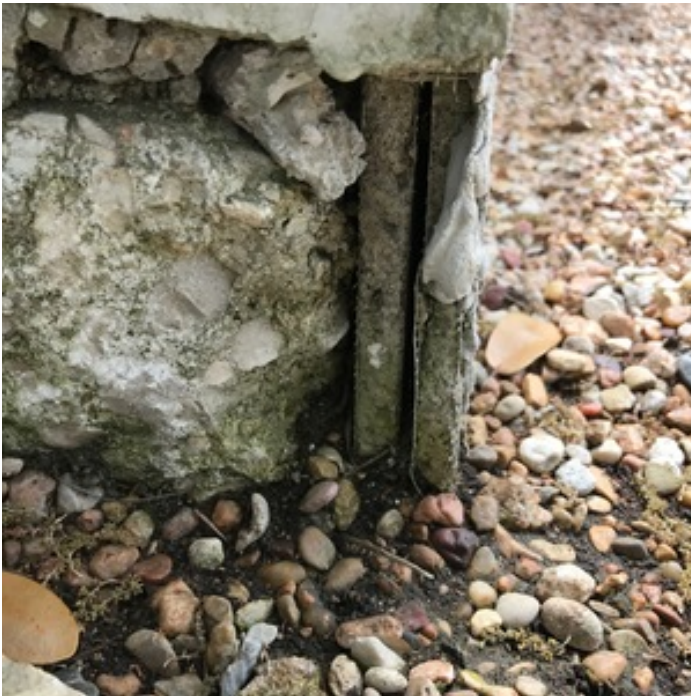
BACKER BOARD AT EXTERIOR WALL

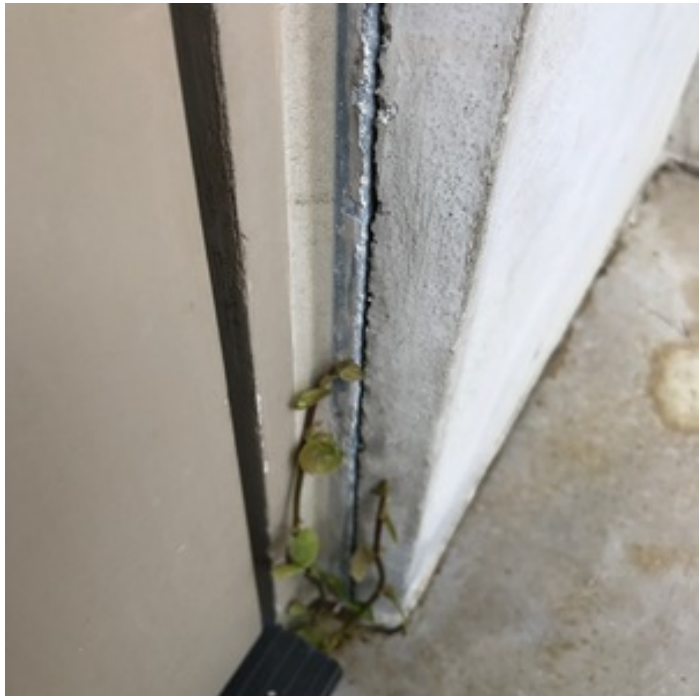
MINOR GAPS NEAR DOOR CONNECTIONS

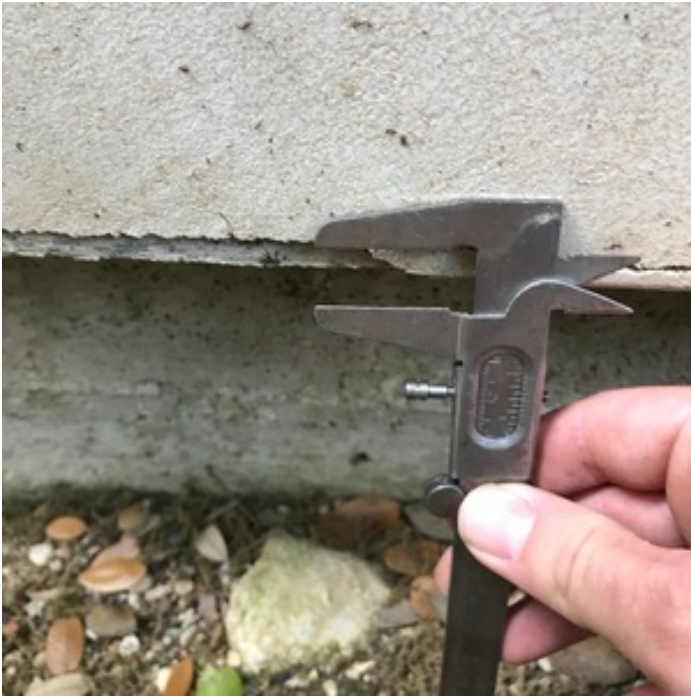
MATERIAL SEPARATION AT EDGE TRIM

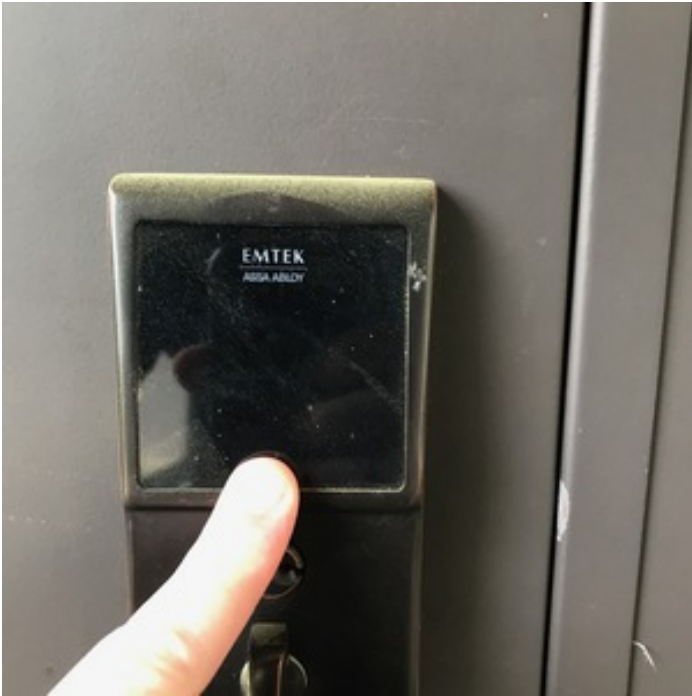
NON FUNCTIONAL KEY PAD

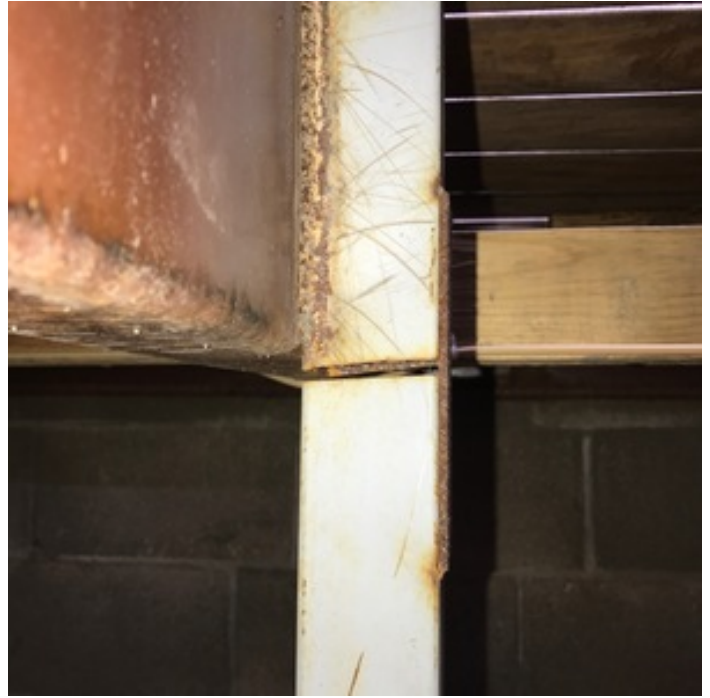
CUT PIERS - PURPOSE UNKNOWN

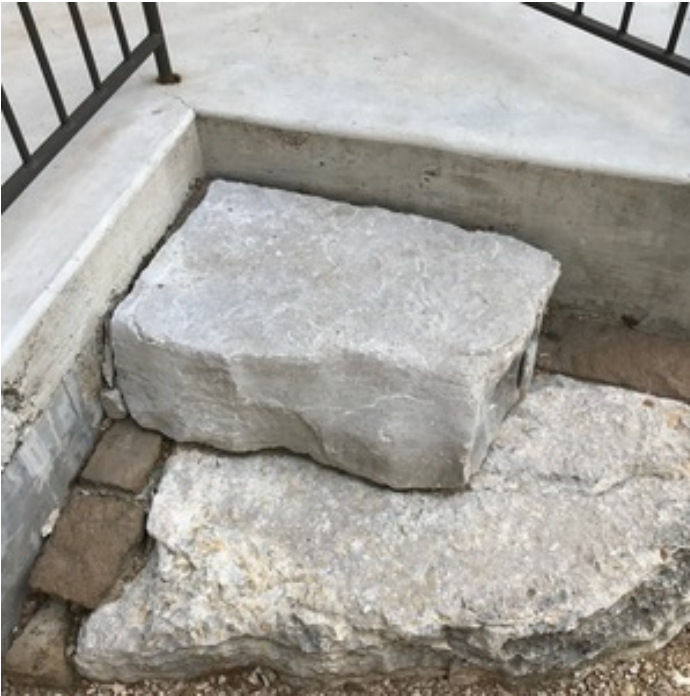
UNEVEN STEP AT PORCH

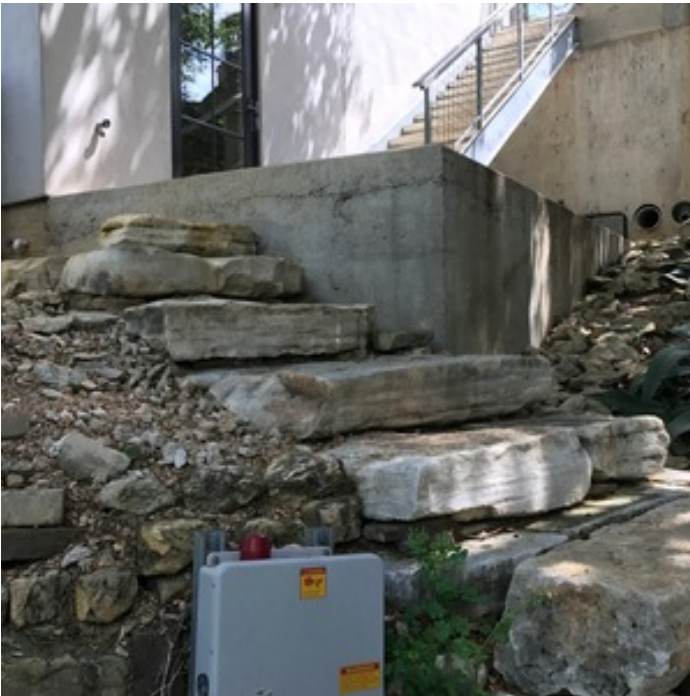
NO DECK/STEP RAILING

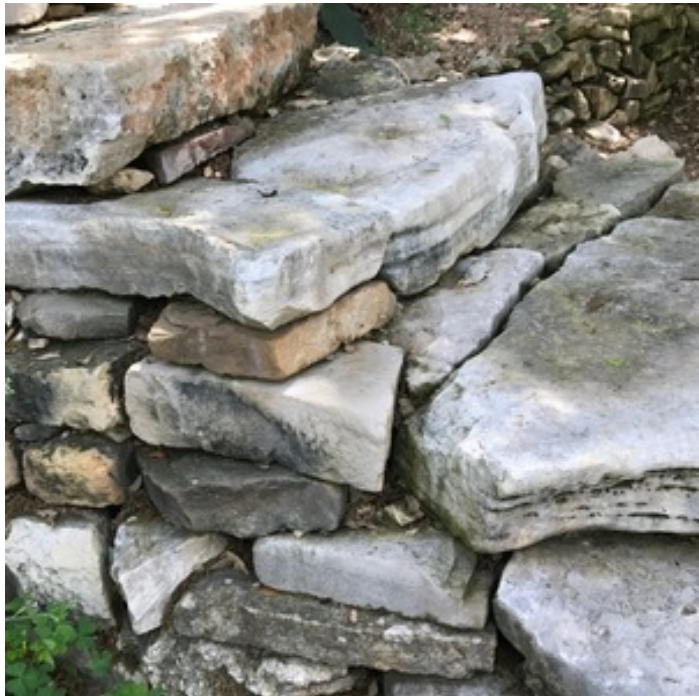
NO RAILING/DRY STACK STEPS

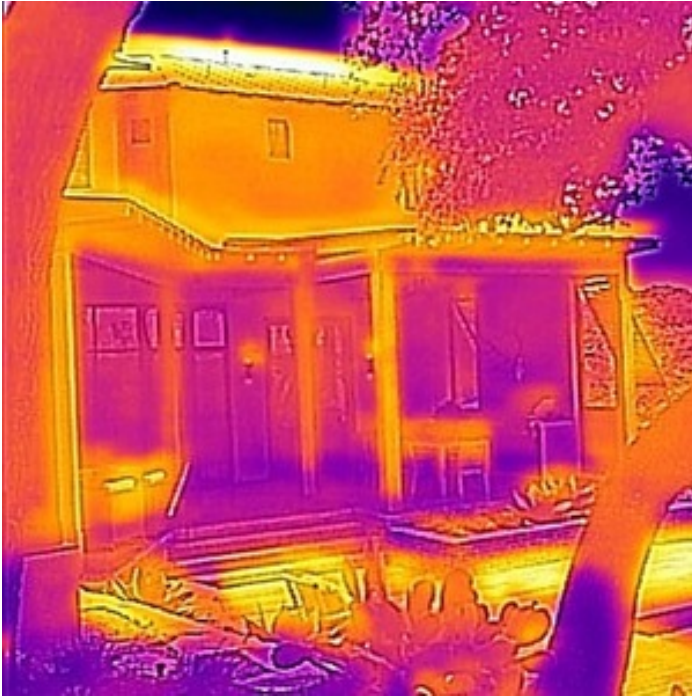
NORMAL READINGS - THERMAL CAMERA

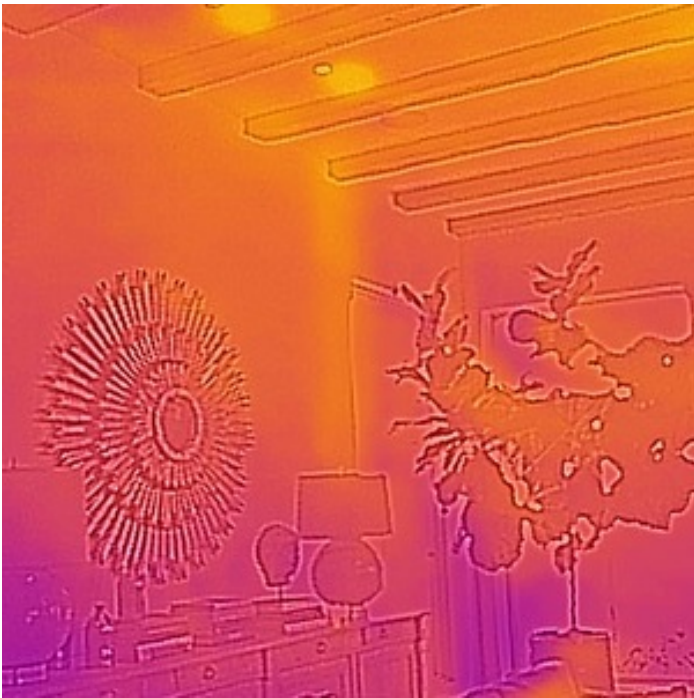
NORMAL READINGS - THERMAL CAMERA

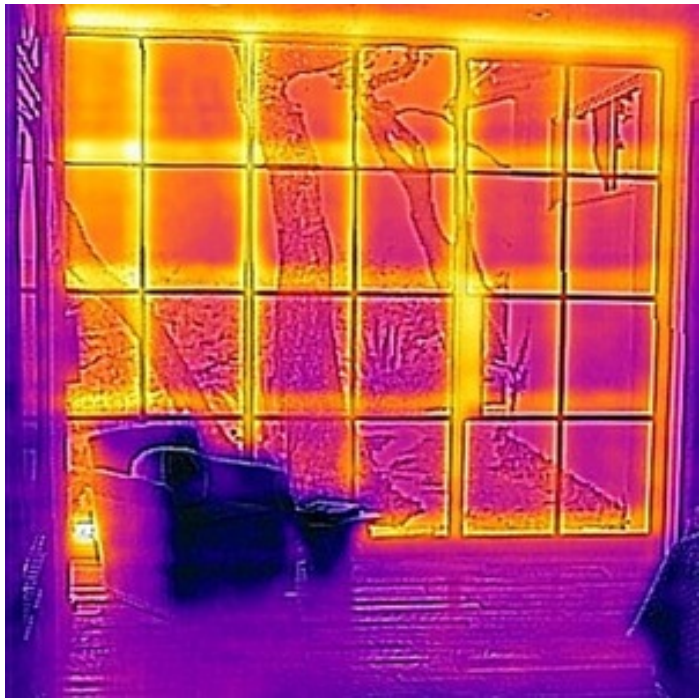
NORMAL READINGS - THERMAL CAMERA

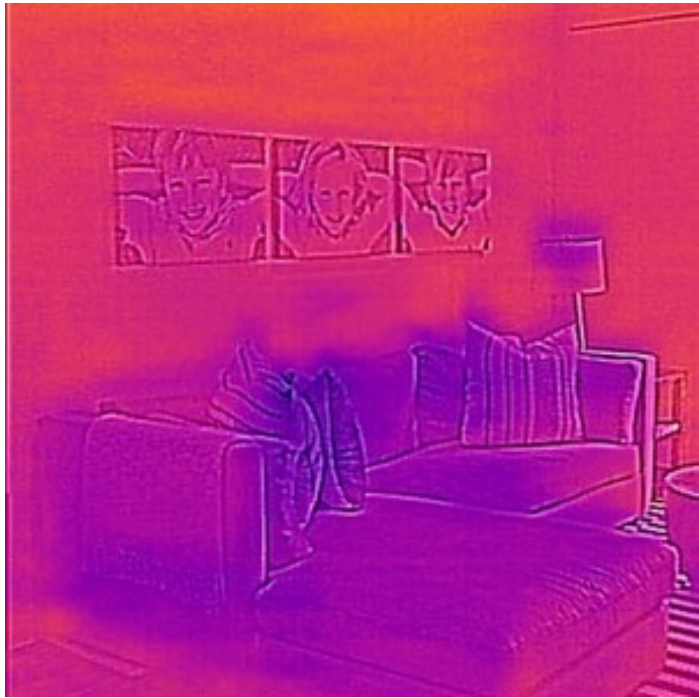
NORMAL READINGS - THERMAL CAMERA

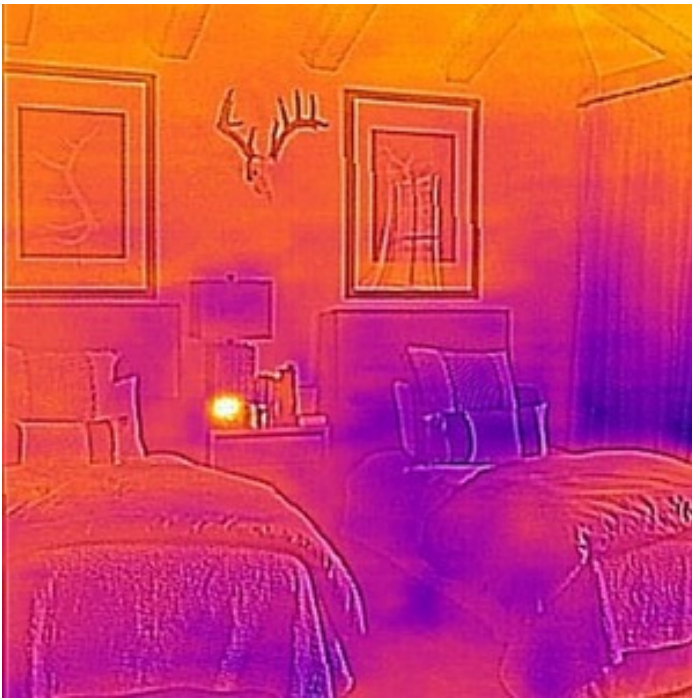
NORMAL READINGS - THERMAL CAMERA

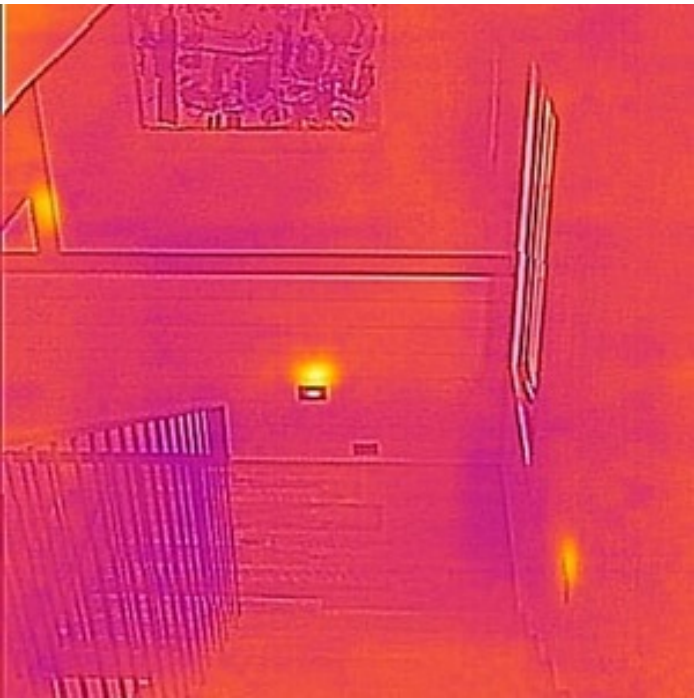
NORMAL READINGS - THERMAL CAMERA

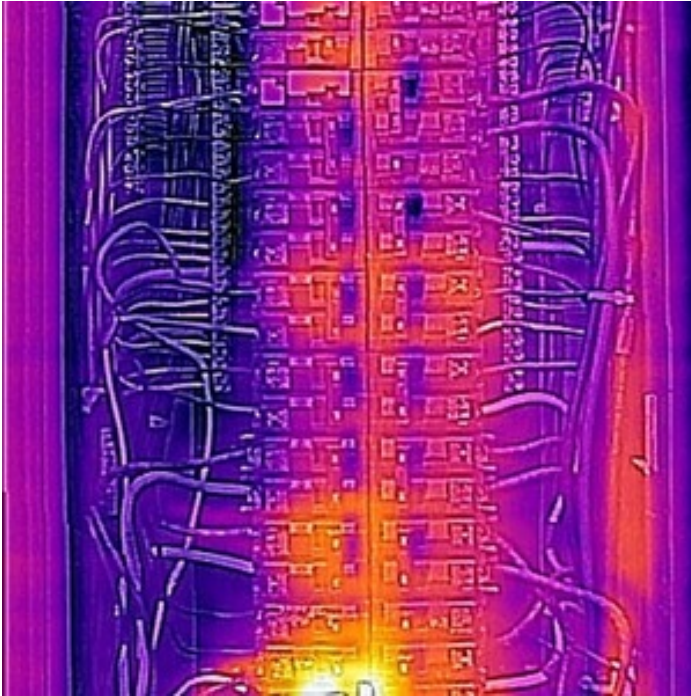
NORMAL READINGS - THERMAL CAMERA

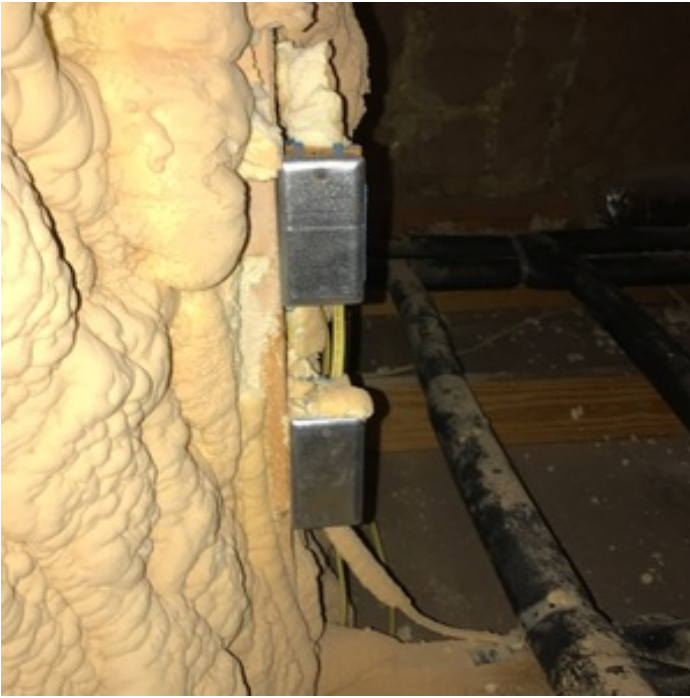
PROPER WIRE PROTECTION

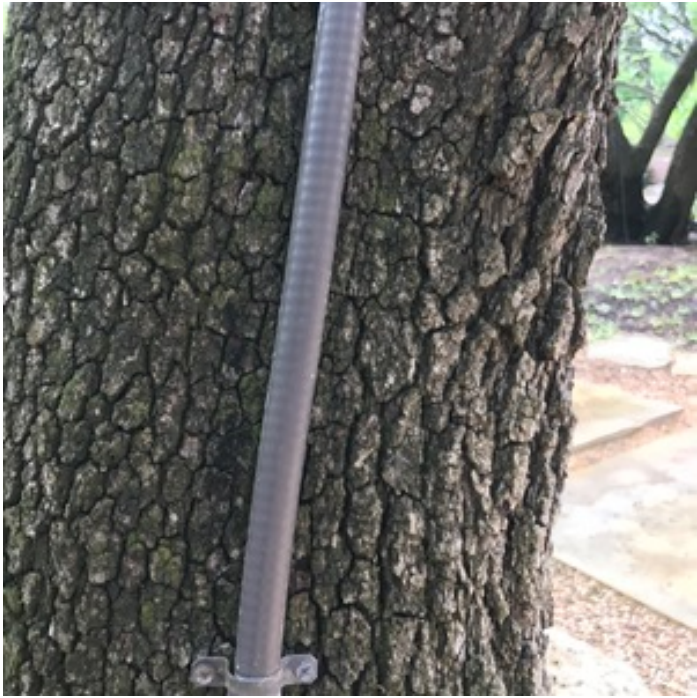
PROPER EXTERIOR WIRE PROTECTION

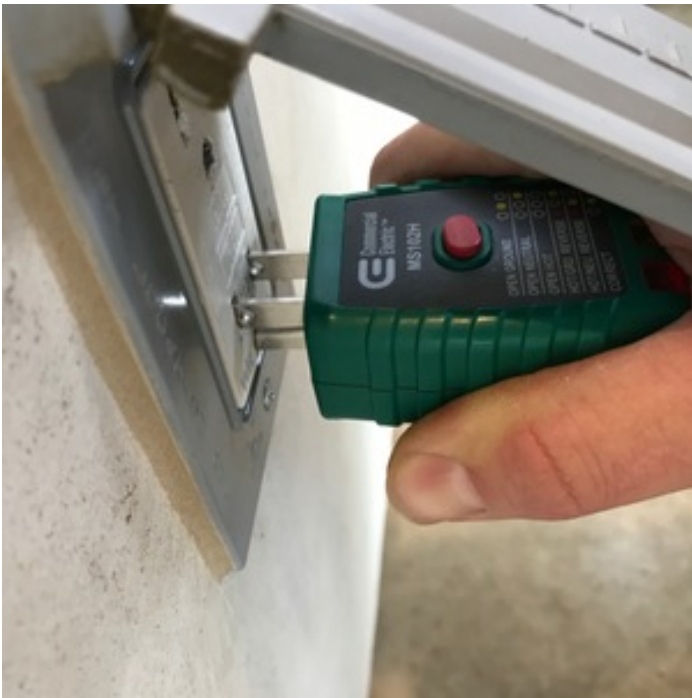
ISSUE AT OUTLET INSERT

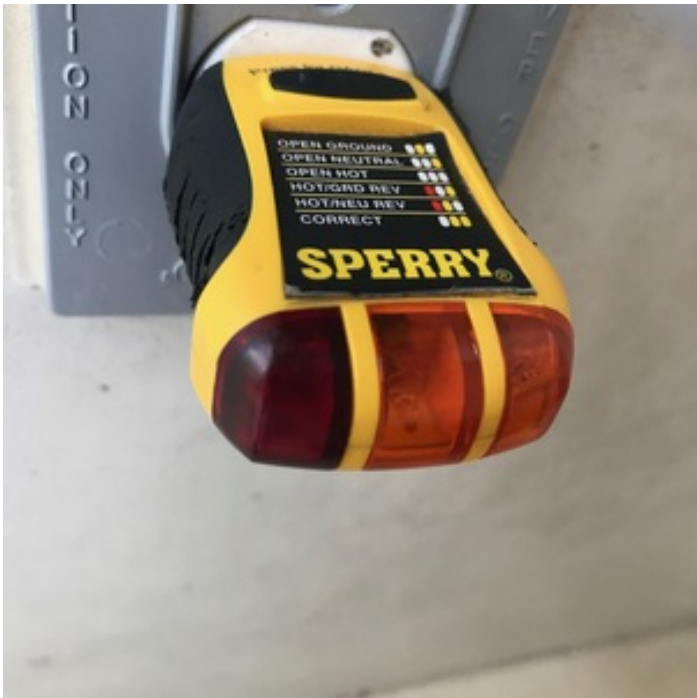
NON FUNCTIONAL EXTERIOR OUTLETS

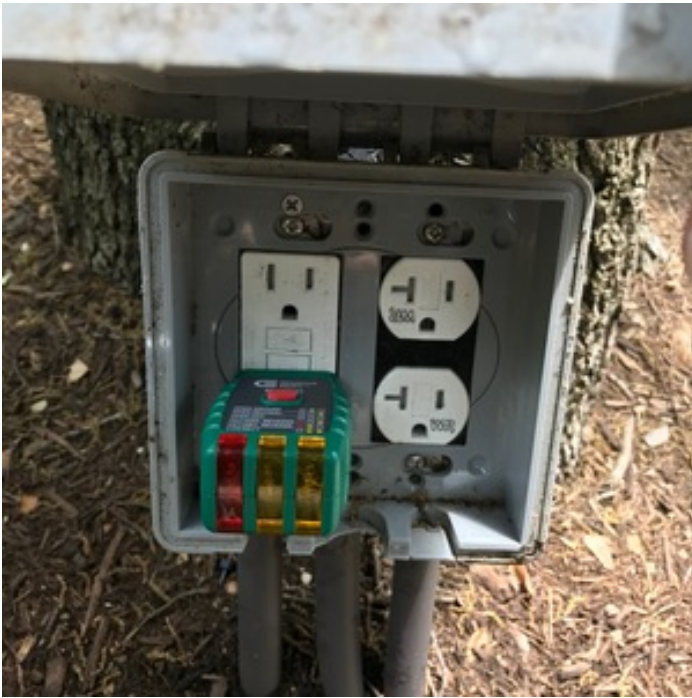
NON FUNCTIONAL LANDSCAPE OUTLETS

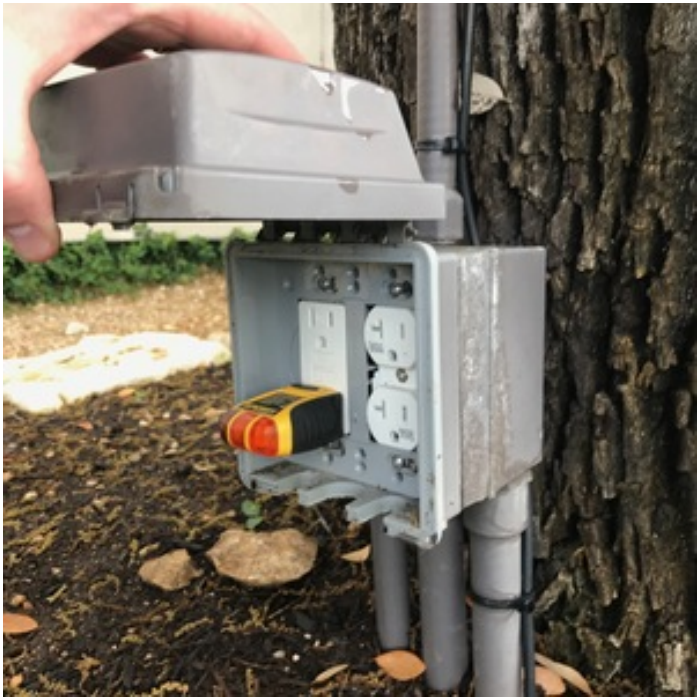
NON FUNCTIONAL LANDSCAPE OUTLETS

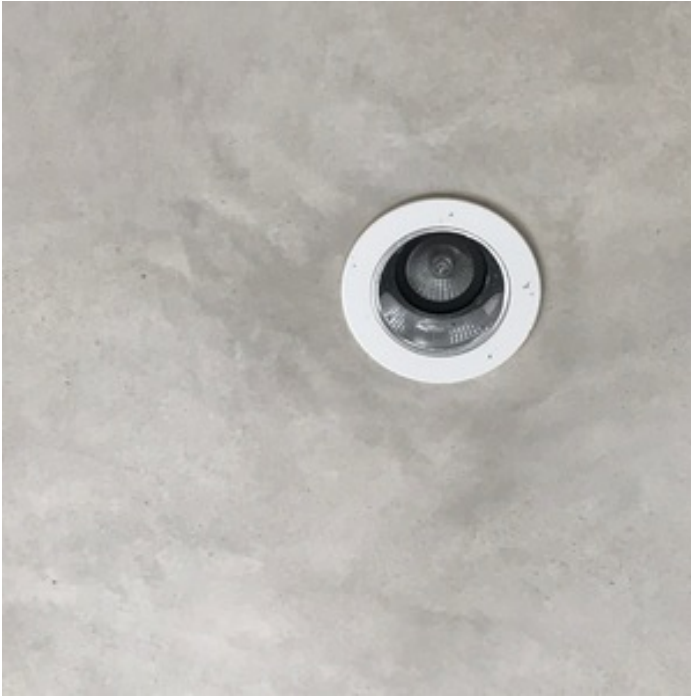
NON FUNCTIONAL LIGHTS
