Property: 2905 Richard Ln.
Austin, Texas 78703
Client: Carol Dochen
Inspection Type: Property Assessment Report
Lead Inspector: Andy Jordan #9458
Date: April 5, 2018

ADDENDUM: REPORT SYNOPSIS

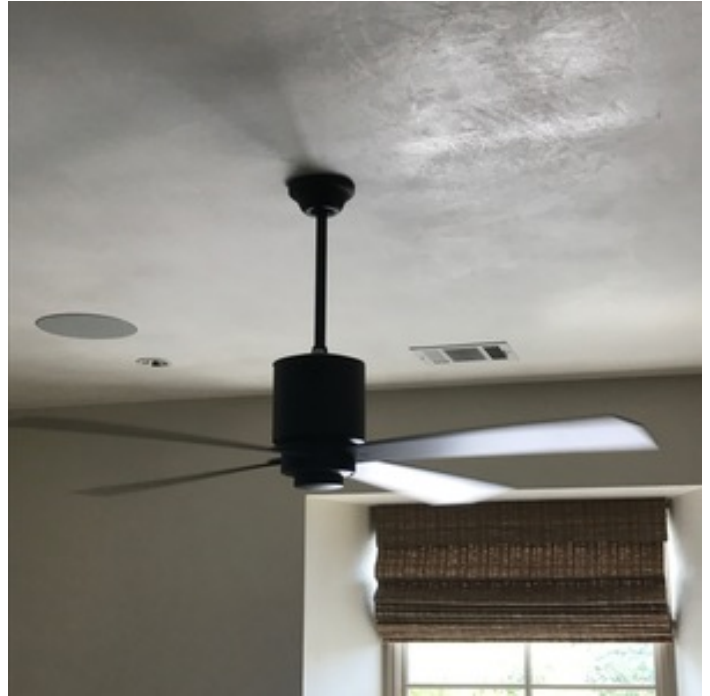
EXCESS WOBBLE

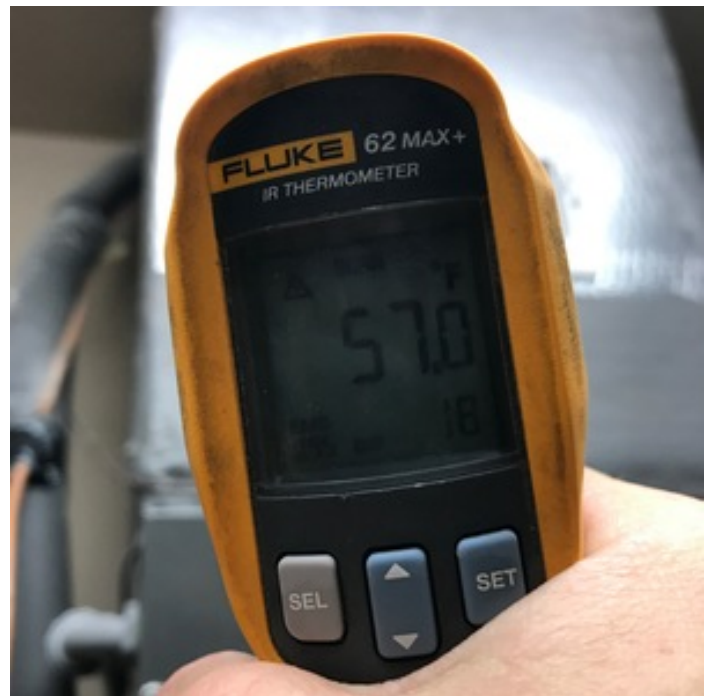
NORMAL SUPPLY TEMP - LOWER UNIT

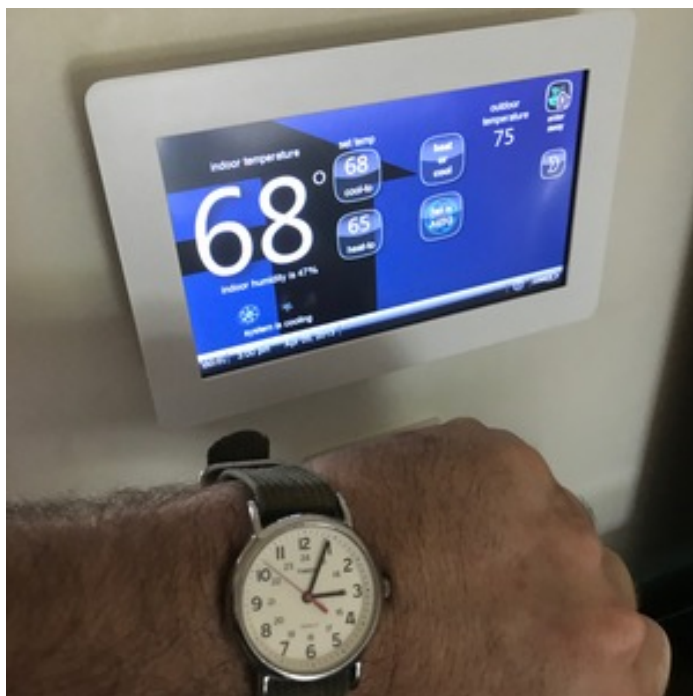
SYSTEMS MET COOLING DEMAND

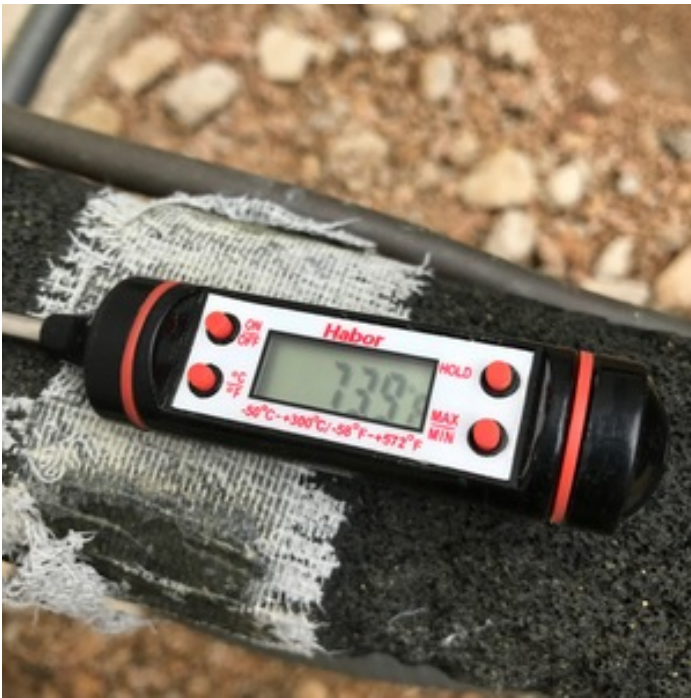
ELEVATED SUCTION LINE TEMP

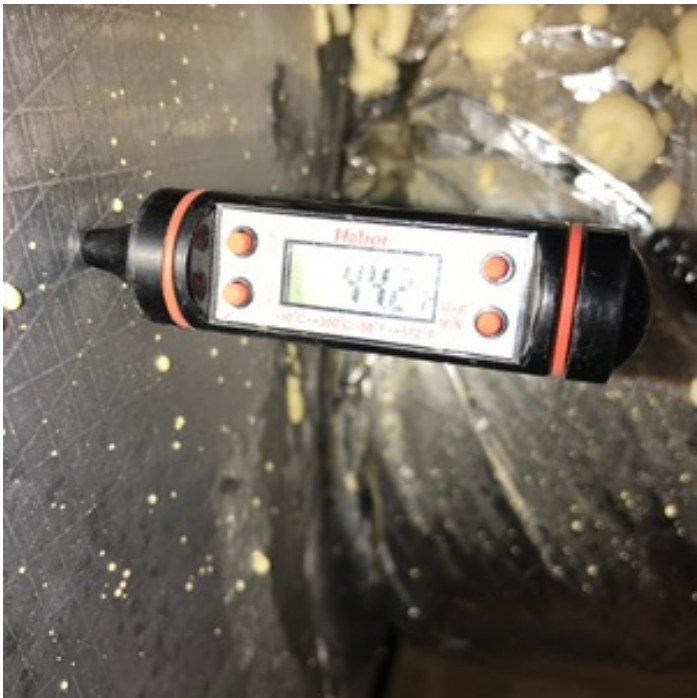
SUPPLY DELTA OUTSIDE RANGE (MARGINALLY)

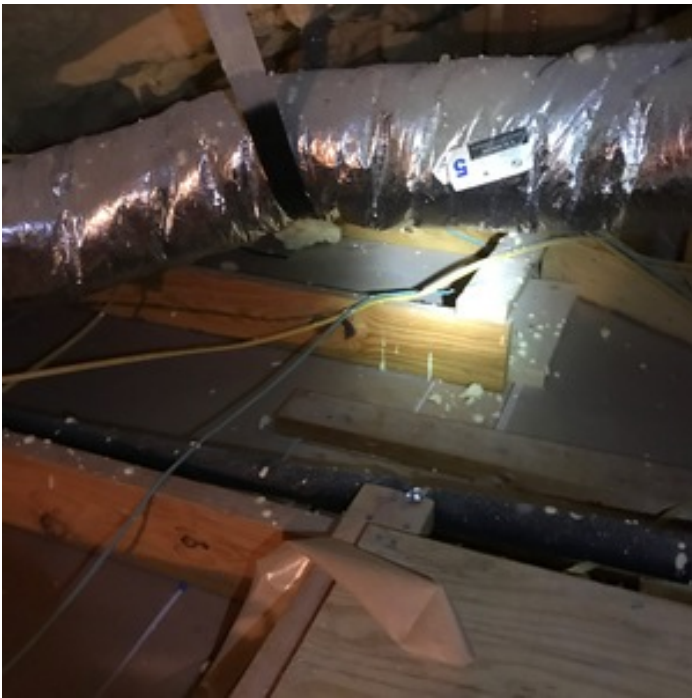
DUCTS PROFESSIONALLY INSTALLED

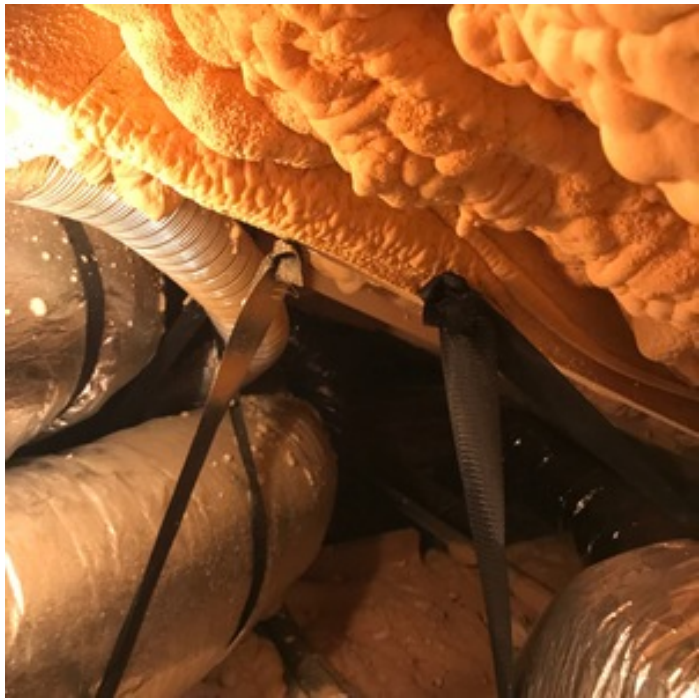
DUCTS PROFESSIONALLY INSTALLED

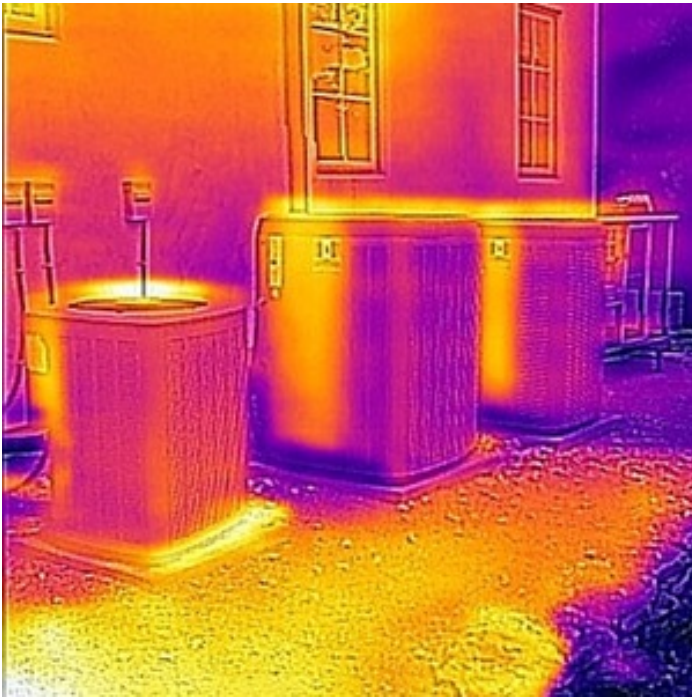
NORMAL READINGS - THERMAL CAMERA

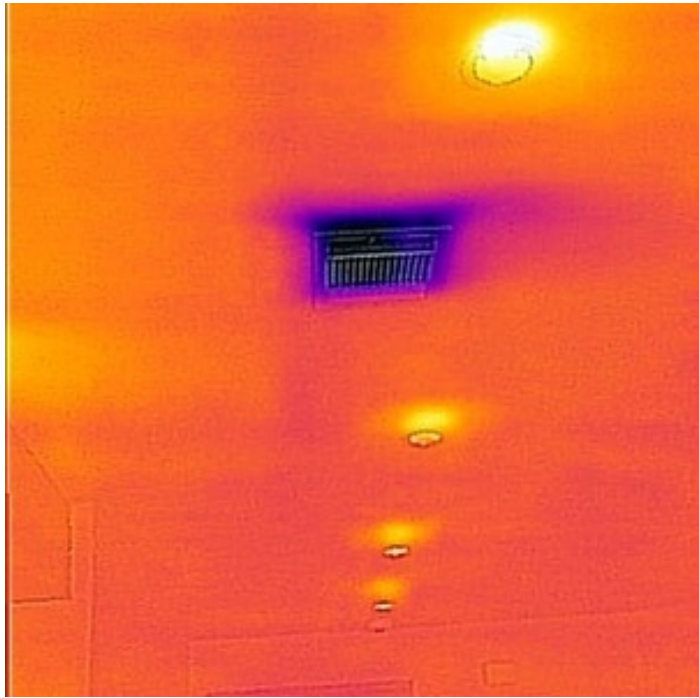
NORMAL READINGS - THERMAL CAMERA

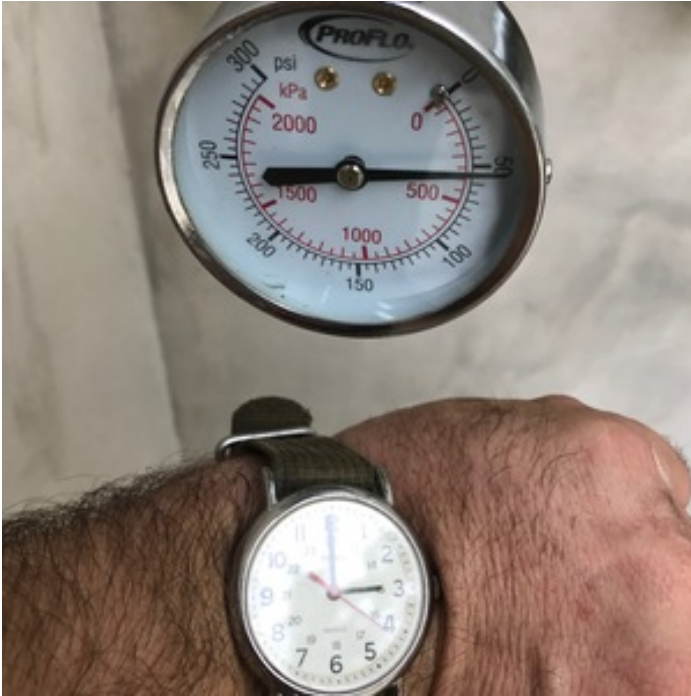
START PRESSURE TEST

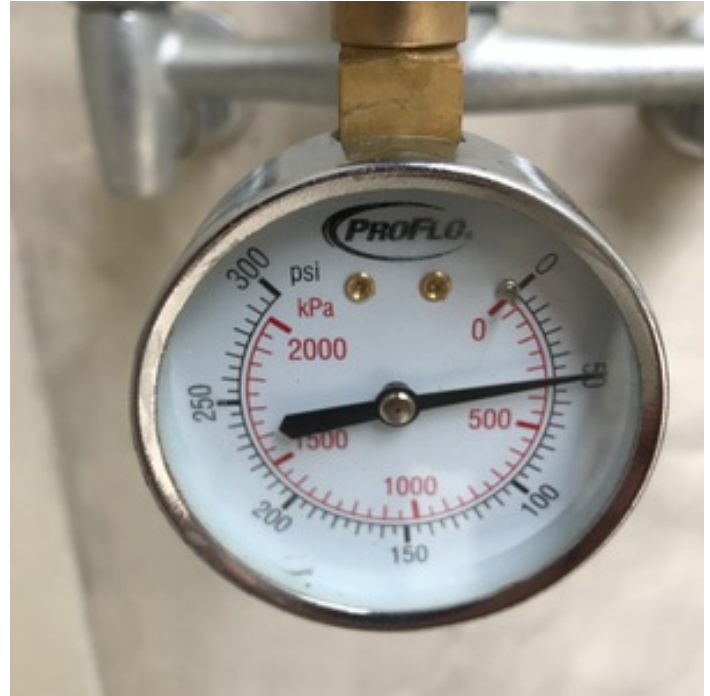
END TEST - PRESSURE HOLDING

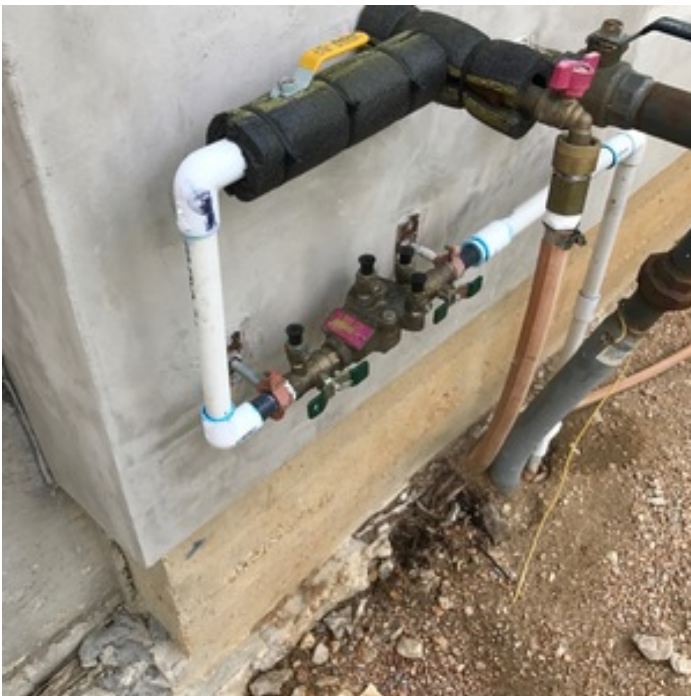
PROTECT/INSULATED EXPOSED PIPING

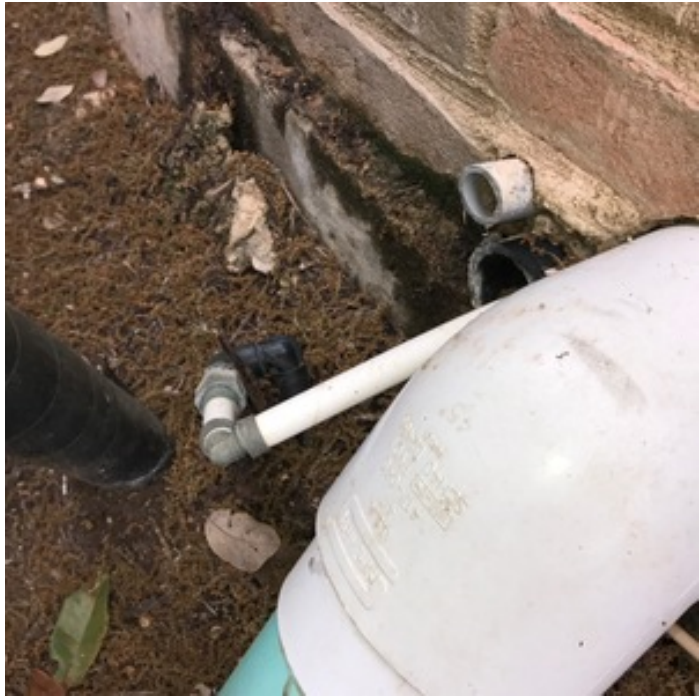
PROTECT ALL EXPOSED PIPING

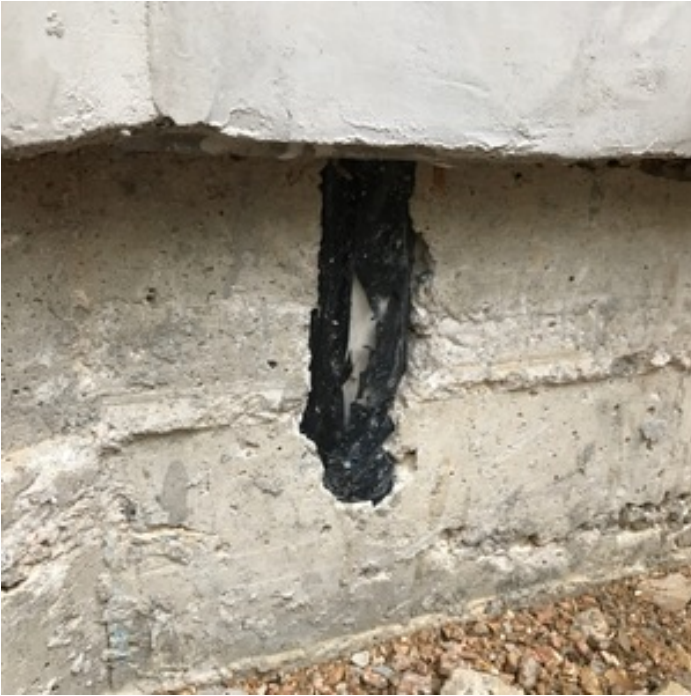
COVER/SEAL EXPOSED PIPE

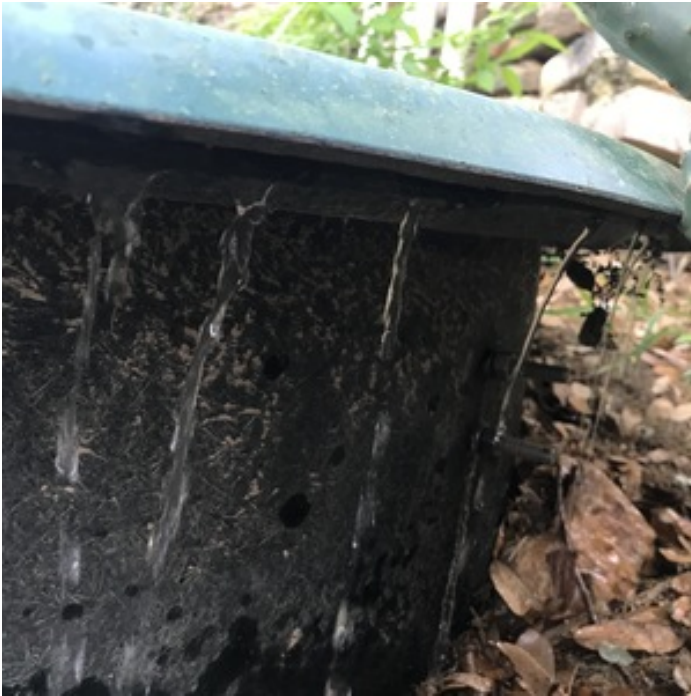
NON FUNCTIONAL/SUMP TANK OVERFLOW

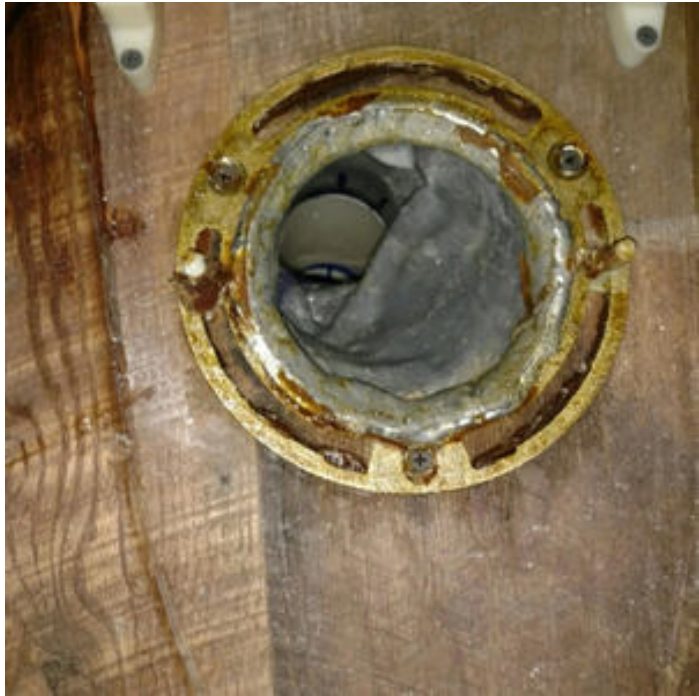
COMMODE DRAIN REDUCED (OVER 50%)

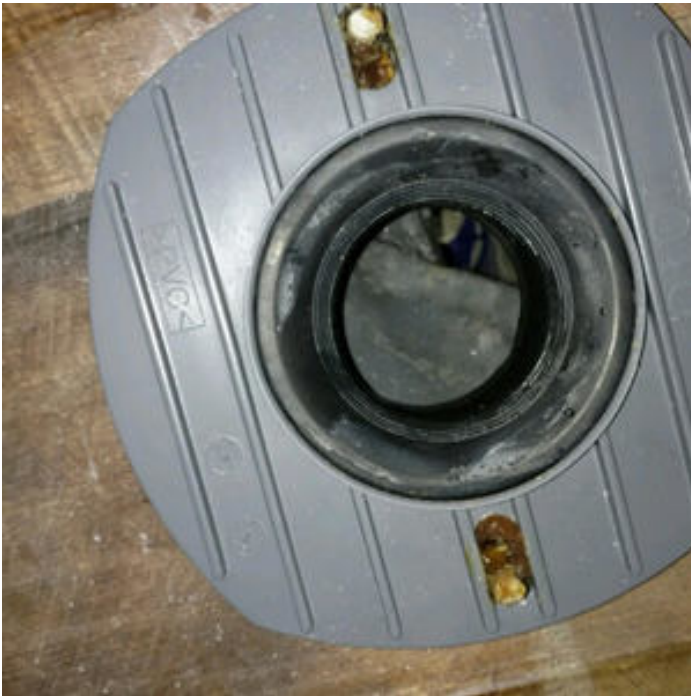
COMMODE DRAIN REDUCED (OVER 50%)

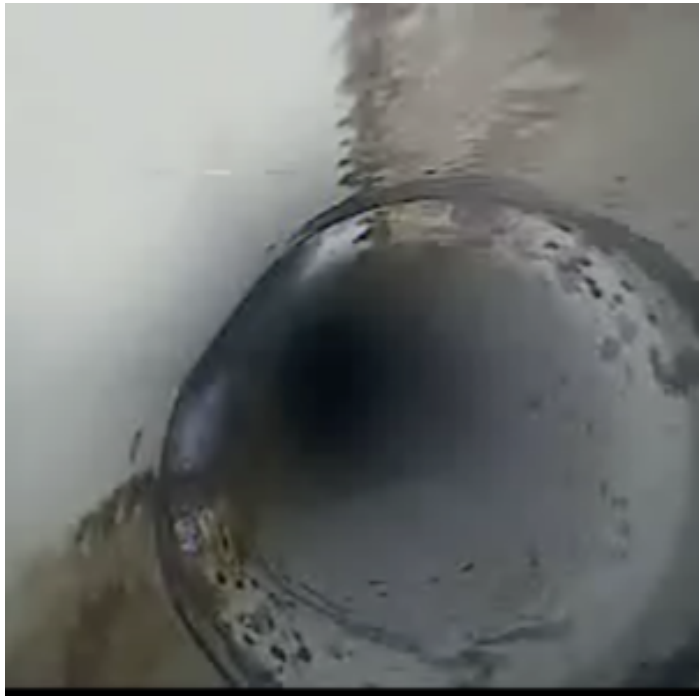
PIPE CAMERA - NO ISSUES OBSERVED

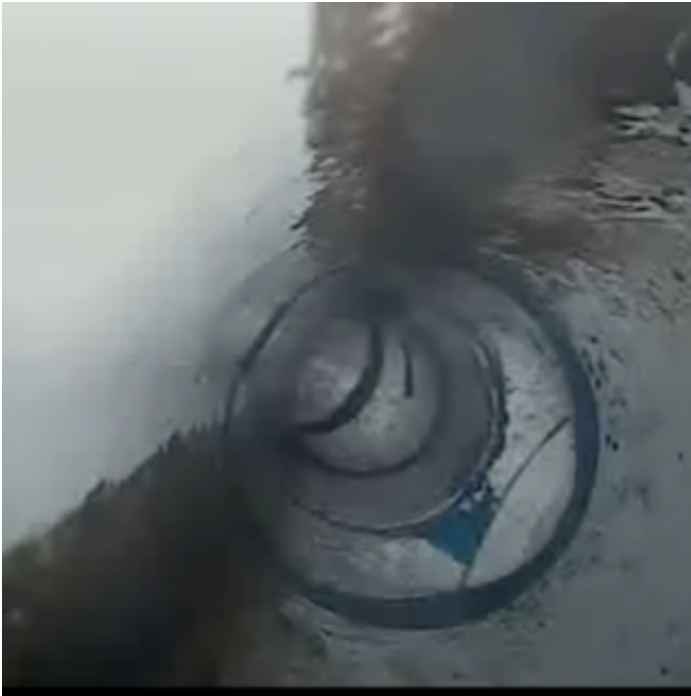
PIPE CAMERA - NO ISSUES OBSERVED

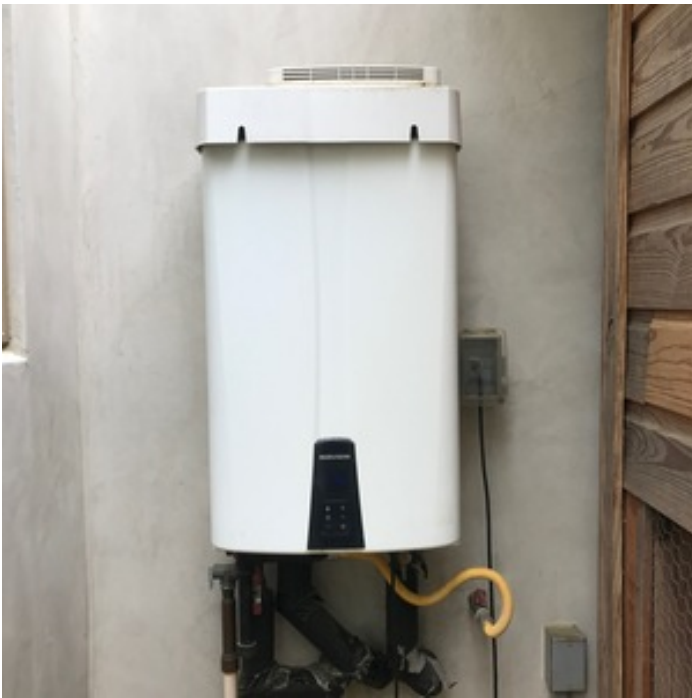
THREE TANKLESS SYSTEMS PRESENT

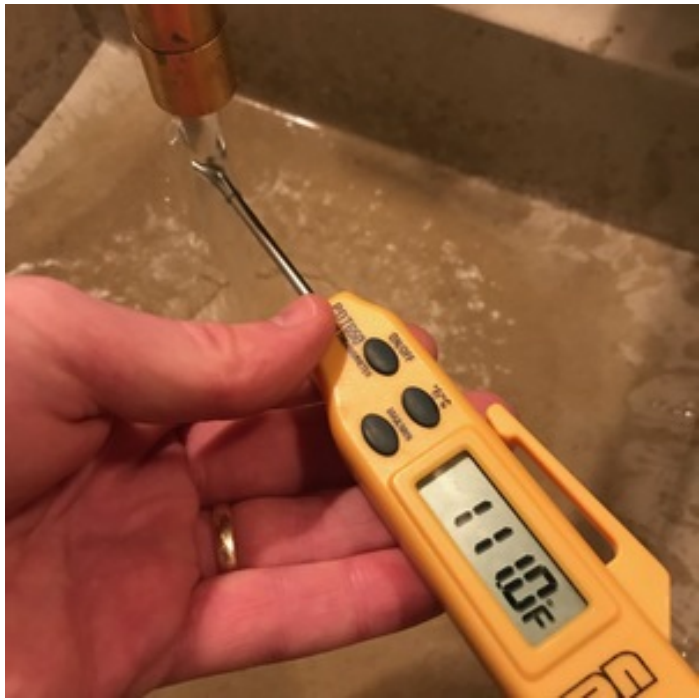
NORMAL TEMPERATURE READINGS

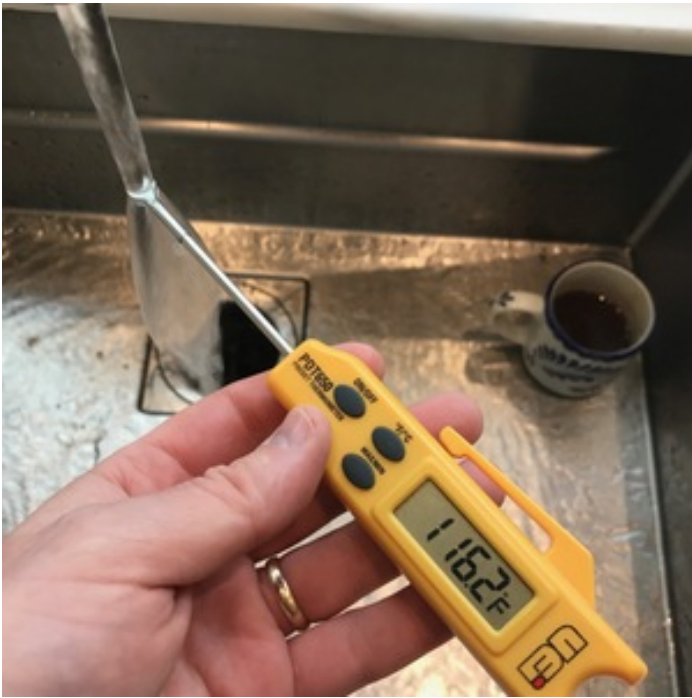
NORMAL TEMPERATURE READINGS

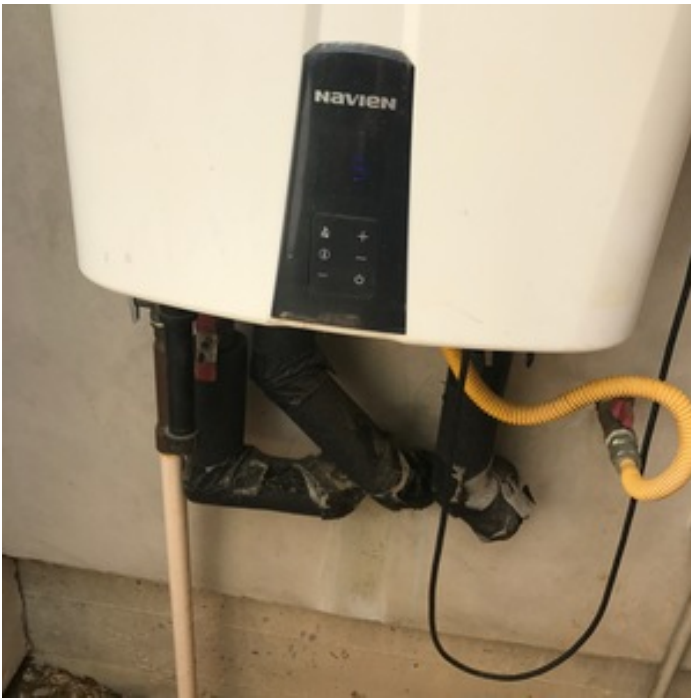
EXTEND CONDENSATE DRAINS

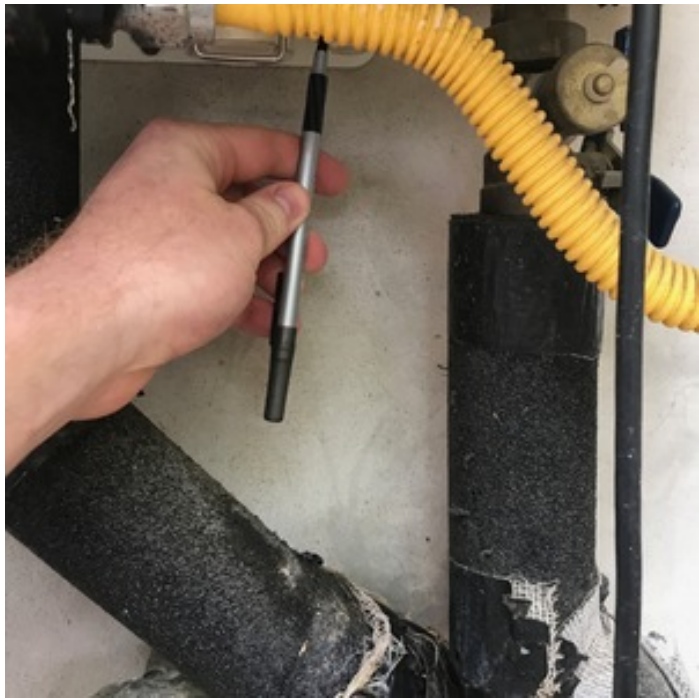
EXTEND CONDENSATE DRAINS

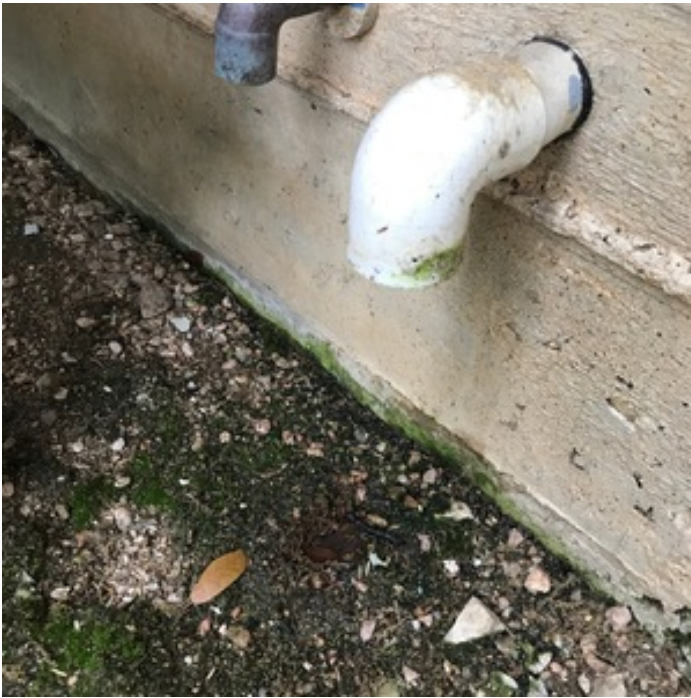
EXTEND CONDENSATE DRAINS

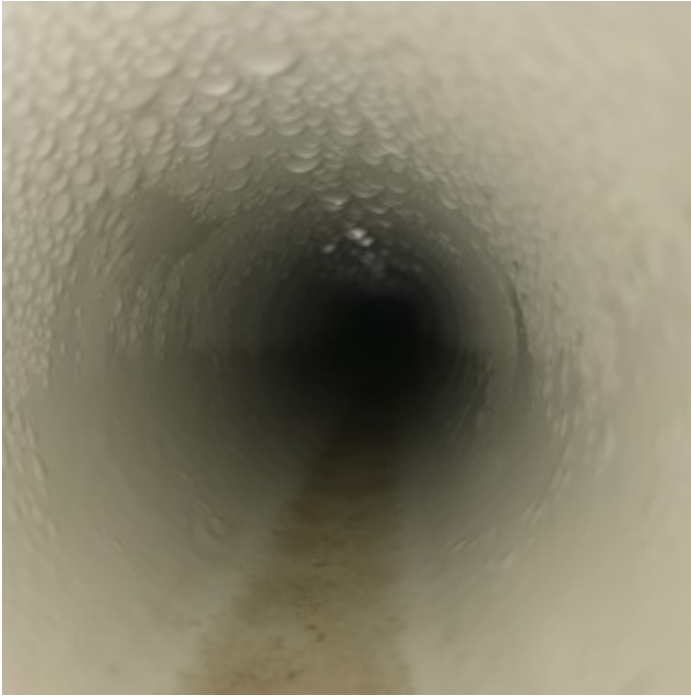
EXCESS CONDENSATE POOLING

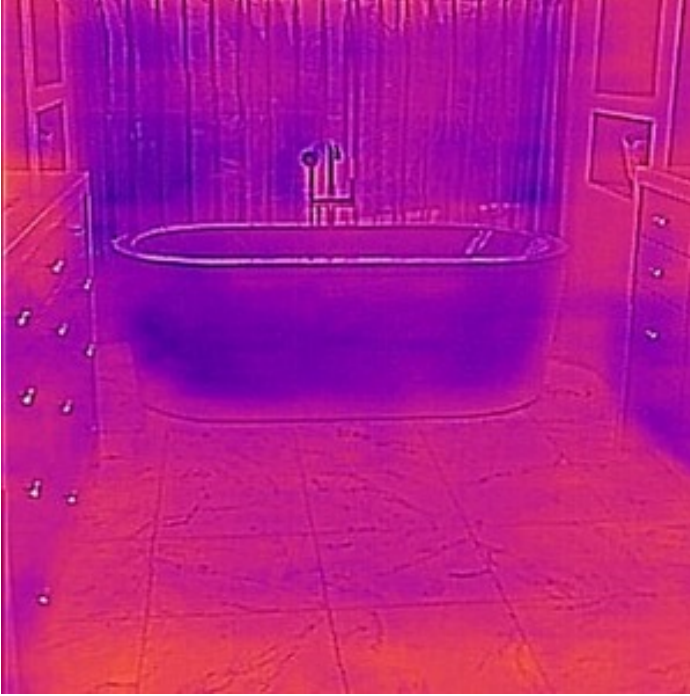
NORMAL READINGS - THERMAL CAMERA

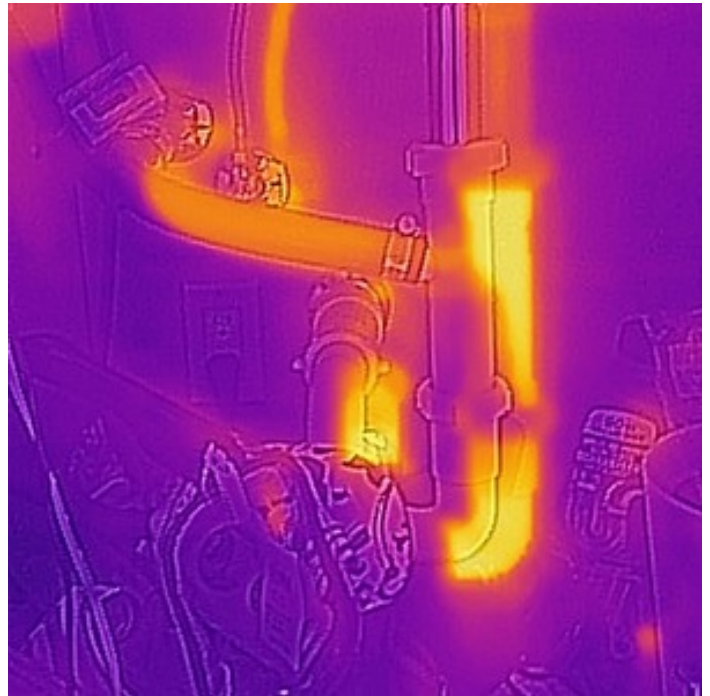
NORMAL READINGS - THERMAL CAMERA

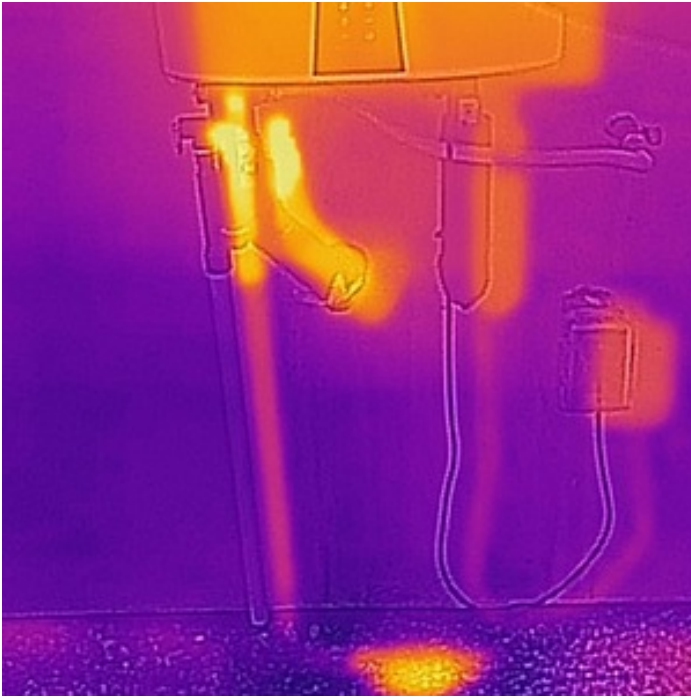
NORMAL READINGS - THERMAL CAMERA

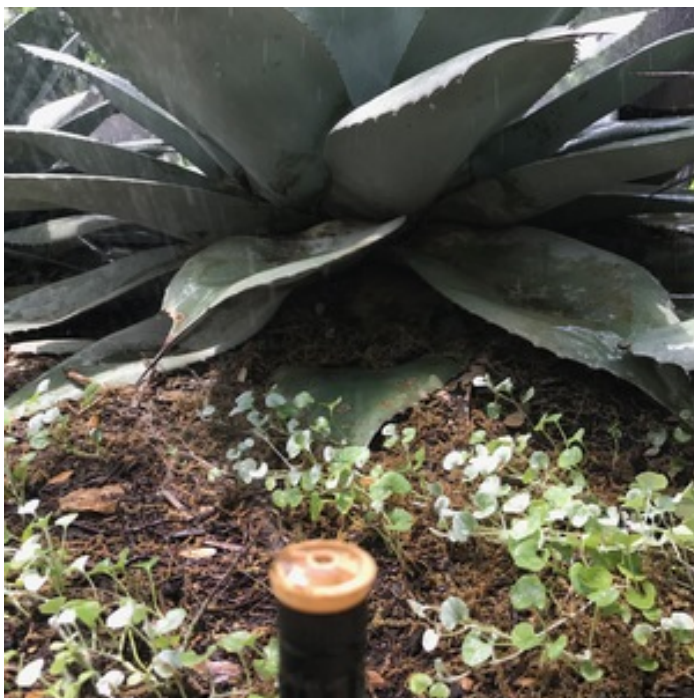
NON FUNCTIONAL HEAD

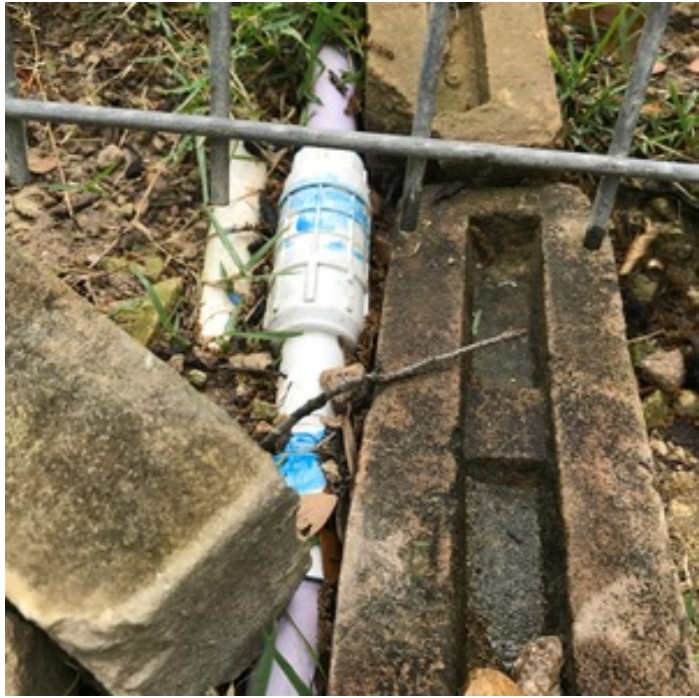
ZONE #3: Back Yard Flat Grass Area / 6 Rotating Sprayers / 1x Ruptured Head / Exposed Supply Lines / Physical Damage Concerns

EXPOSED SUPPLY LINES
