PROPERTY INSPECTION REPORT

Prepared For:	Carol Dochen (Name of Clie	ent)
Concerning:	2905 Richard Ln. Austin, Texas 78703	
	(Address or Other Identification	of Inspected Property)
By:	Andy Jordan, Lic #9458	April 5, 2018
	(Name and License Number of Inspector)	(Date)
	(Name License Number of Sponsoring Inspecto	or)

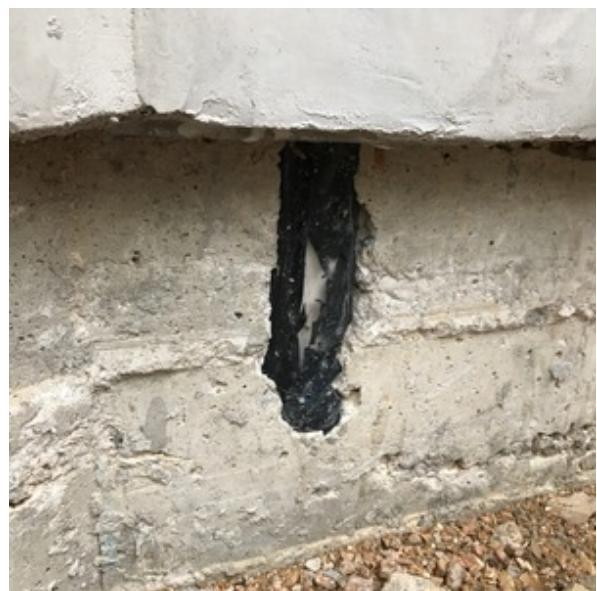
-Protruding Nails at Back Foundation/Decking Walls: Remove Protruding Nails to Reduce Risk of Injury -Portions of Form Boards Left in Place (Back Wall): Remove Wood Debris Near Foundation to Prevent Termite Attraction

-Exposed Plumbing at Back Foundation Wall: Install Foundation Parging to Improve Material Protection

REMOVE PROTRUDING NAILS

EXPOSED PLUMBING - BACK WALL

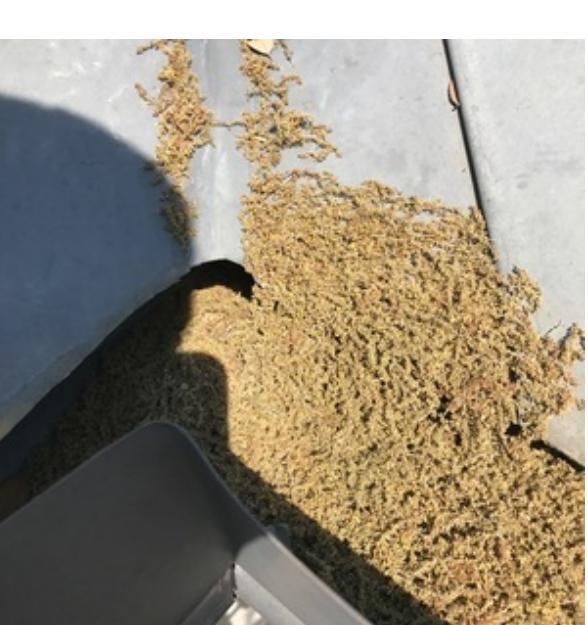
MONITOR NEGATIVE GRADE - RIGHT

SERVICE/CLEAR GUTTERS

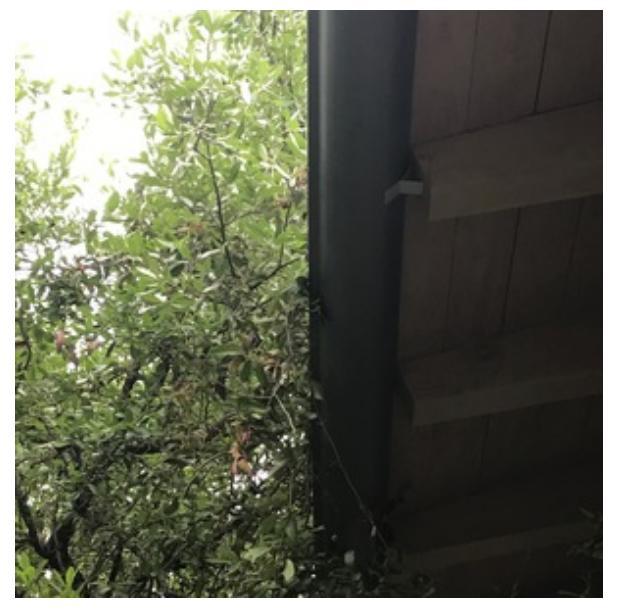
TREES IN CONTACT WITH GUTTERS/ROOF

-Trim Trees to Prevent Further Damage to Gutter/Structure

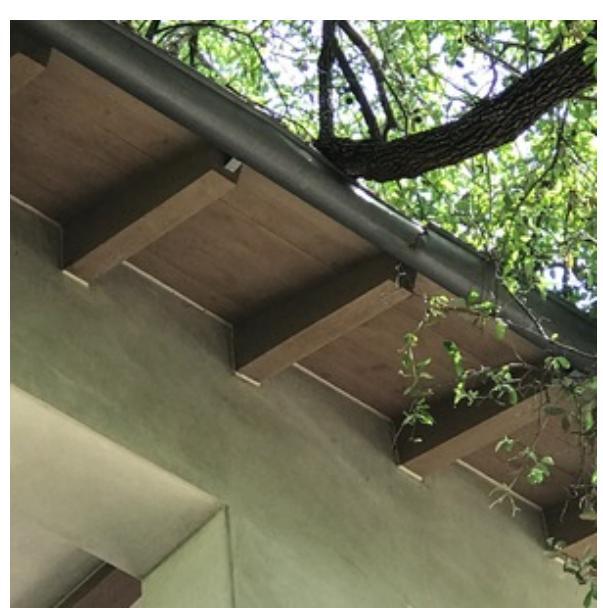
-Replace Damaged Gutters Due to Tree Contact: Left Side Structure Near Carport

GUTTER DAMAGE - LEFT SIDE

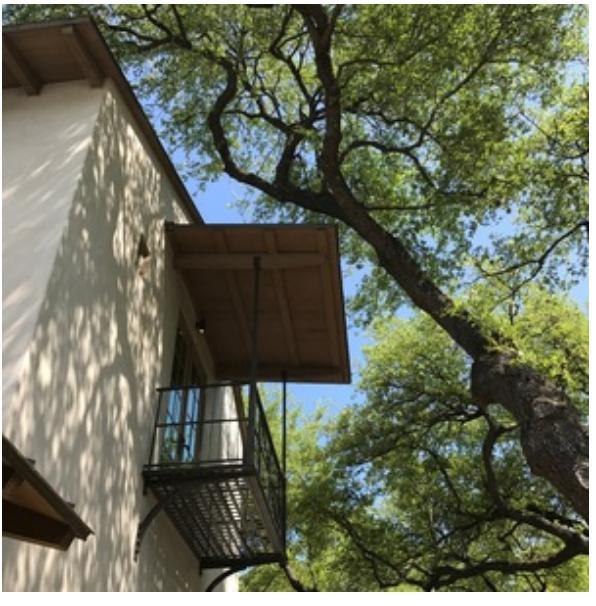
BRANCHES OVERHANG ROOF

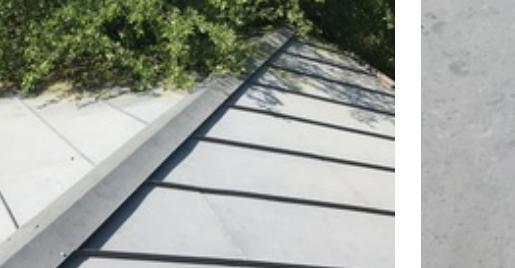
ELIMINATE TREE CONTACT

INSTALL CONCERN AT BOOTS

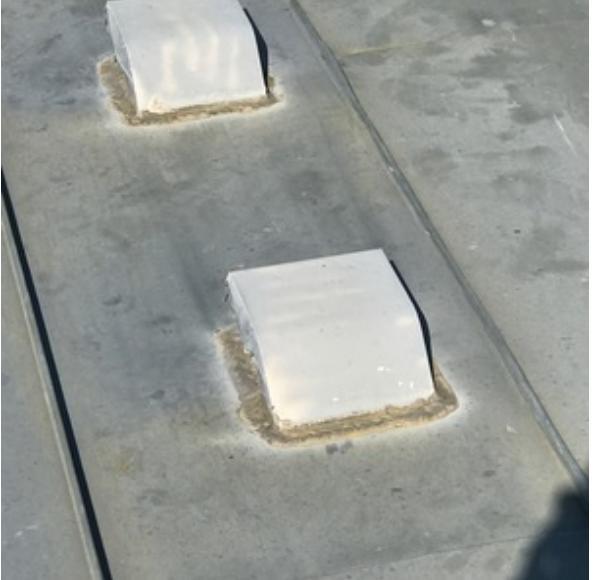
-Improper Installation of Roof Vent Pipe Boots/Flashing at Various Areas: Increased Likelihood of Moisture Penetration (Contact Roofing Specialist to Update as Needed)

INSTALL CONCERN AT BOOTS

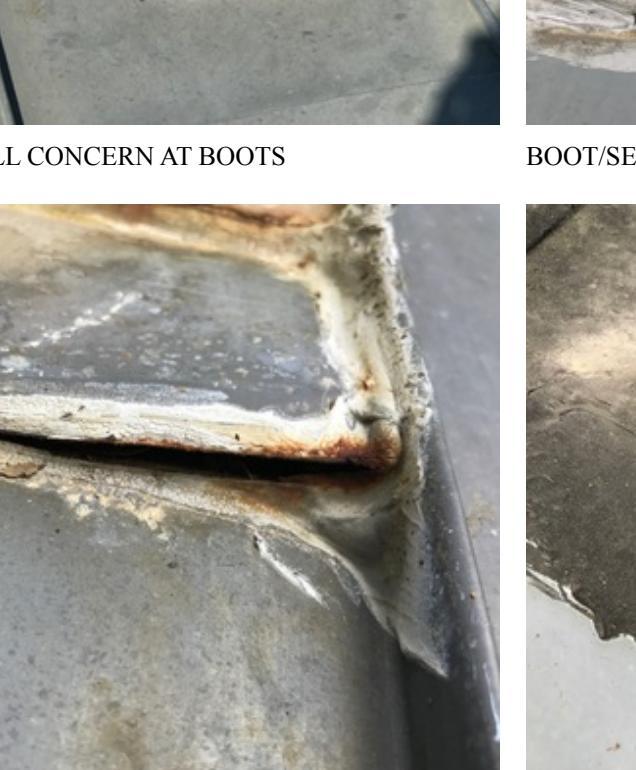
-Excess Use of Caulking/Sealing as Primary Means of Moisture Protection (Right Side and Various Vent Boots): Contact Roofing Specialist to Update as Needed

FLASHING/PANEL ISSUES - RIGHT SIDE

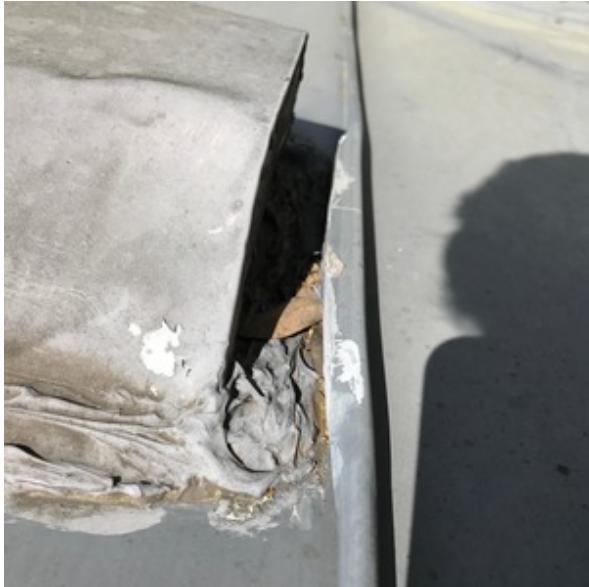
BOOT/SEAM CONCERN - LEFT SLOPE

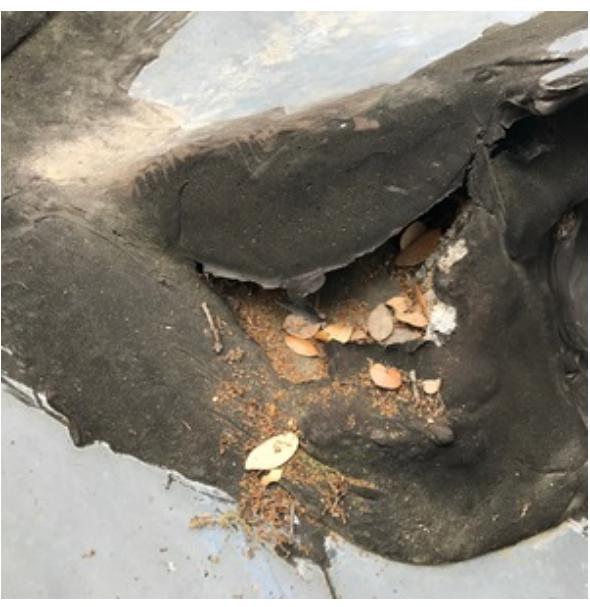
INSTALL/MOISTURE PENETRATION CONCERNS

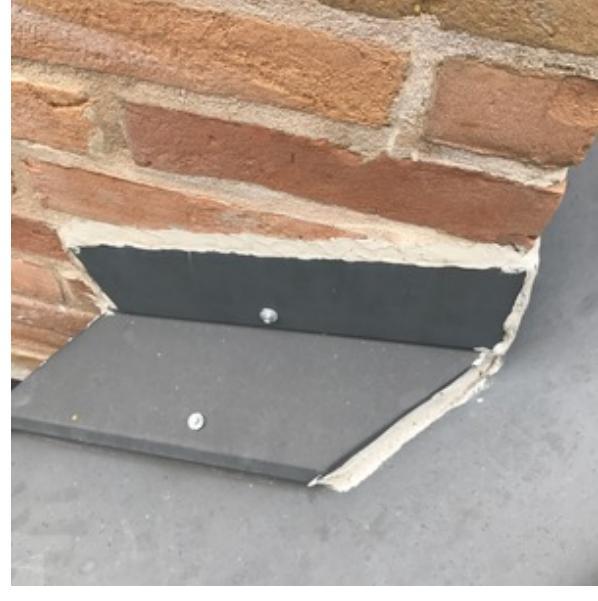
INSTALL CONCERN - RIGHT FLAT ROOF

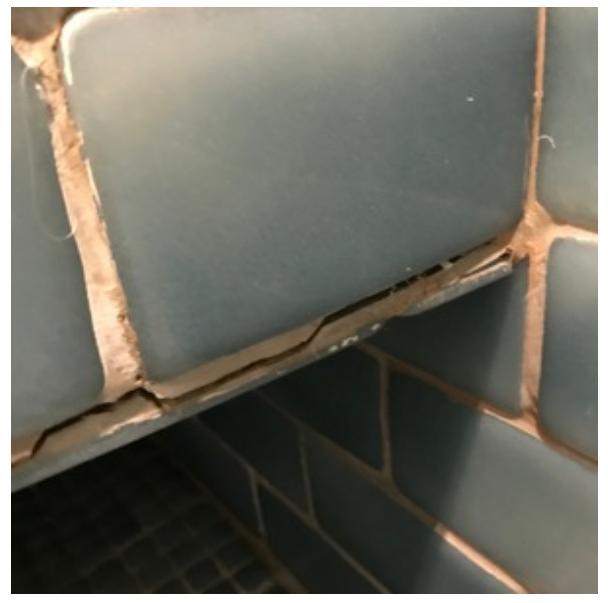
TILE GAPS/TUB SURROUND

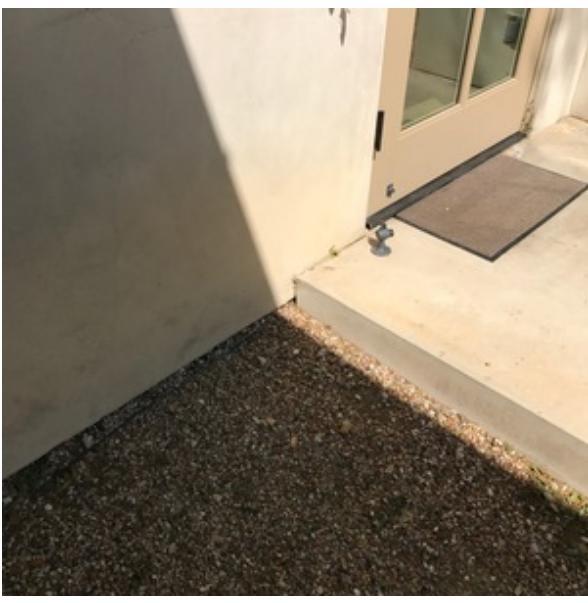
SLAB ADJACENT INTERIOR DAMAGE

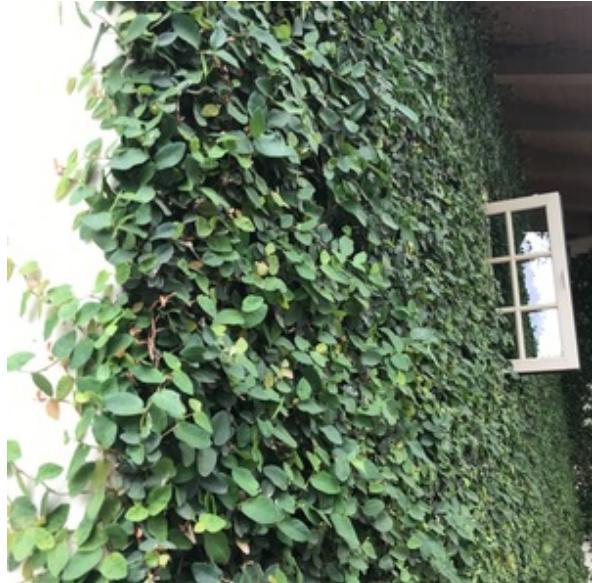
HEAVY FOLIAGE CONTACT

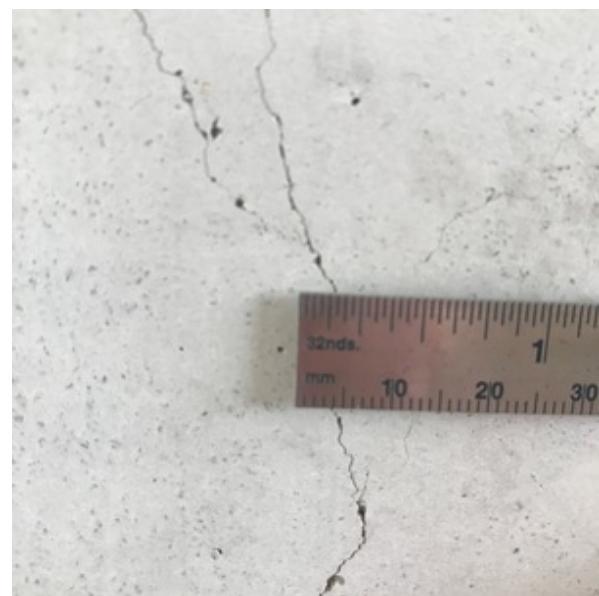
MONITOR NORMAL CRACKING

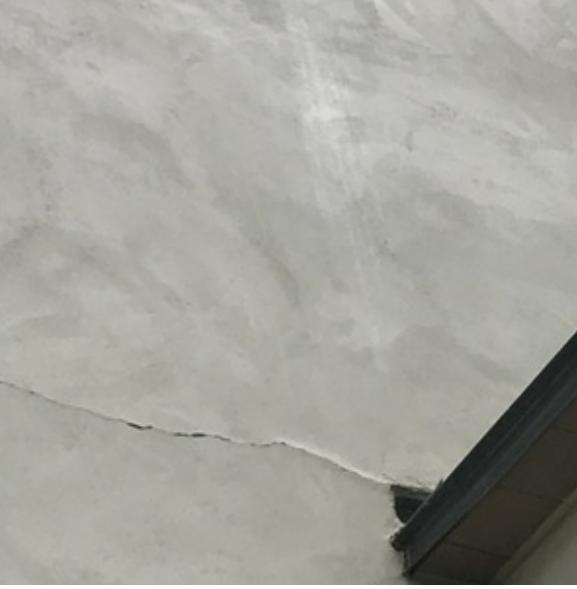
EXPANSION CRACKS/MOISTURE CASCADE

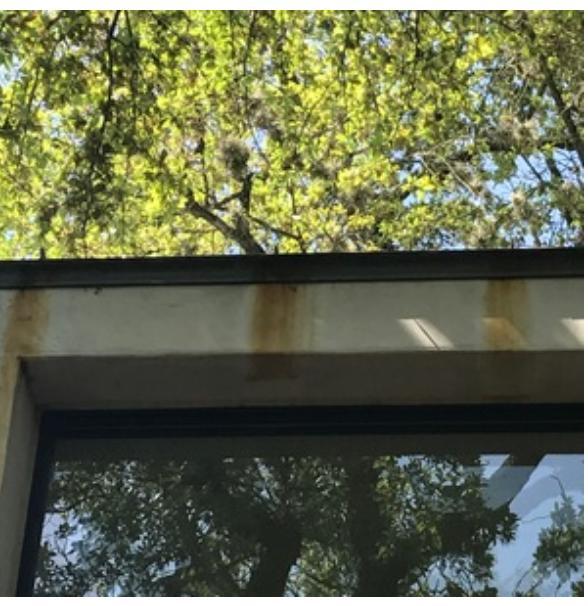
MOISTURE WICK NEAR MASTER BATH

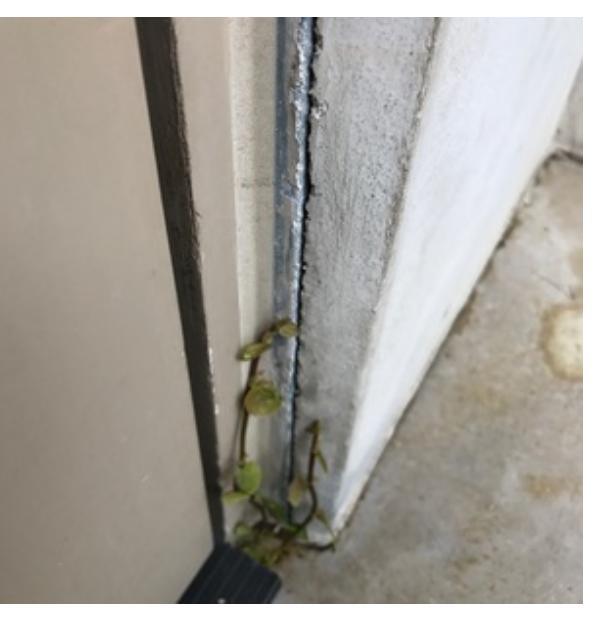
MINOR GAPS NEAR DOOR CONNECTIONS

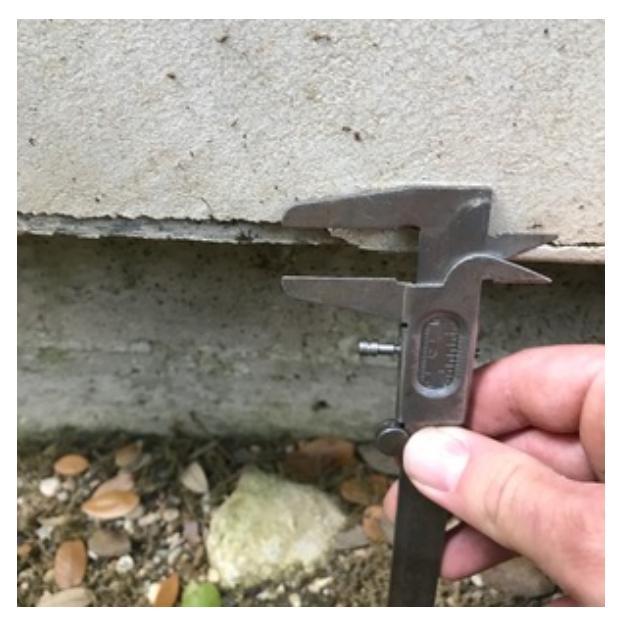
MATERIAL SEPARATION AT EDGE TRIM

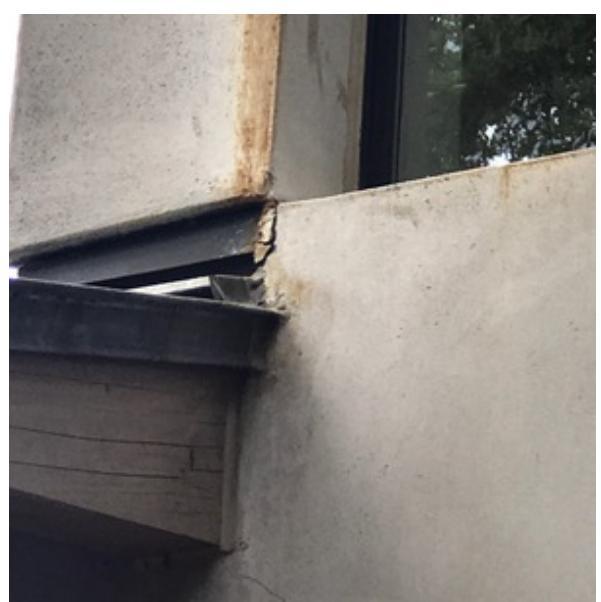
SIDING CRACK NEAR ROOF TRIM - RIGHT

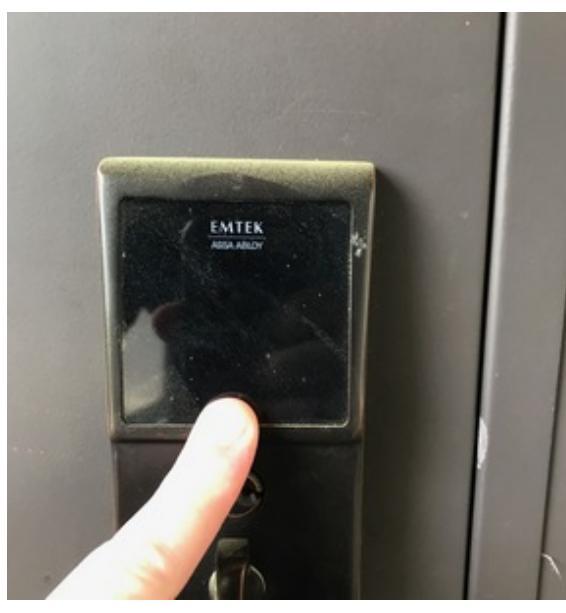
NON FUNCTIONAL KEY PAD

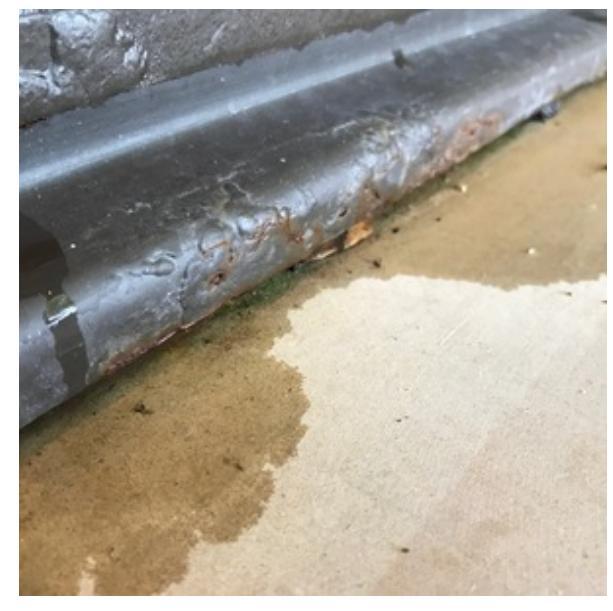
RUST/DAMAGE AT THRESHOLD

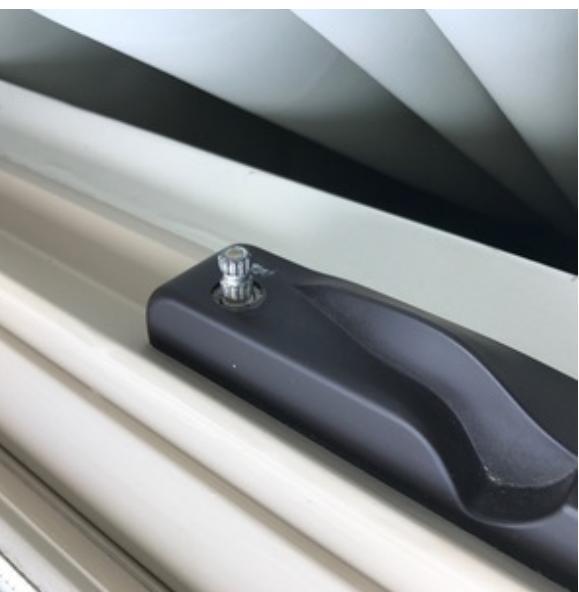
REMOVED MOTORIZED BLIND

MISSING CRANKS

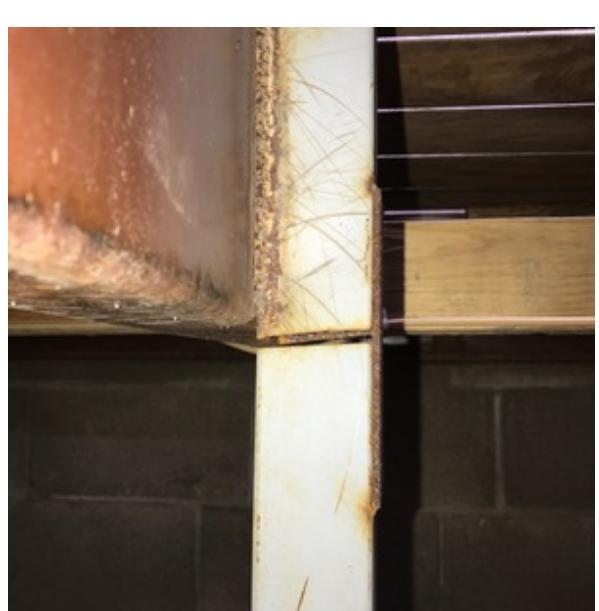
CUT PIERS - PURPOSE UNKNOWN

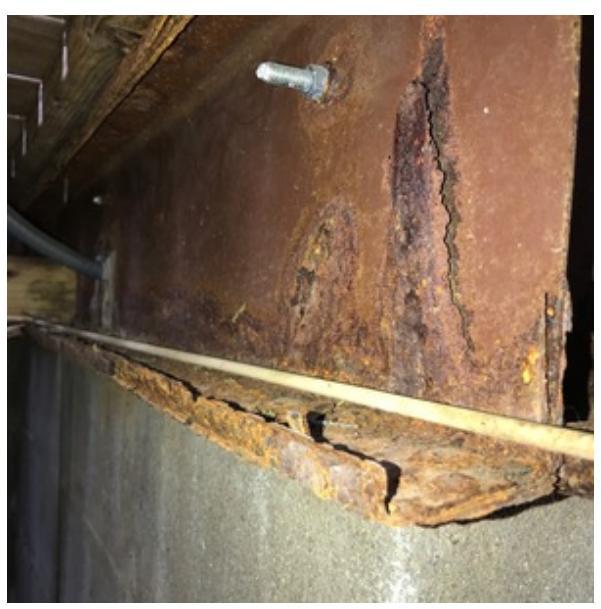
BEAM DAMAGE - POOL DECK

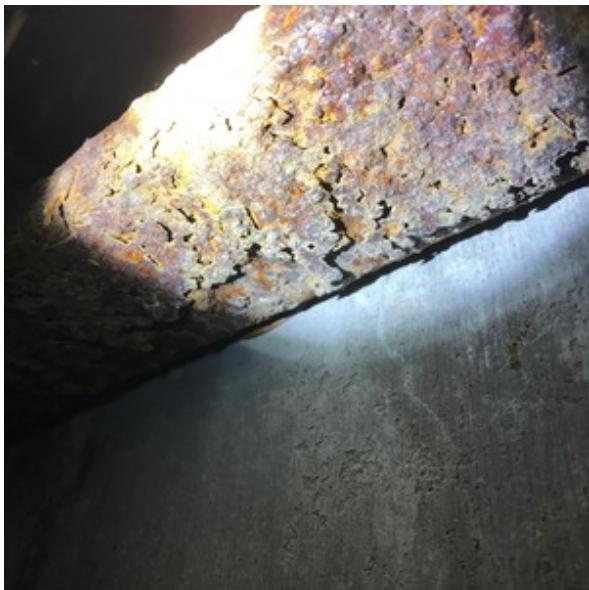
BEAM DAMAGE - POOL DECK

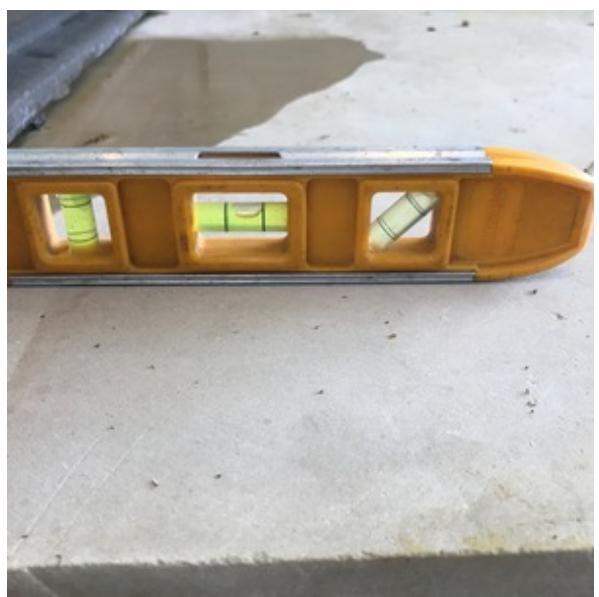
SLOPE CONCERN AT DOOR PAVERS

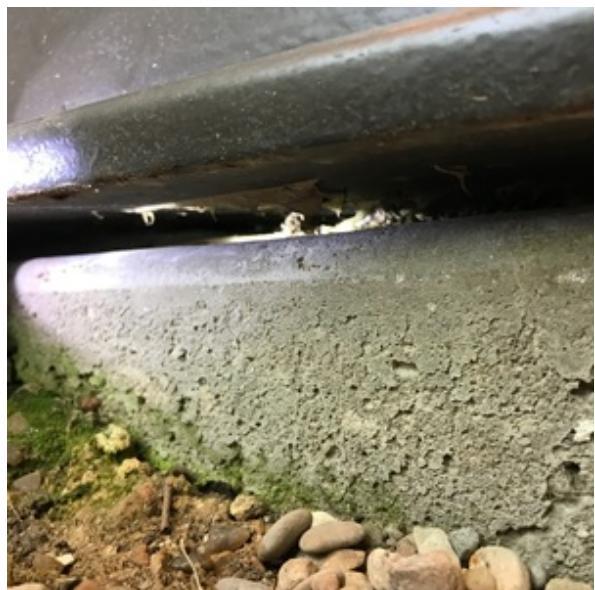
MOISTURE ENTRY - PAVER/THRESHOLD

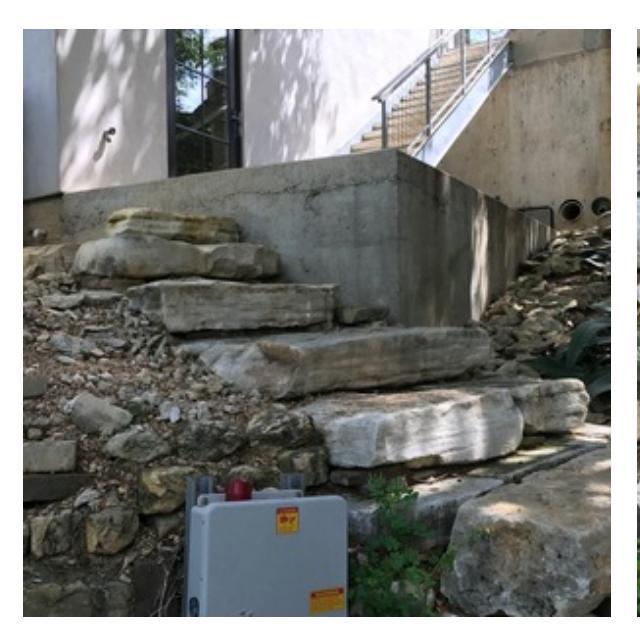
NO DECK/STEP RAILING

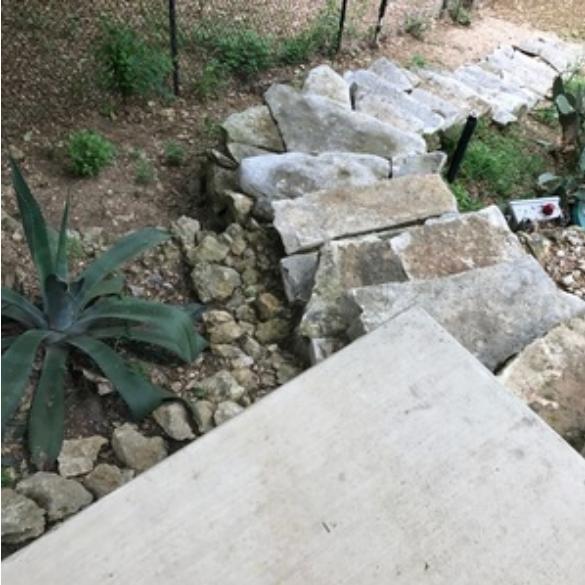
MISSING RAILING/UNEVEN STONE STEPS

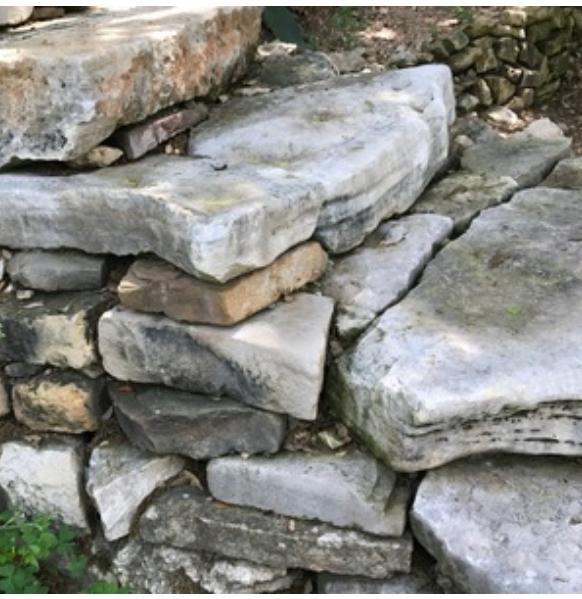
NO RAILING/DRY STACK STEPS

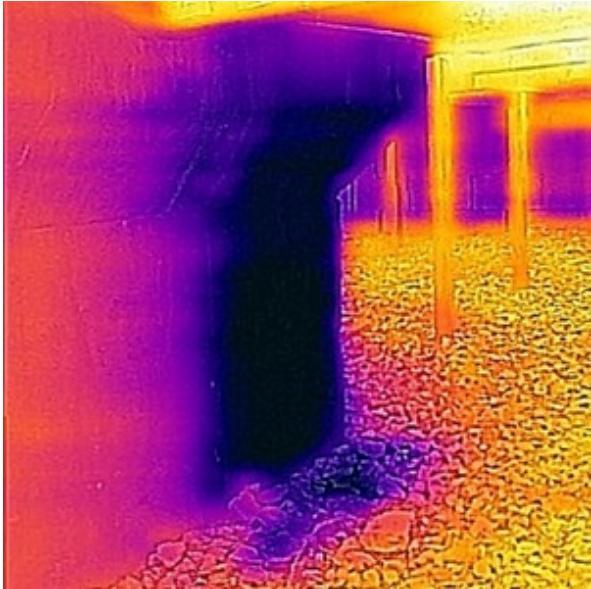
-Address Leakage at Pool Wall: See 'Porches, Decks, Balconies, Carports' Chapter -Address Pooling at Pavers/Exterior Doors: Moisture Entry Concern
I=Inspected	NI=Not Inspected	NP=Not Present	D=Deficient	
I NI NP D

LEAK AT POOL WALL

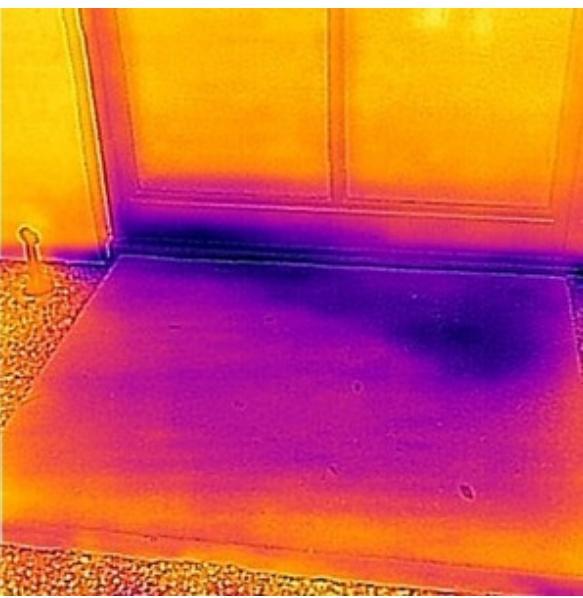
POOLING AT PAVERS

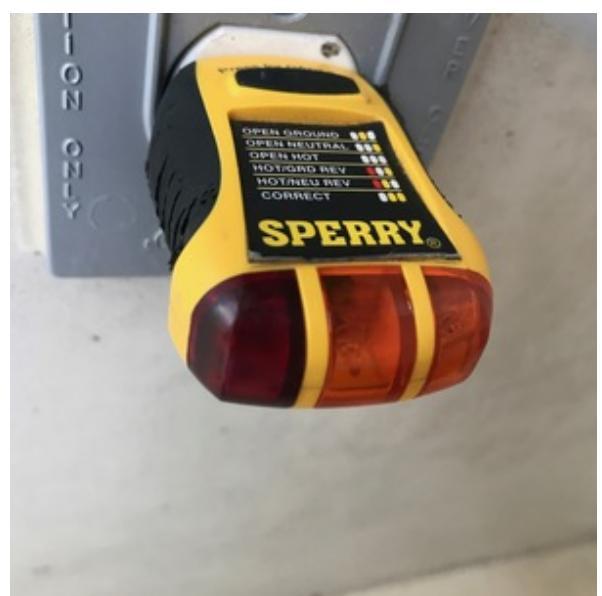
-Damage to Main Back Patio Outlet (Safety Covers at Power Insert Preventing Use): Replace/Update as Needed -Non Functional Doorbell: Consult Electrician/Update as Needed

ISSUE AT OUTLET INSERT

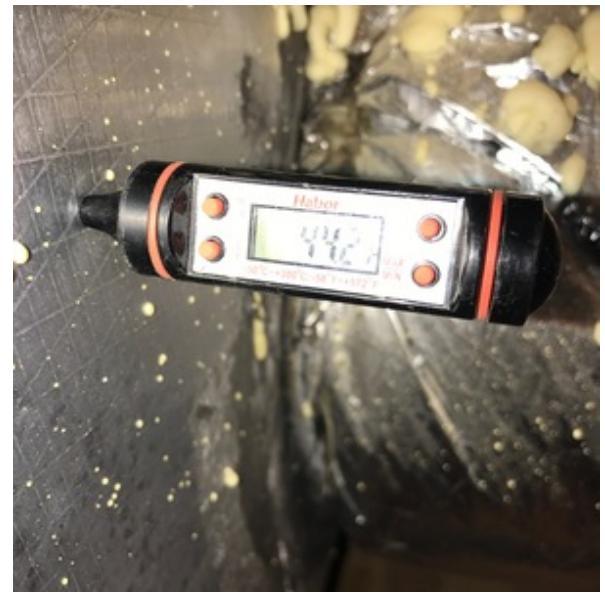
SUPPLY DELTA OUTSIDE RANGE (MARGINALLY)

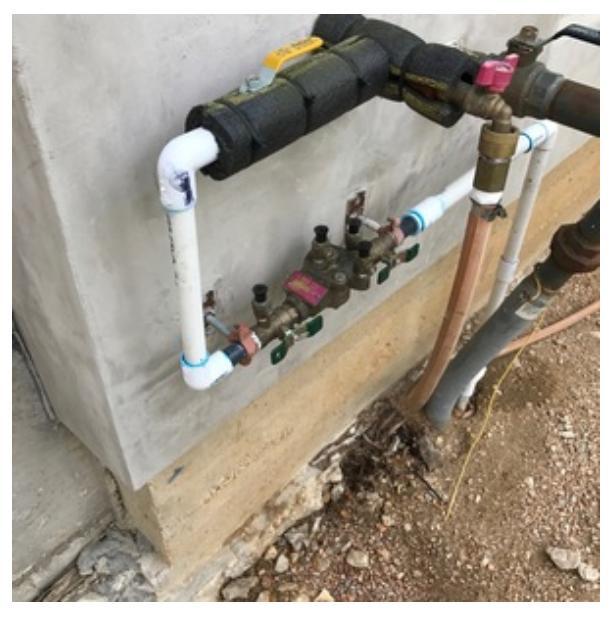
PROTECT/INSULATED EXPOSED PIPING

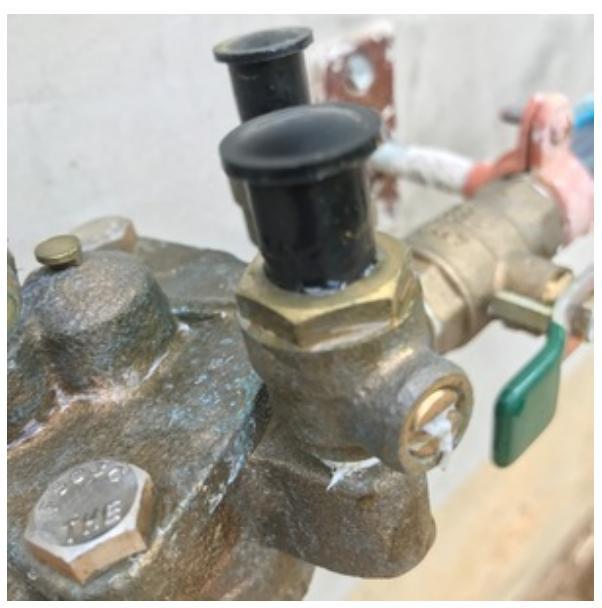
ACTIVE LEAK - PRESSURE VALVE

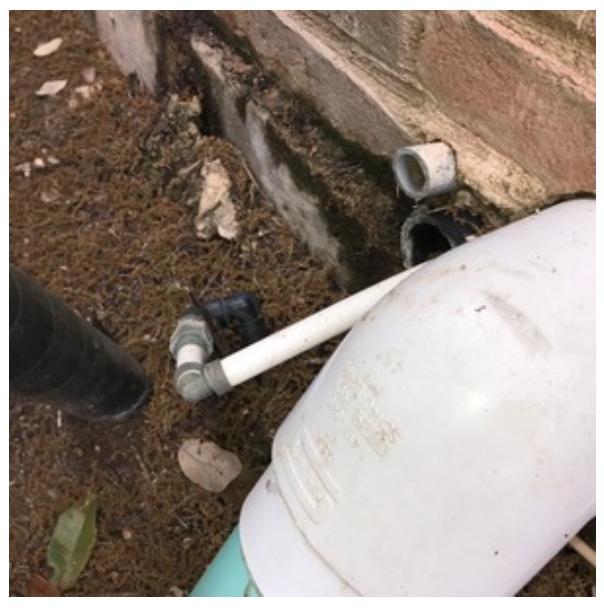
PROTECT ALL EXPOSED PIPING

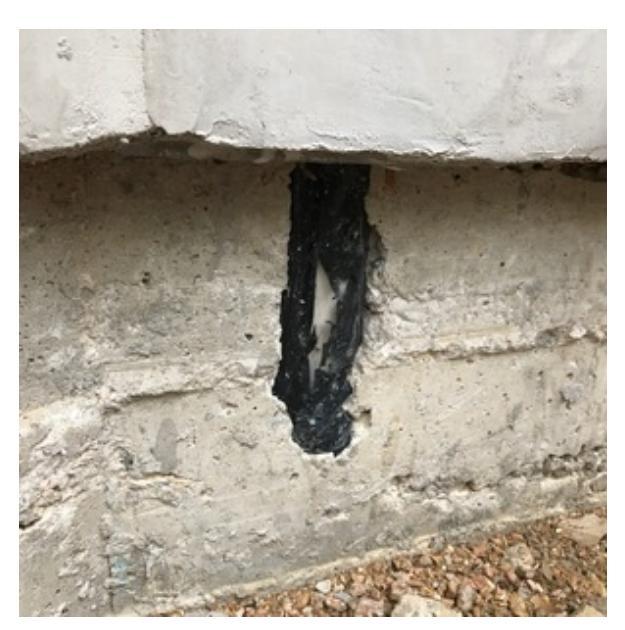
COVER/SEAL EXPOSED PIPE

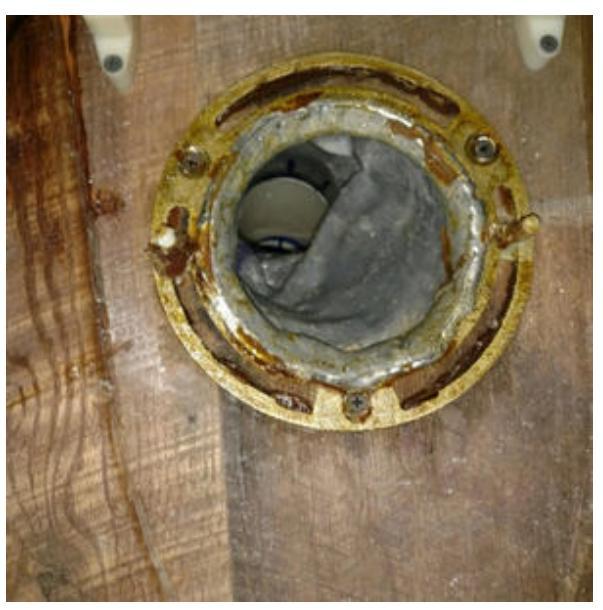
COMMODE DRAIN REDUCED (OVER 50%)

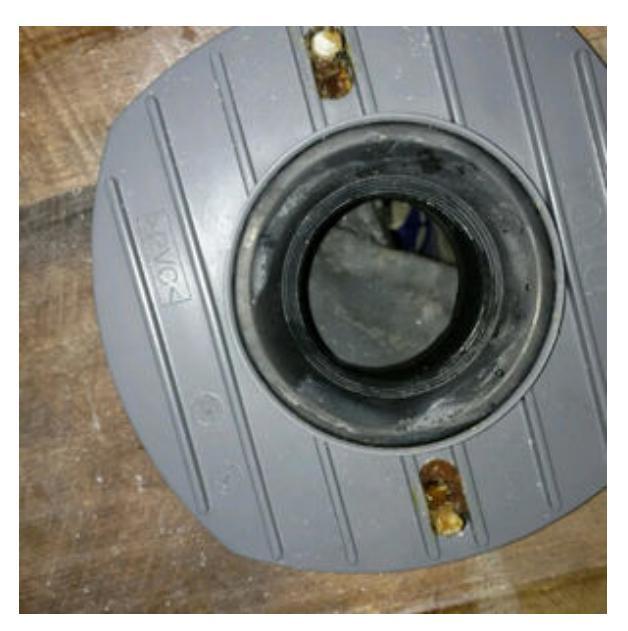
COMMODE DRAIN REDUCED (OVER 50%)

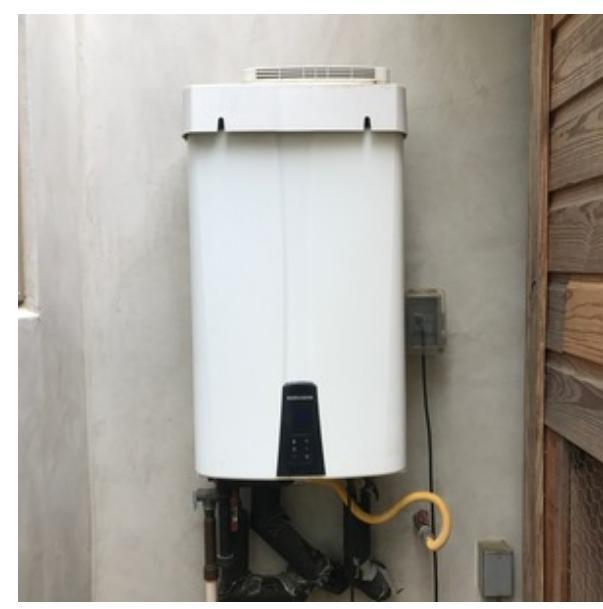
THREE TANKLESS SYSTEMS PRESENT

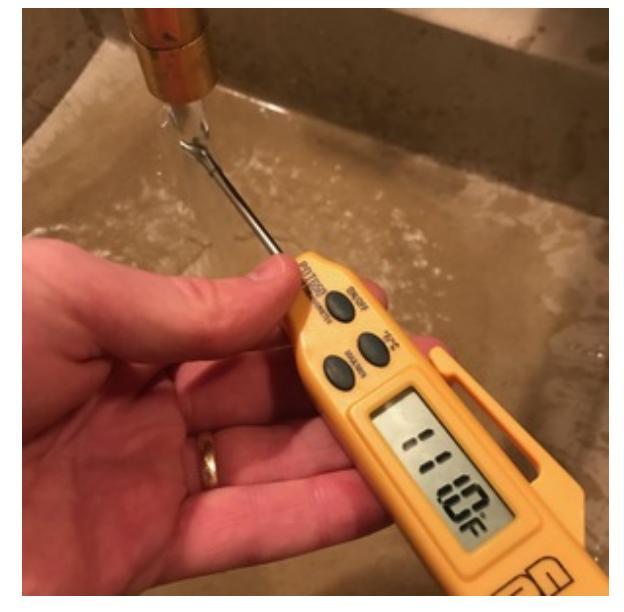
NORMAL TEMPERATURE READINGS

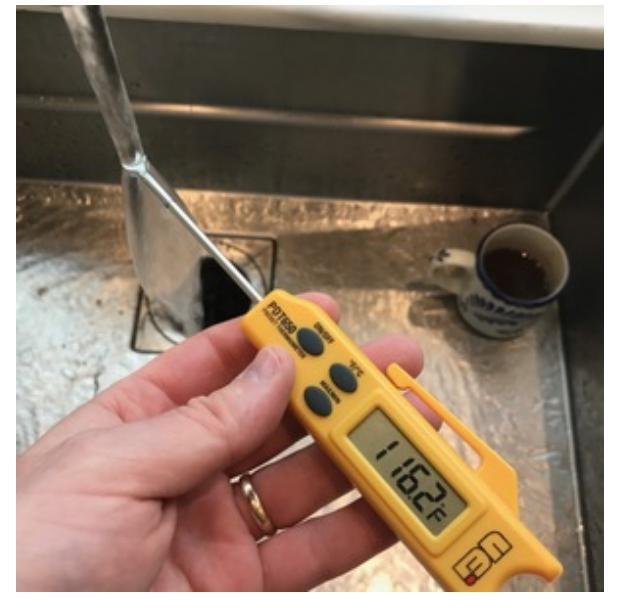
NORMAL TEMPERATURE READINGS

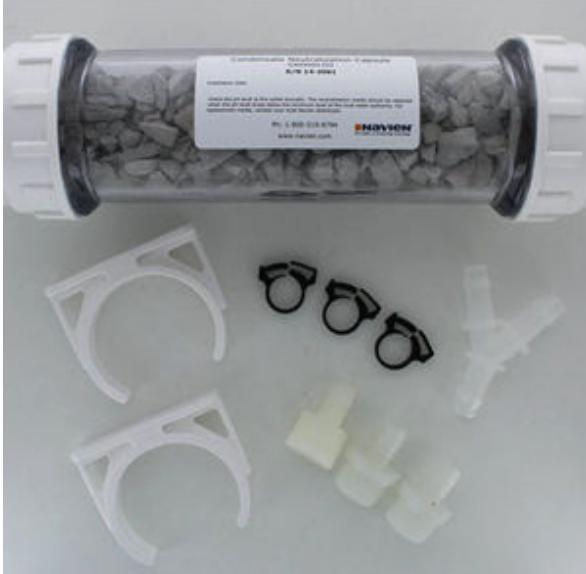
EXAMPLE: NAVIEN NEUTRALIZER

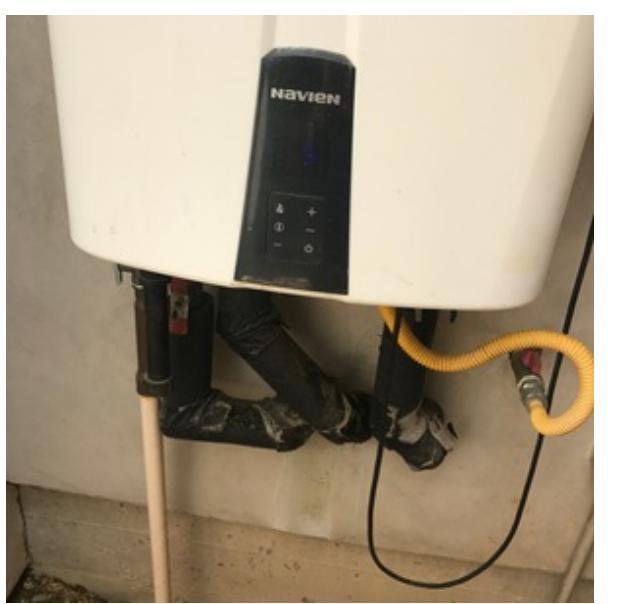
-Condensate Drain Lines Terminate at Foundation Walls: Drain Line Extensions Recommended Where Feasible (Improved Moisture and Insect Protection)

EXTEND CONDENSATE DRAINS

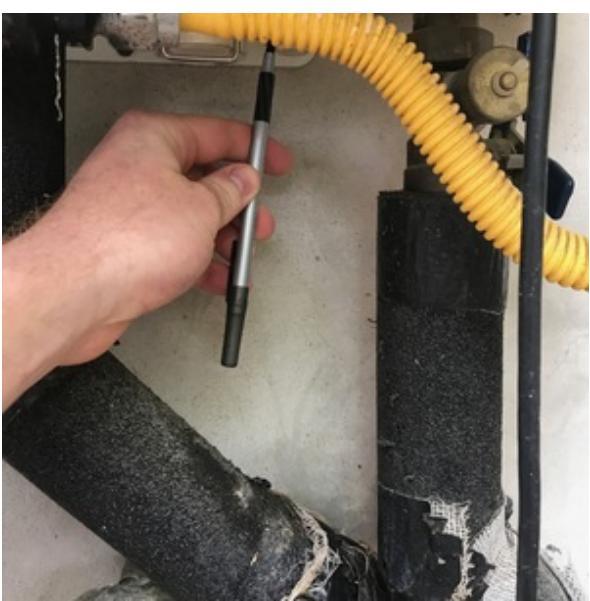
EXTEND CONDENSATE DRAINS

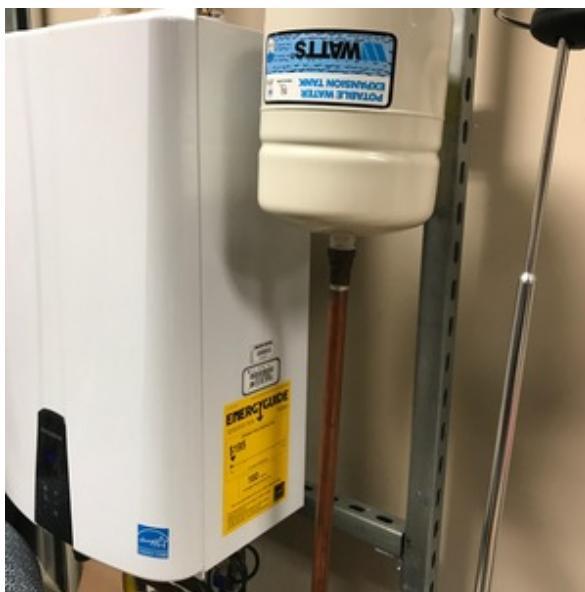
SECURE/LEAK PROTECT EXPANSION TANK

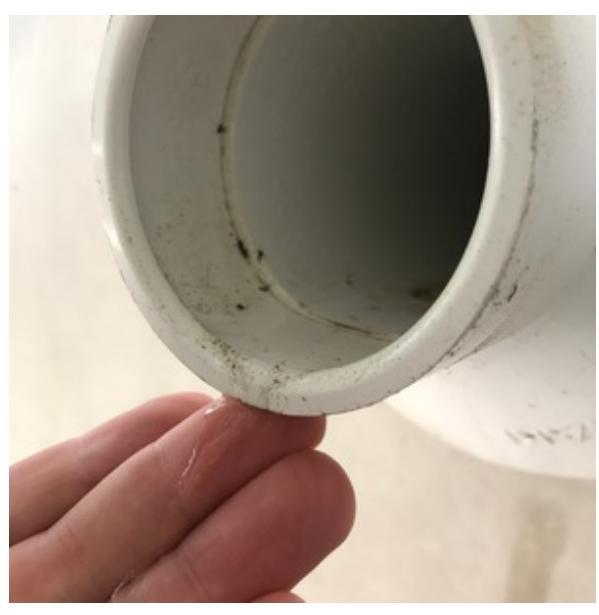
EXCESS CONDENSATE/EXHAUST FLUE

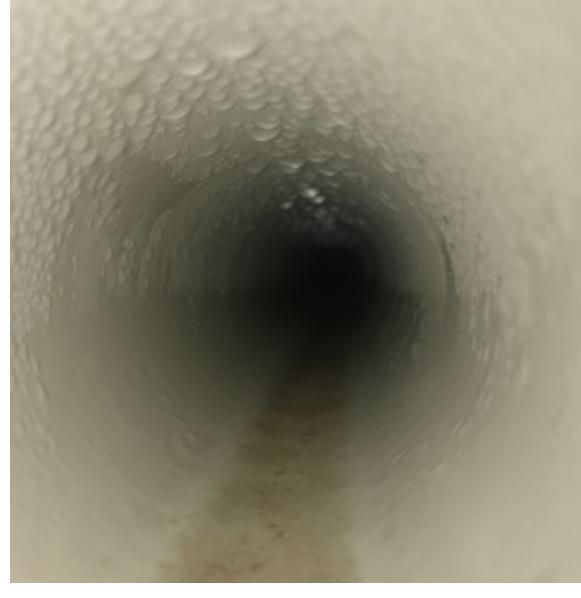
EXCESS CONDENSATE POOLING

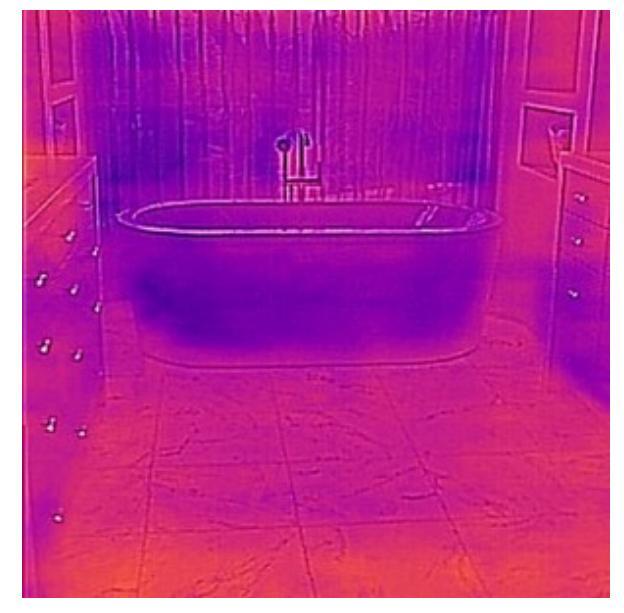
NORMAL READINGS - THERMAL CAMERA

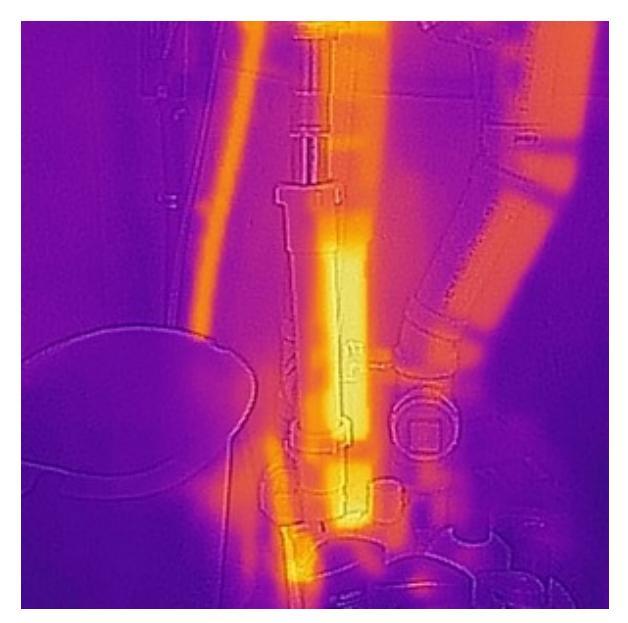
NORMAL READINGS - THERMAL CAMERA

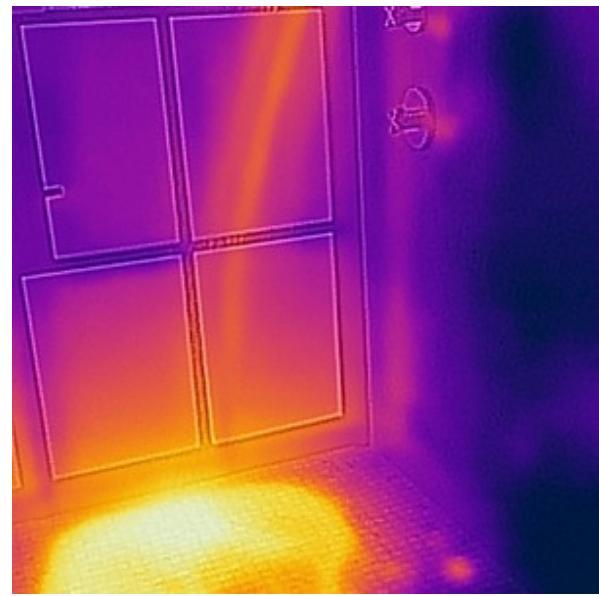
NORMAL READINGS - THERMAL CAMERA

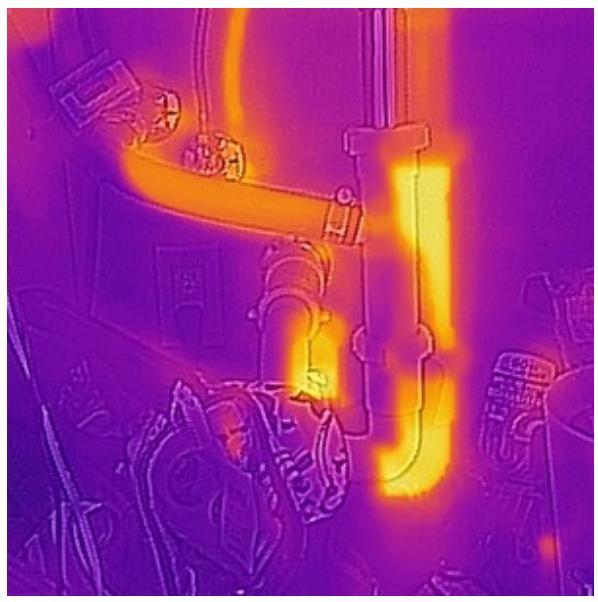
NORMAL READINGS - THERMAL CAMERA

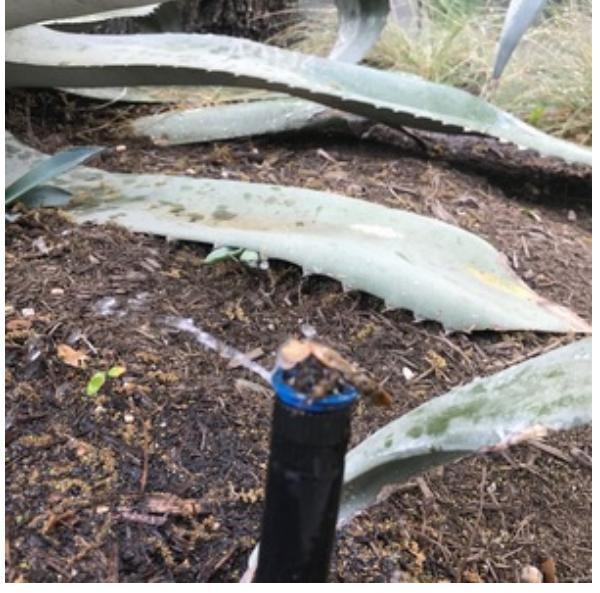
HEAD LEAK

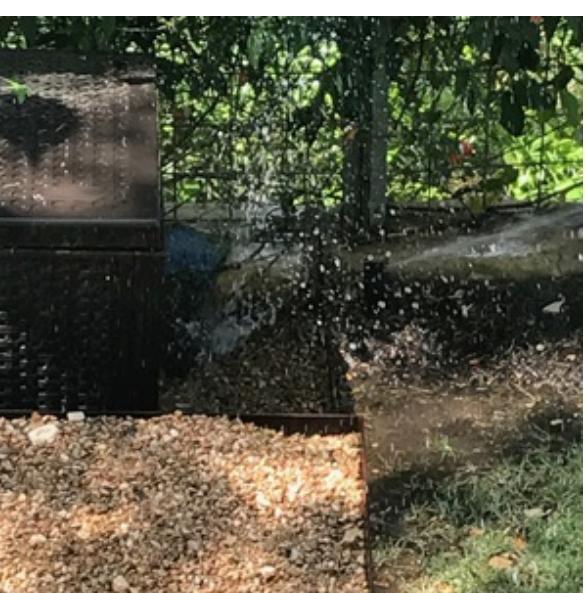
ZONE #3: Back Yard Flat Grass Area / 6 Rotating Sprayers / 1x Ruptured Head / Exposed Supply Lines / Physical Damage Concerns

RUPTURED HEAD

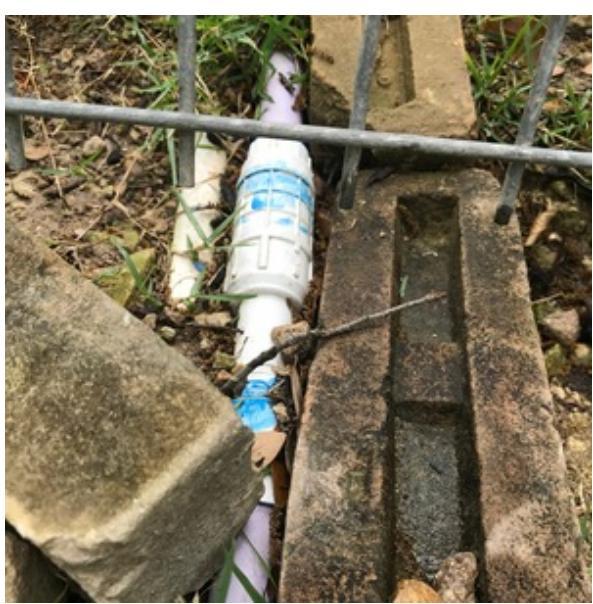
EXPOSED SUPPLY LINES
